I R Johnson MRICS, Chartered Building Surveyor

IRJ/AH/S1147/FBS

Introduction to the Report

*STREATLAM AND STAINTON STAINTON VILLAGE NZ O1 NE 13/216
Former farmhouse at West Farm*

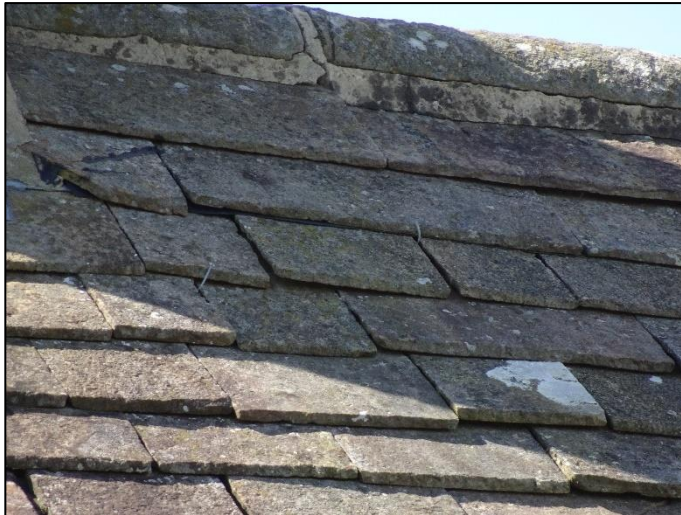
Photograph 6

- 3.1.5. There are numerous re-fixed slates and isolated damaged stone slates which should be programmed for replacement.

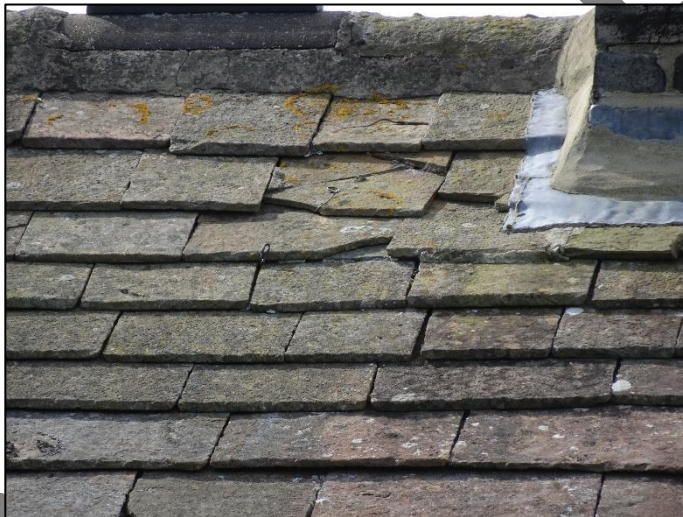
Photograph 10

3.1.6. The slates are nail fixed to the battens and consequently will be difficult to replace. Traditional methods are to fix the slates with pegs hung over the battens.

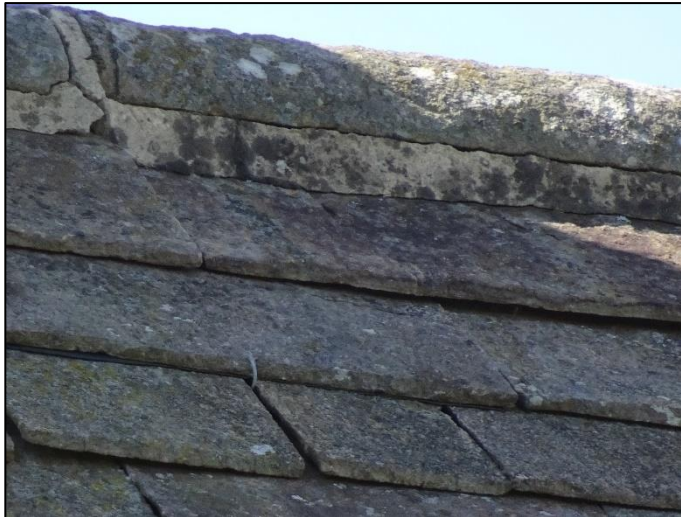
Photograph 11

- 3.1.8. There is slight undulation to the main roof, not unusual for a property of this age and type of construction.
- 3.1.9. The lean-to roof has natural non-interlocking clay pantiles and the single-storey roof over the garage and boot room has natural interlocking clay pantiles with mortar bedded and pointed angular stone ridges.
- 3.1.10. There are mortar pointed verges to the roofs. Isolated cracked mortar and some patch repairs have been previously undertaken.
- 3.1.11. No repairs are currently required.
- 3.1.12. There is a stone water table bed to the right side of the main roof and left and right sides of the front lean-to roof.

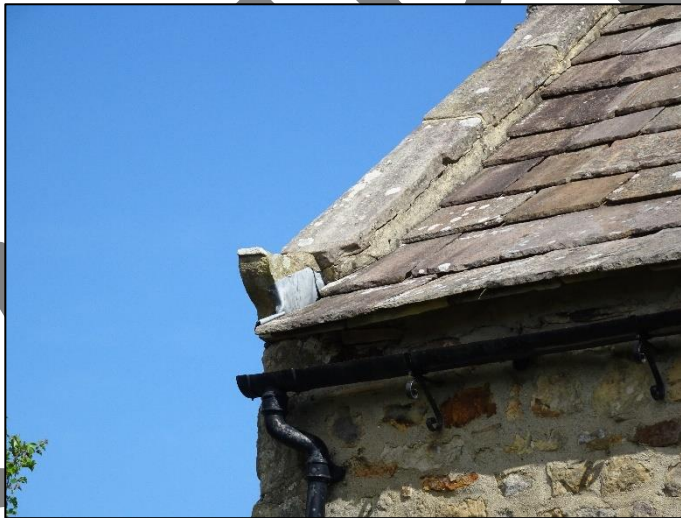
Photograph 14

- 3.1.15. The pointing/bedding to the front right has been replaced but to the rear there is cracked and eroding mortar which will require replacement.

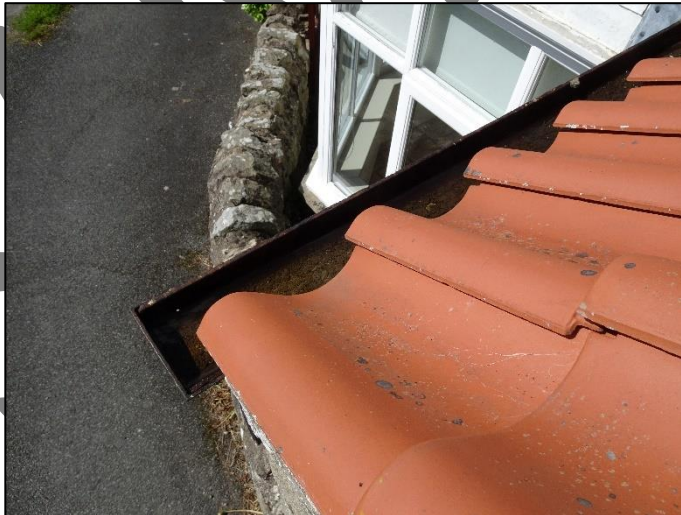
Photograph 25

- 3.3.4. The cast iron gutters discharge to cast iron rainwater downpipes and the plastic gutters to a plastic downpipe.
- 3.3.5. The weather remained dry during the survey and therefore the gutters were not seen under operational conditions.
- 3.3.6. To the rear right, the roof slates project beyond the gutters and therefore rainwater will miss the gutters.

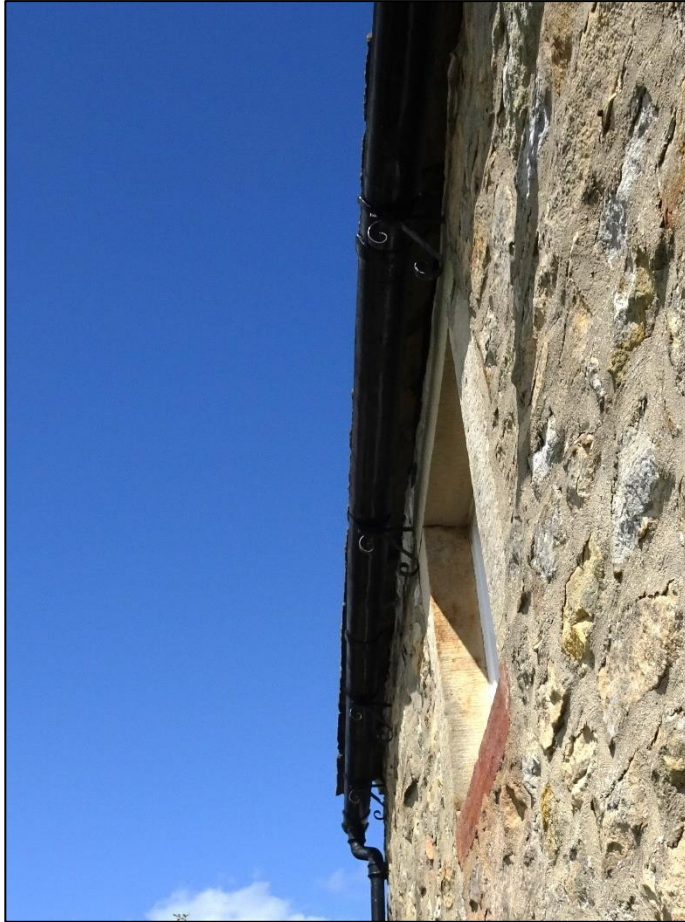
Photograph 26

- 3.3.7. The gutters are also positioned significantly below the level of the roof slates and I would recommend that these are adjusted accordingly.
- 3.3.8. There is no evidence of any leaks to the rainwater gutter joints.
- 3.3.9. The cast iron gutters are fixed on traditional drive-in brackets to the main roof and fascia brackets to the single-storey roofs.
- 3.3.10. There is a lead lined abutment gutter where the garden room roof abuts the rear of the garage and boot room.

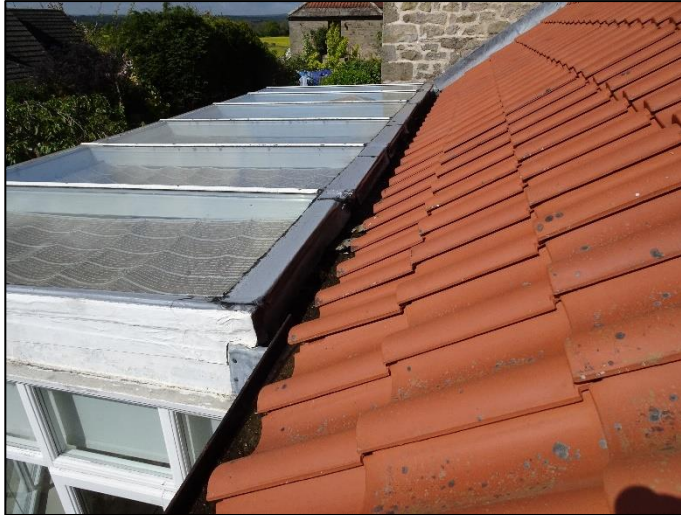
Photograph 28

- 3.3.11. The lead lining was seen to be in satisfactory condition, however it does not appear to have been installed in accordance with The Lead Association, Guide to Good Site Practice and will have limited life expectancy.

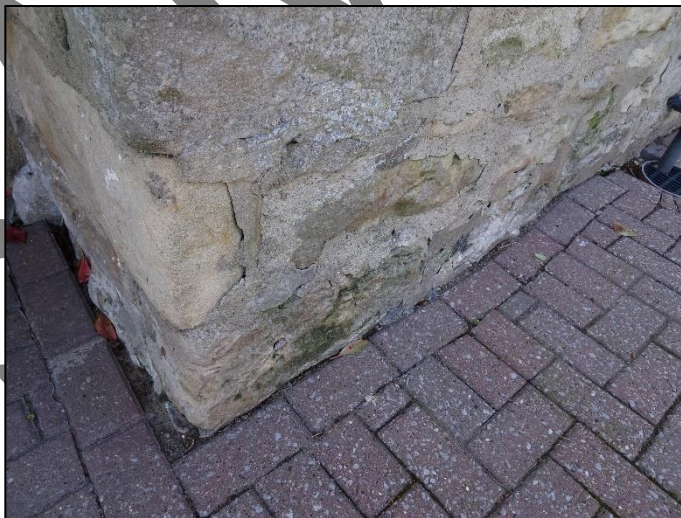
Photograph 32

- 3.4.15. There are isolated areas of open and loose mortar joints requiring re-pointing.

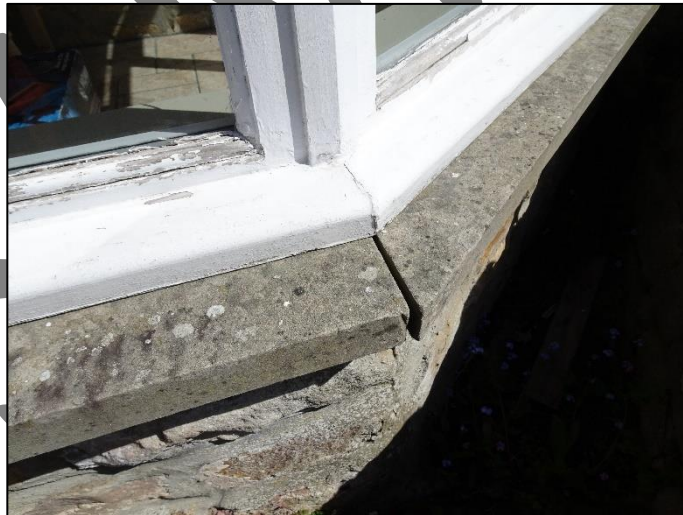
Photograph 36

- 3.4.27. Window and door reveals are mortar pointed.
- 3.4.28. There is isolated cracking to some of the pointing which will require replacement as part of future maintenance and repairs.

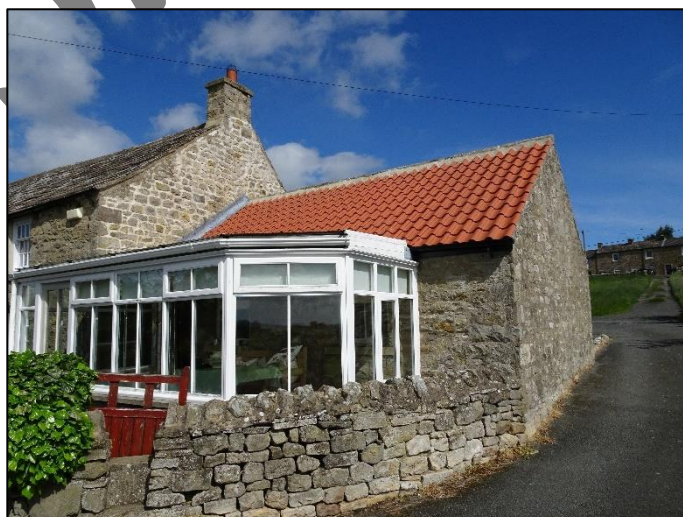
Photograph 40

- 3.5.10. There is decay to the timberwork which requires repair, although I anticipate replacement will prove to be necessary.

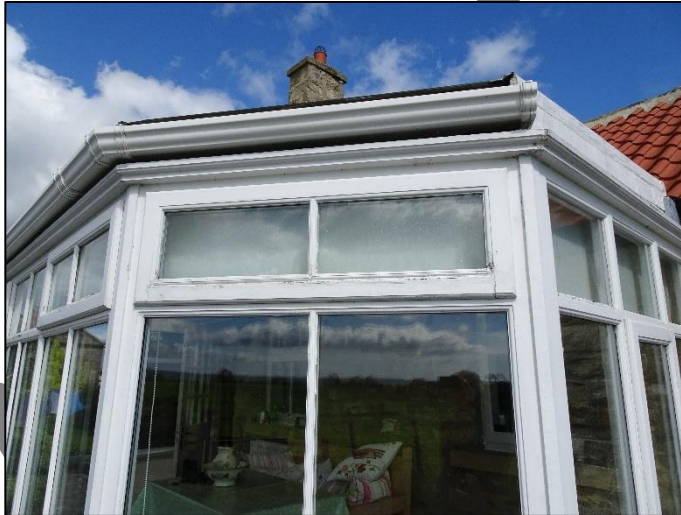
Photograph 42

- 3.5.11. Numerous glazed units have failed and should be replaced.
- 3.5.12. The roof is of timber frame construction with double-glazed units.
- 3.5.13. Flash band has been installed over the timbers to prevent water penetration.

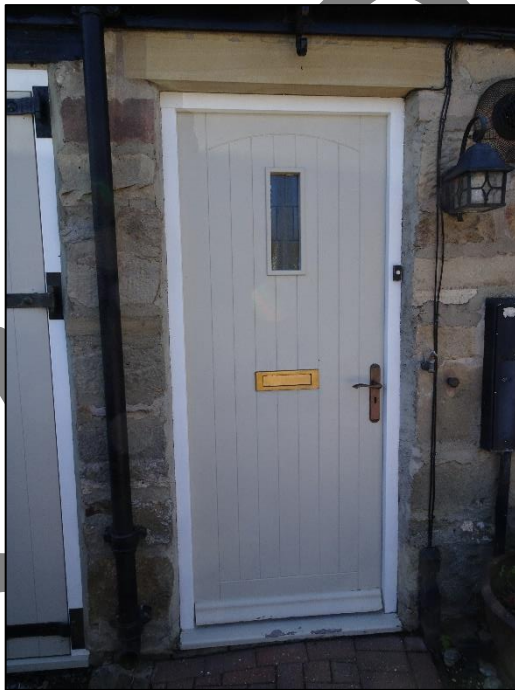
Photograph 47

- 3.5.15. The doors are currently in satisfactory condition.
- 3.5.16. The garden room door is a panelled and glazed door which has evidence of decay.
- 3.5.17. The door binds in the framework and has been planed numerous times and has not been re-decorated.
- 3.5.18. The handles/latch are defective.

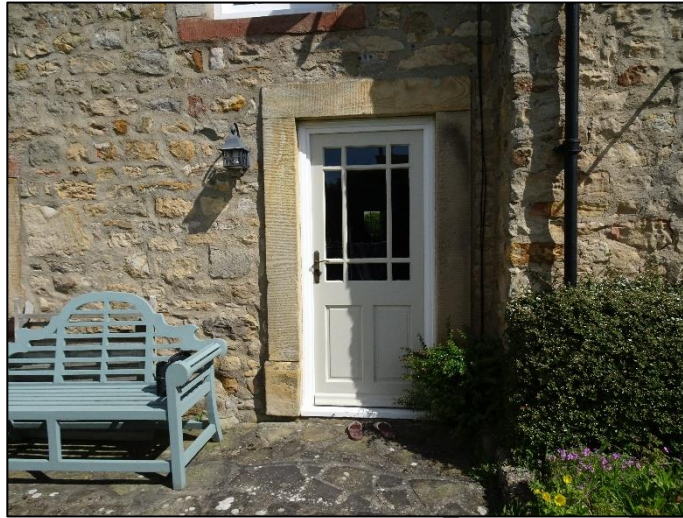
Photograph 48

- 3.5.20. The door has been previously planed and the wood has not been re-decorated.
- 3.5.21. If left undecorated, the wood will expand and require adjustment again.
- 3.5.22. There are two pairs of vertical boarded garage doors which are in good condition.
- 3.6. **External Grounds and Boundaries**
- 3.6.1. The property occupies a sloping site with gardens to the front and rear.
- 3.6.2. Access is via a private drive from the public highway which has a tarmacadam surface.

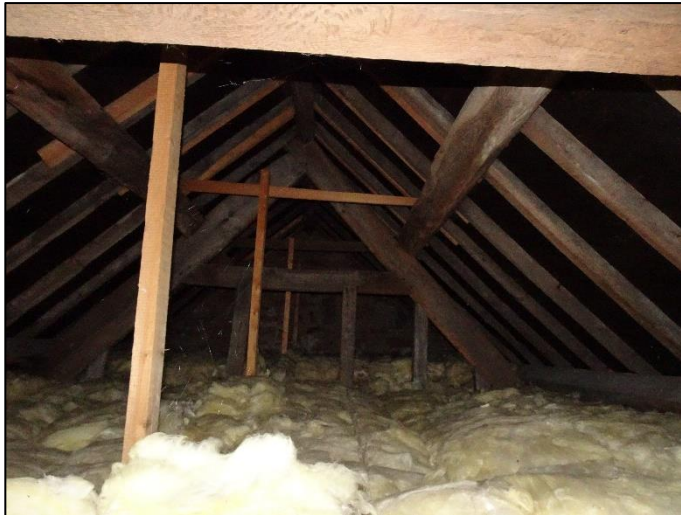
Photograph 63

- 3.7.8. There is evidence of significant woodworm infestation to some of the principal roof timbers, although none of this was noted to be active.
- 3.7.9. Strengthening has been undertaken and numerous rafters have been replaced.

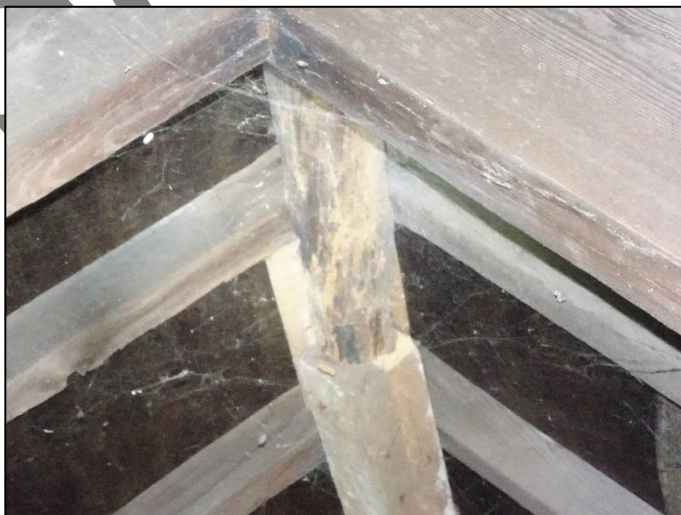
Photograph 69

- 3.7.19. There is old woodworm infestation noted to the timbers.
- 3.7.20. There is a bitumen-based roofing felt draped over the rafters which has a hole to one area and ideally would be patch repaired, although this is difficult.

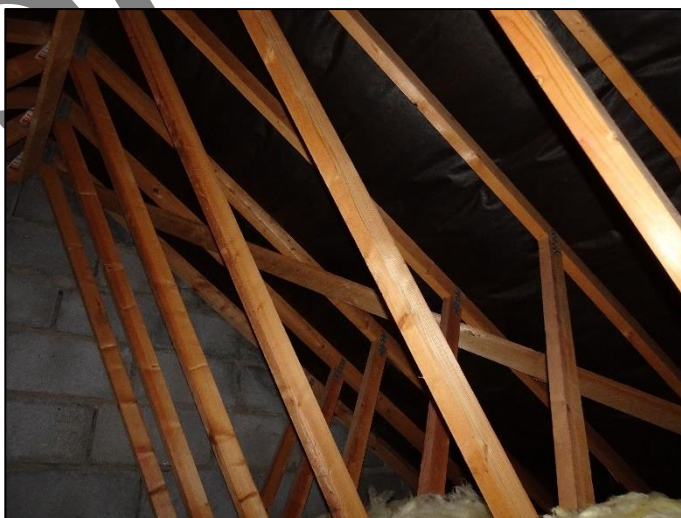
Photograph 76

- 3.7.34. There are no lateral restraint straps to the gable and ideally these would be provided.
- 3.7.35. The roof structure is braced to a reasonably good standard but not full in accordance with current guidelines.
- 3.7.36. The bitumen underfelt will have decayed where it is draped into the gutters and consideration should be given to the fitting of plastic eaves trays.

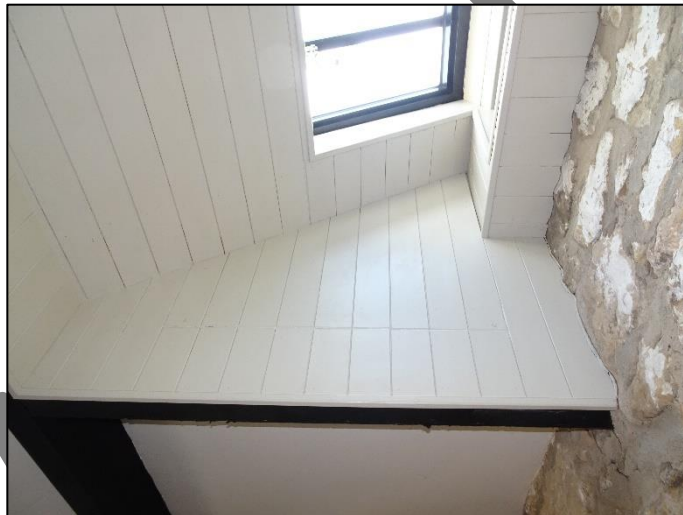
Photograph 77

- 3.8.3. There is some undulation and cracking to the lath and plaster ceilings, in particular the bathroom ceiling.

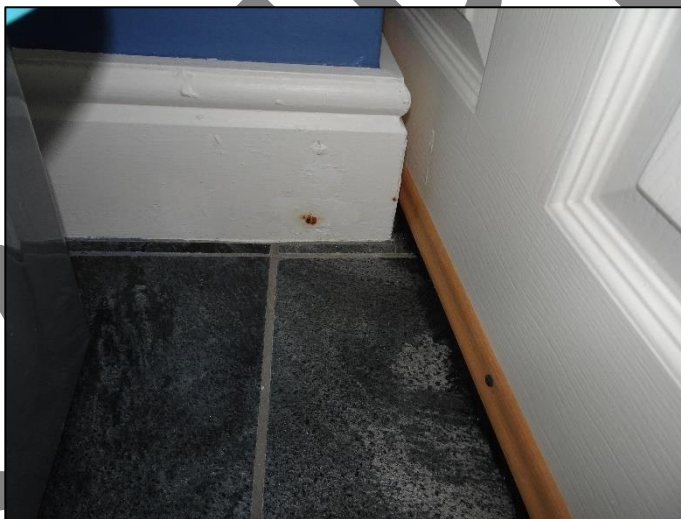
Photograph 87

- 3.9.9. There is some damp staining either side of the kitchen entrance door.

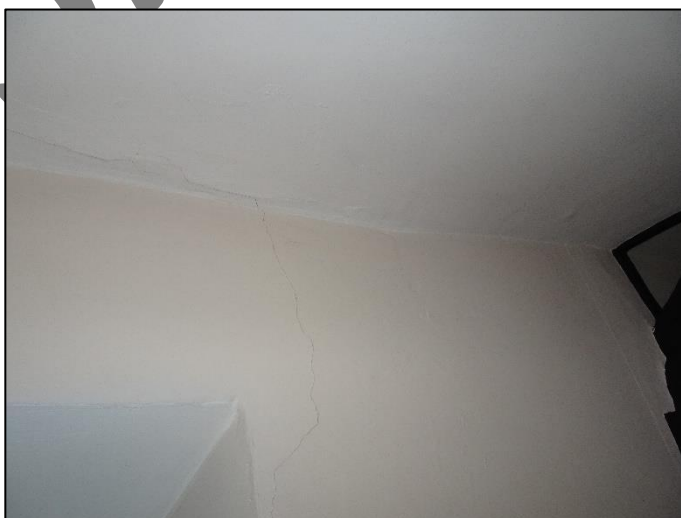
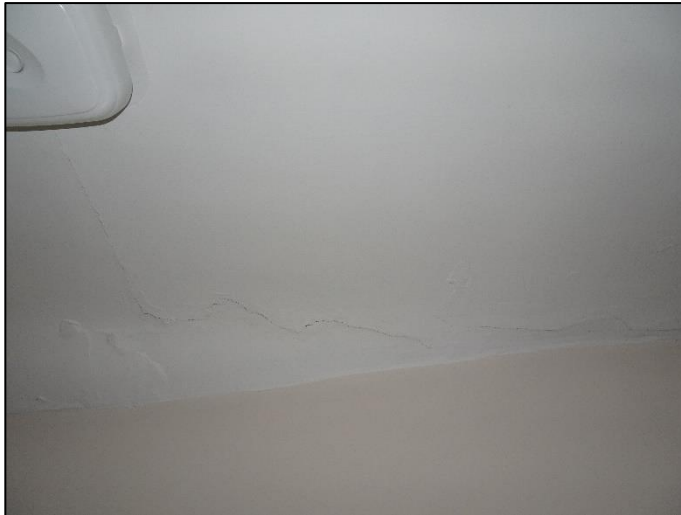
- 3.9.14. There is hairline cracking above the landing window which extends into the ceiling as a result of deflection of the floors onto which the stud partitions are constructed.

- 3.9.15. I do not anticipate that this will become significantly worse, but it is likely that if the crack has filled, it will re-open.
- 3.9.16. There is some deterioration of the paint finishes in the landing window due to penetrating dampness and which will prove difficult to eradicate.
