IRJ/AD/AH/EC/S1214/L3

Introduction to the Report

Instructions received are to carry out an RICS Level 3 Building Survey of the property which were accepted and confirmed in my letter of the

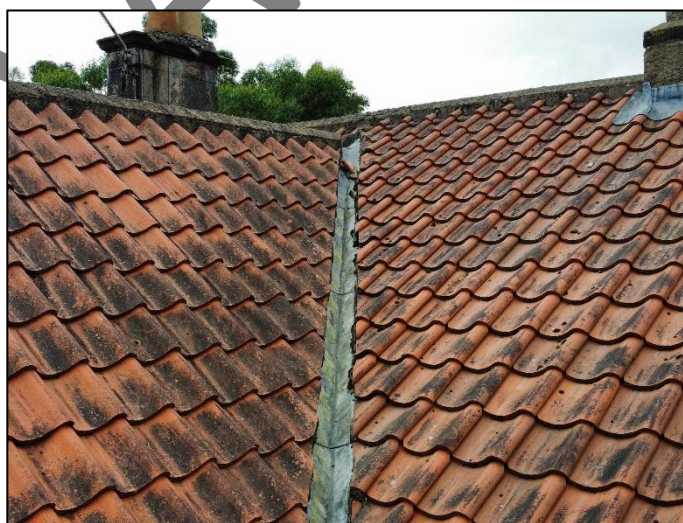
Photograph 10

- 3.1.8. Mortar pointing to some of the tiles bedded onto the valley is loose/missing and there are isolated broken/damaged tiles which should be replaced where necessary.

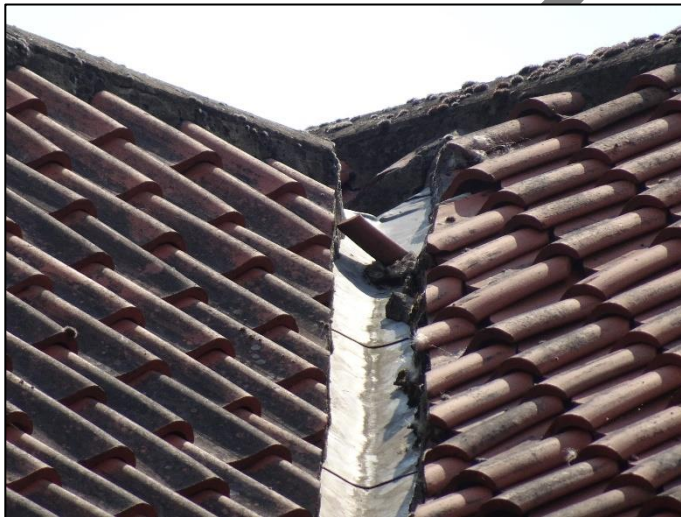
Photograph 15

- 3.1.9. The roof slopes were seen to be free from significant defects, on an even plane with no significant undulation or deflection.
- 3.1.10. There are upstands with stone water table to each of the gable apexes.
- 3.1.11. The water tables to the rear slopes of the left and right-side wings are bedded onto the pantiles.
- 3.1.12. To the left side wing, there is a damaged water table which should be replaced.

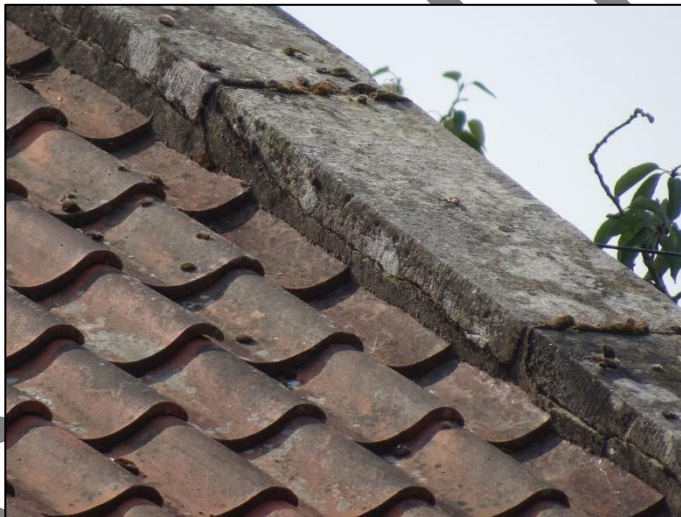
Photograph 17

- 3.1.13. Mortar pointing between the roof tiles and stone water tables is cracked and missing to some areas and will require replacement as part of routine ongoing repairs and maintenance.

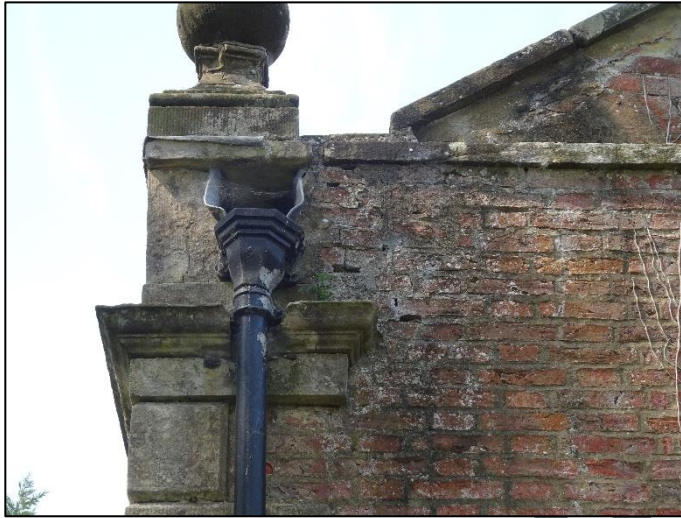
Photograph 22

- 3.1.16. To the front-right wing and left side of the central main roof, water staining is evident to the base of the water tables as a result of water running over the sides of the lower water tables.

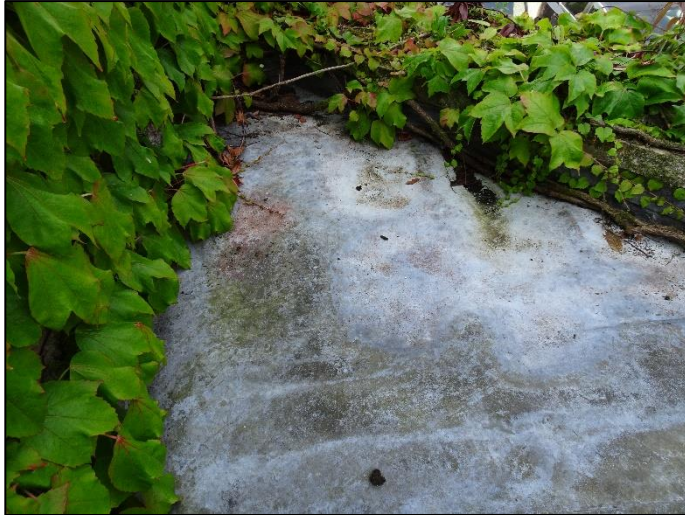
Photograph 29

- 3.1.28. There is evidence of ponding water to the roof and the deck was noted to be soft underneath as a result of previous water penetration.

- 3.1.29. The leadwork and deck will require replacement to this area.
- 3.1.30. The leadwork is splitting to the rear right, requiring replacement.

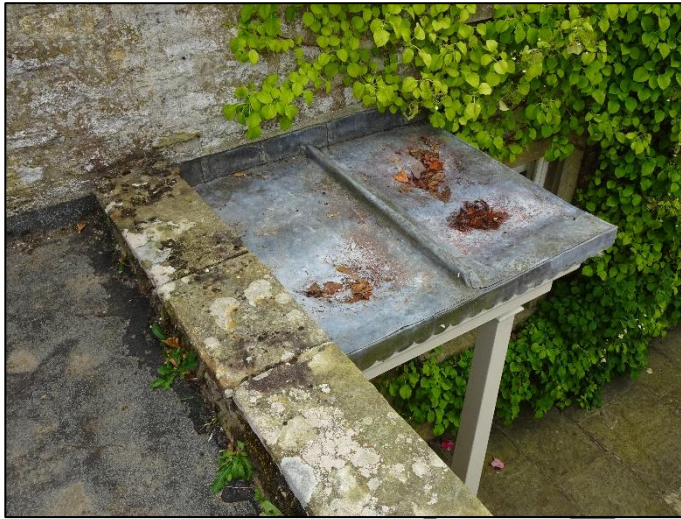
Photograph 32

- 3.1.31. To the rear of the offshoot there is a lead covered flat roof over the entrance door. The deck is distorted indicating previously defective lead however the roof has been re-covered. The deck will require replacement in the future.

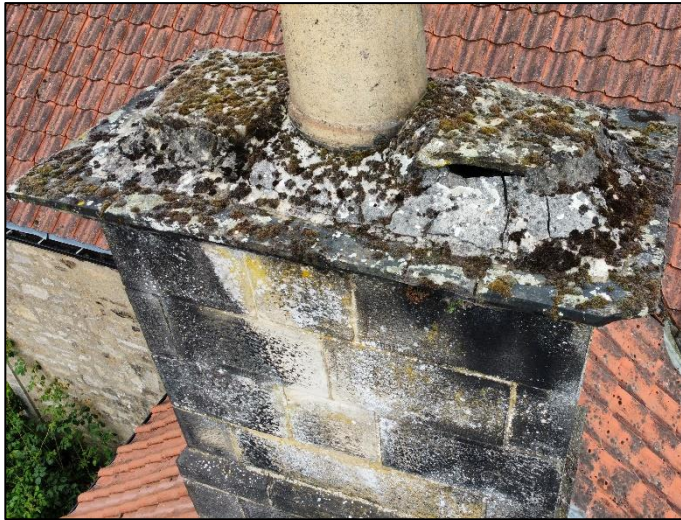
Photograph 34

- 3.2.1. There are nine chimney stacks serving the property, all of which terminate with clay pots.
- 3.2.2. The pots are mortar bedded and flaunched.
- 3.2.3. To stack No. 8, two flues are capped off with stone flags. The mortar flaunching is defective requiring replacement.

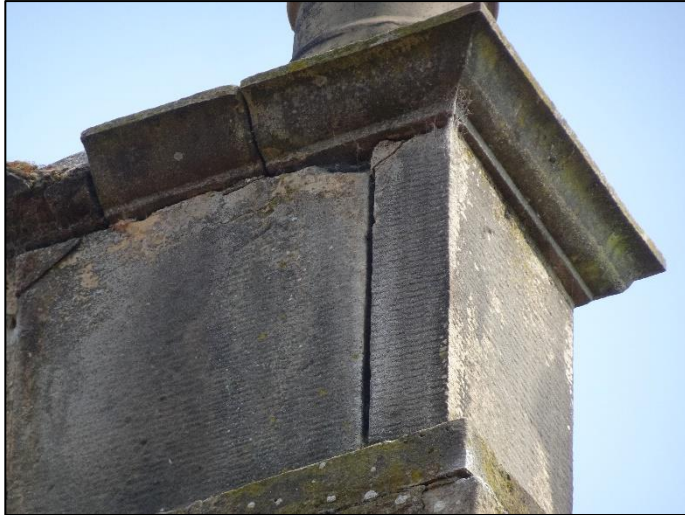
Photograph 48

- 3.2.9. There is eroded and cracked stonework and damaged/eroded cornice to the older stacks (2, 3 and 4).

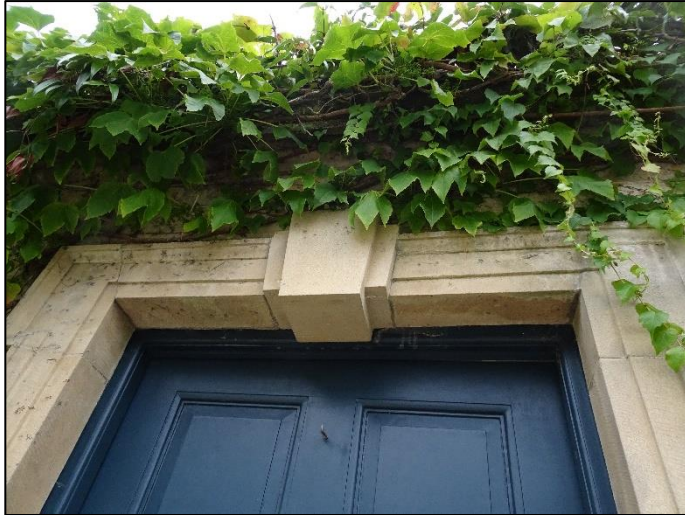
Photograph 64

- 3.4.7. The key stone to the entrance vestibule door has been replaced and the door head has dropped towards the key stone. This is not considered to be progressive in nature.

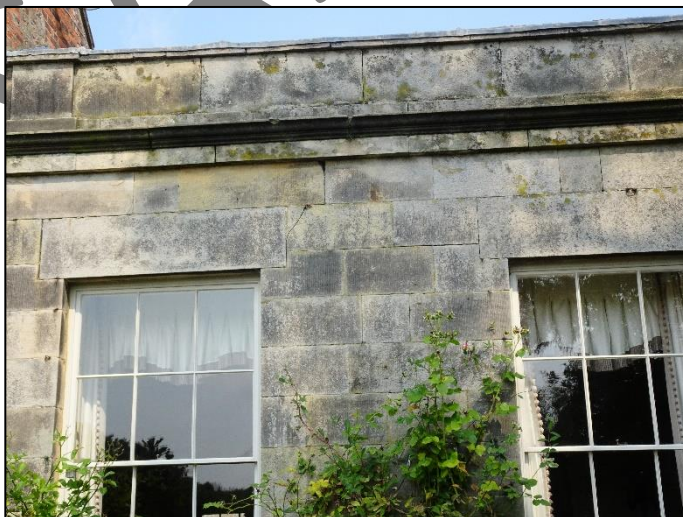
Photograph 71

- 3.4.12. There has been structural movement to the right-side wing, evidenced by cracked and sloping masonry and distorted window openings. The movement is old standing and there is no evidence of a progressive nature to the movement.

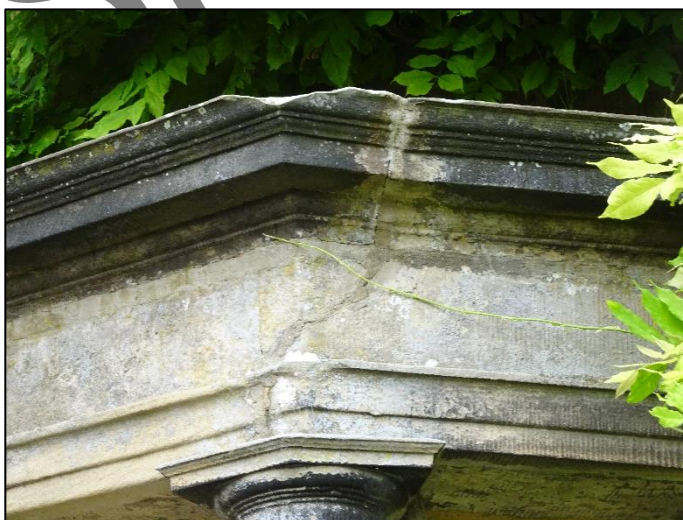
Photograph 76

3.4.17. There is previous cracking evident to the left-side bay which has been re-pointed and the cracks have not re-opened.

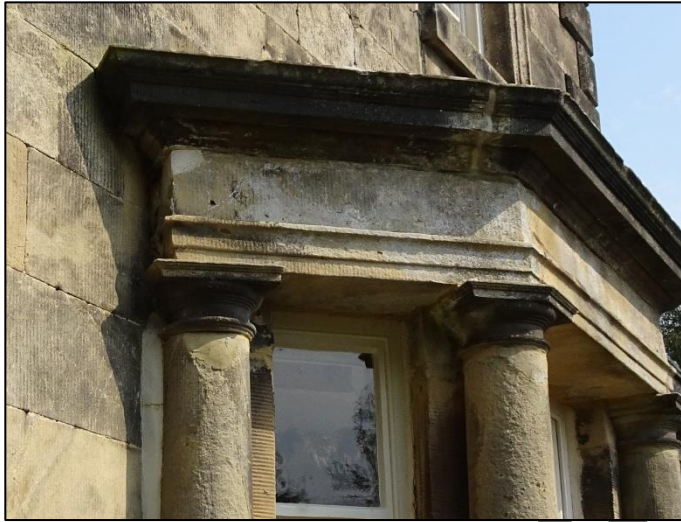
Photograph 77

- 3.4.18. Repairs to eroded stone have been previously undertaken to a poor standard and this should be carefully removed and repairs made with a lime mortar.

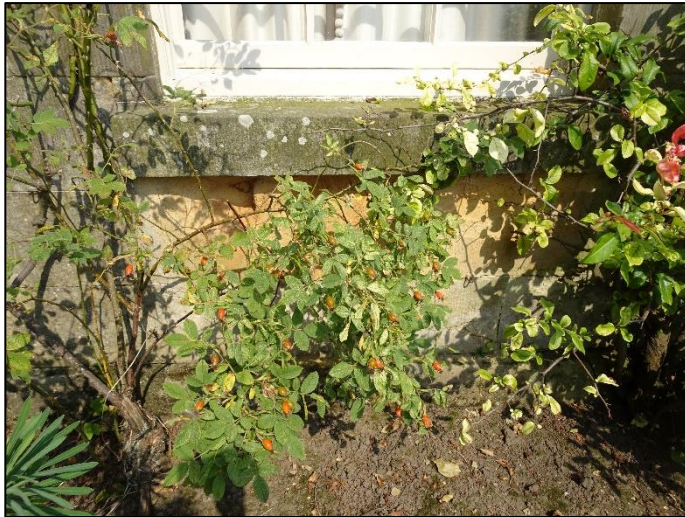
Photograph 79

- 3.4.20. There is deteriorating stonework beneath the two original window openings, particularly the window closest to the central bay and which will require replacement as part of ongoing repairs and maintenance.

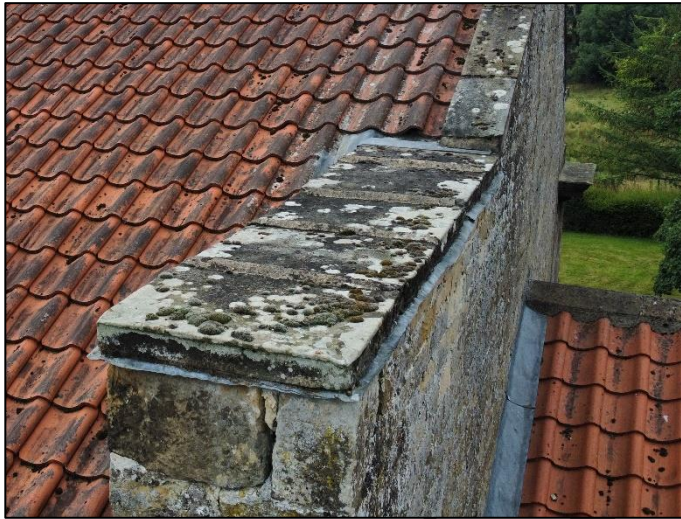
Photograph 85

- 3.4.25. There is an upstand to the rear left of the main bay with stone coping over a lead damp-proof course to the top. There is deterioration of stonework and mortar joints and splitting to the leadwork requiring re-pointing of the masonry and replacement of the defective lead.

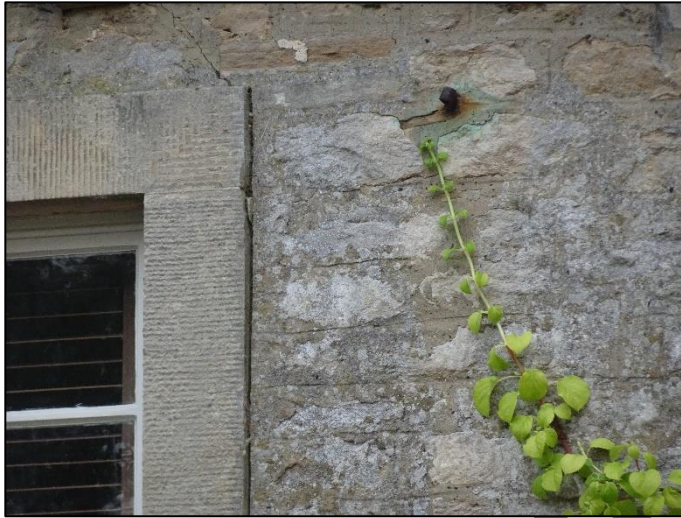
Photograph 91

- 3.4.37. There is minor cracking at higher level to the right-side elevation of the offshoot, which is not considered to be of structural concern and should be re-pointed.

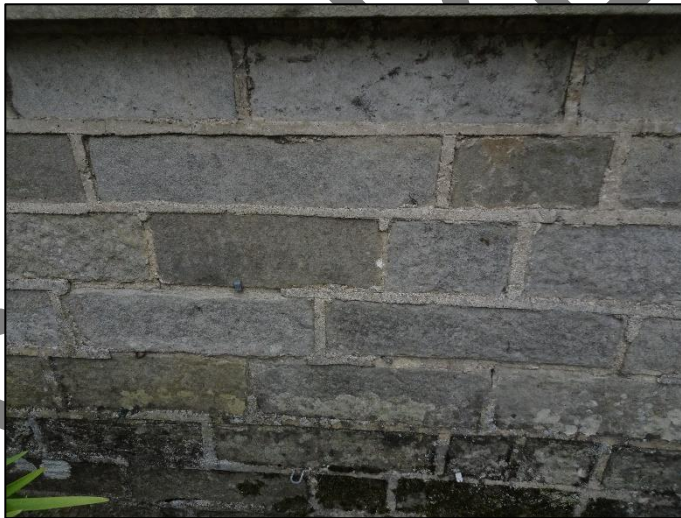
Photograph 92

- 3.4.38. The entrance vestibule has a ribbon style pointing, areas of which are now loose and should be re-pointed.

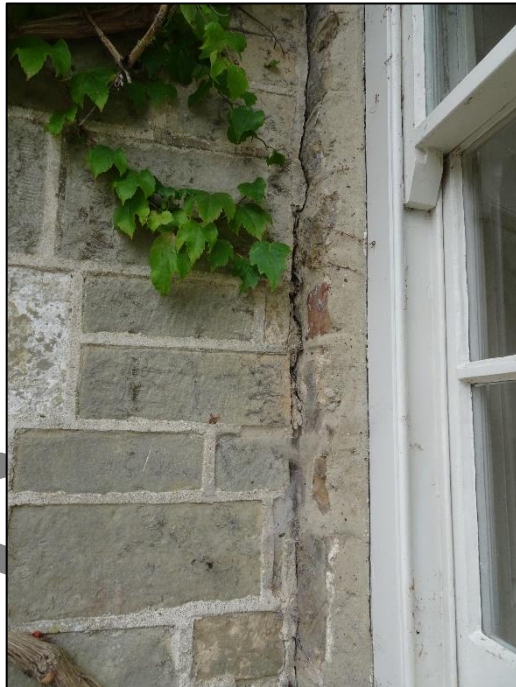
Photograph 97

- 3.4.42. At the abutment of the entrance vestibule, mortar has eroded, leaving a substantial gap which should be re-pointed.

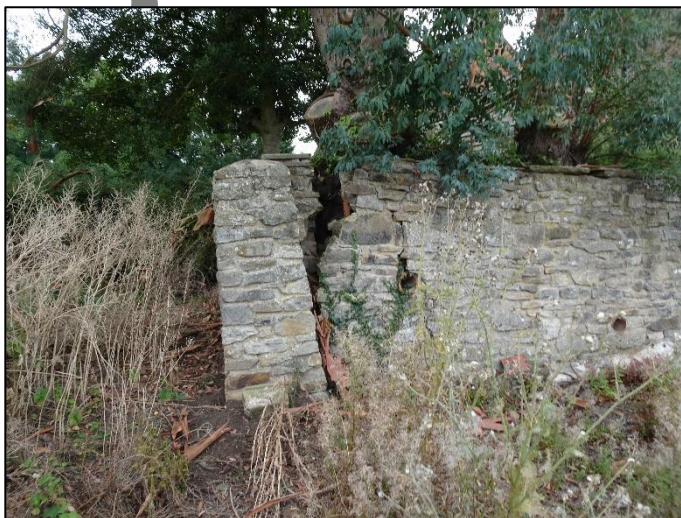
Photograph 109

- 3.6.4. There is a holly tree and large eucalyptus trees to the front-right corner which have caused the wall to lean outwards and will continue to do so until the walls collapse.

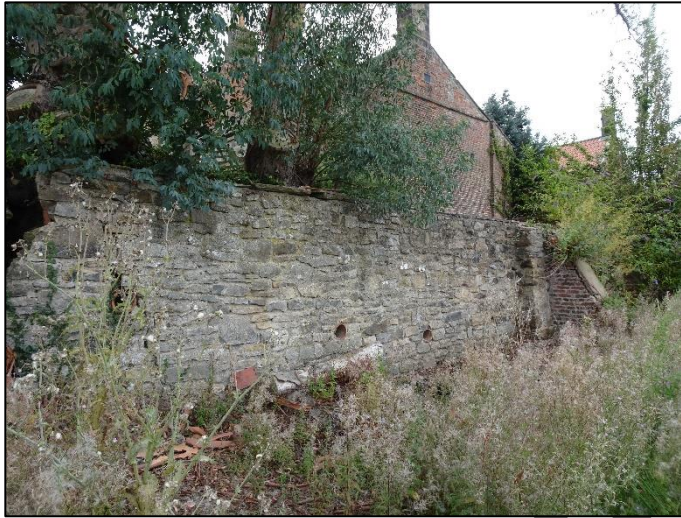
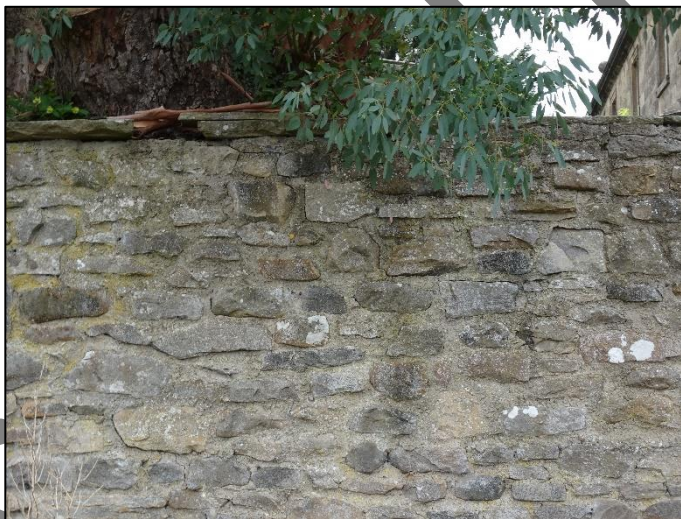
- 3.6.5. To the right corner, a substantial area of wall has been re-built, however cracking has once again occurred due to the eucalyptus tree roots.

- 3.6.6. I would recommend that the tree is removed and the wall re-built as necessary.
- 3.6.7. There are brick-built buttresses to the right side which are deteriorating.

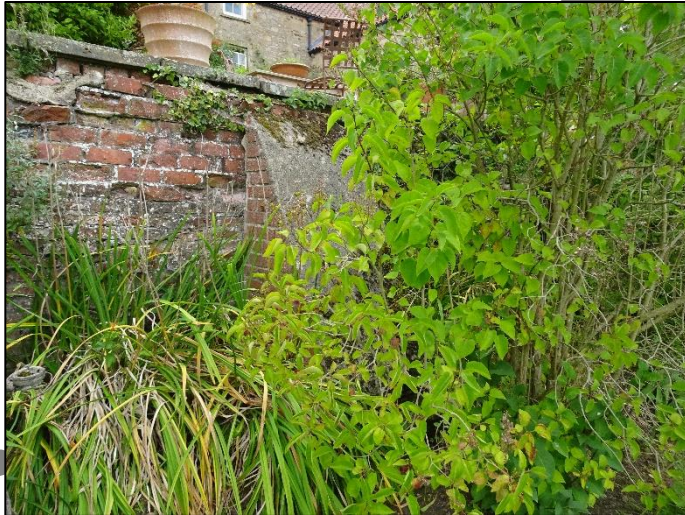
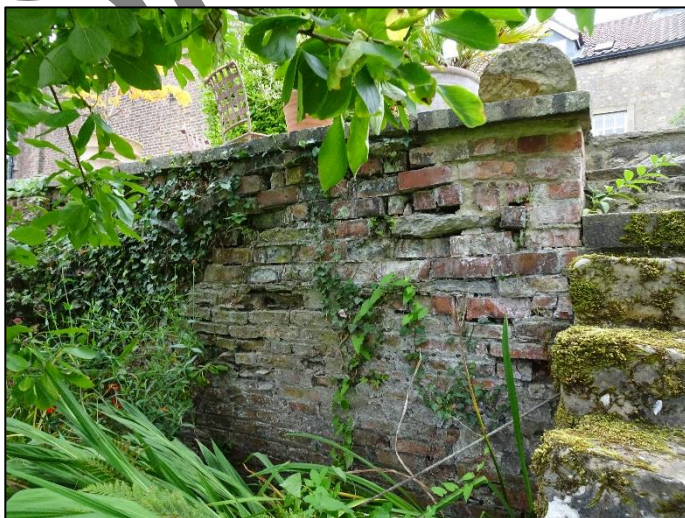
- 3.6.8. Beyond the first buttress, the ha-ha wall is of brick construction, suffering general deterioration and open mortar joints.

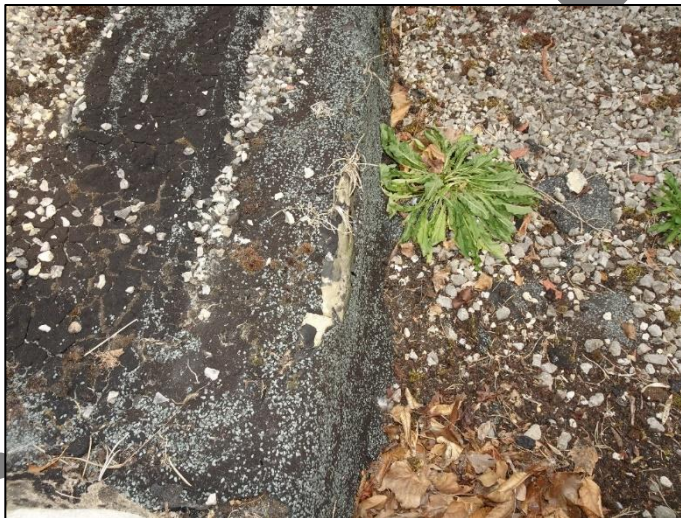
Photograph 145

- 3.7.3. The covering is in poor condition, with numerous splits noted and should be stripped and replaced.

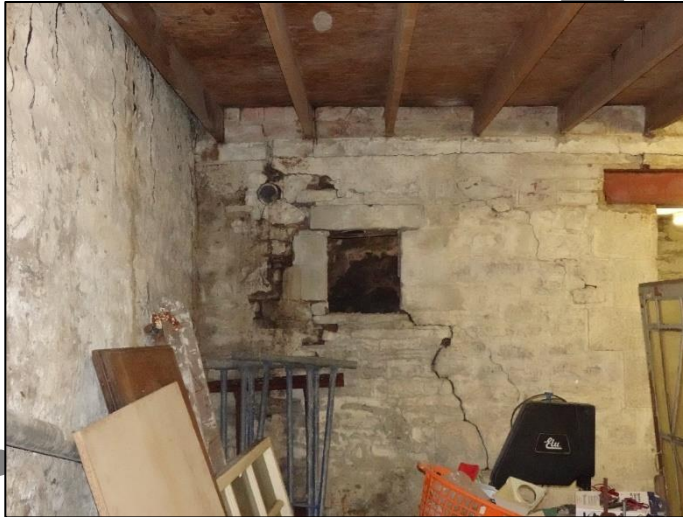
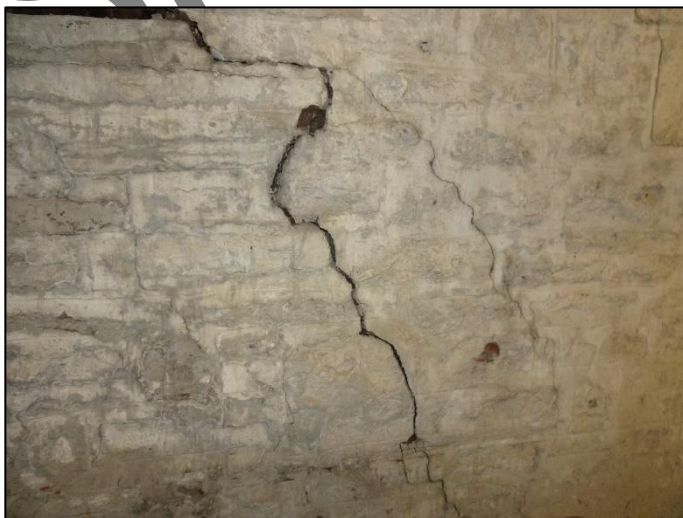
- 3.8.3. There is structural cracking to the internal walls within the main garage area as a result of movement to the rear walls.

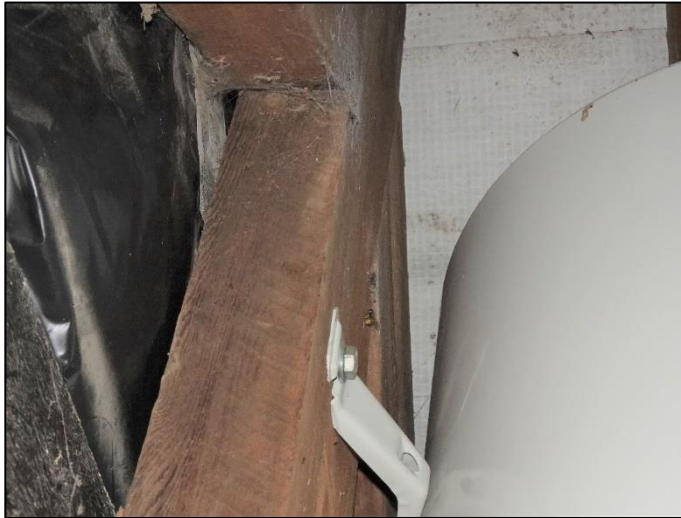
Photograph 167

- 3.10.15. The principal truss appears to be pulling slightly because of the weight of the tank.

- 3.10.16. The upper support brackets to the tanks appear to be bending slightly.
- 3.10.17. I would recommend the tank is relocated and not fixed to the truss.
- 3.10.18. There are expansion header tanks which have insulation fitted.
- 3.10.19. Access to the main roof void, over the left section of the main part of the property is gained via a hatch located to the ceiling of bedroom 1 with retractable loft ladder.
- 3.10.20. There is mains-wired power and lighting provided to the roof void.
- 3.10.21. The roof structure is traditional comprising two principal trusses supporting three rows of purlins to each roof slope in turn supporting common rafters.
