I R Johnson MRICS, Chartered Building Surveyor

IRJ/AH/S1596/L2

Introduction to the Report

Instructions received are to carry out an RICS Level 2 Building Survey of the property which were accepted and confirmed in my letter of the

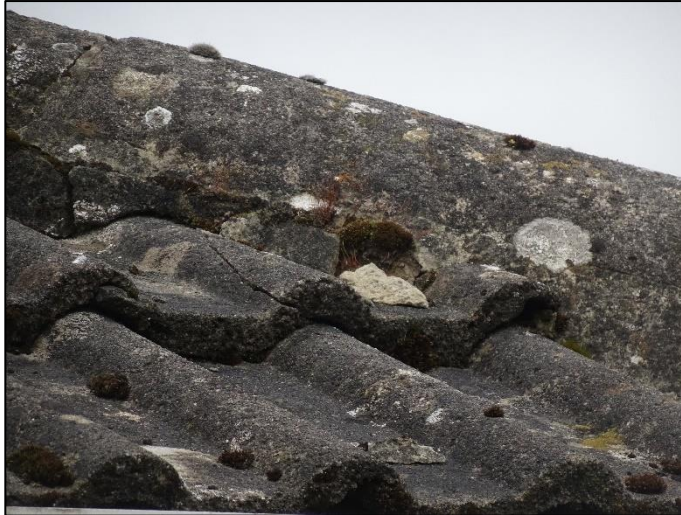
Photograph 3

- 3.1.7. There is an isolated cracked tile evident to the front-left corner and there may be others, although the cracked tile is not damaged to an extent whereby water penetration would be a problem.

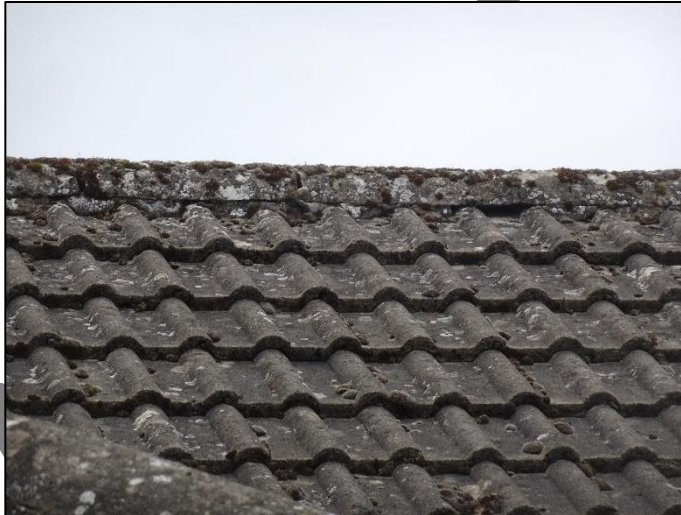
Photograph 4

- 3.1.8. Mortar to the ridges is eroding, cracked and partially missing to some areas and should be replaced.

- 4.4. The roof covering is approaching the end of its anticipated design life expectancy, with perhaps another 10-15 years' useful life remaining.
- 4.5. Mortar bedding and pointing to the ridges is eroded, cracked and missing, some areas requiring replacement.

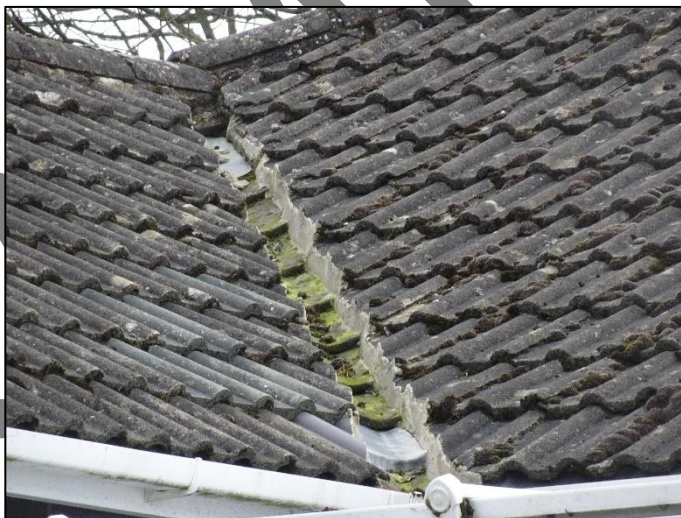
Photograph 7

- 3.1.9. At the intersection of the roof slopes there are valley gutters.
- 3.1.10. I understand from the vendor that the valley has recently overflowed due to blockage, causing damage to the ceiling below, which has been repaired and the valley tiles re-pointed.
- 3.1.11. The valley is tiled, although two pieces of lead have been inserted, I assume where valley tiles may have broken.

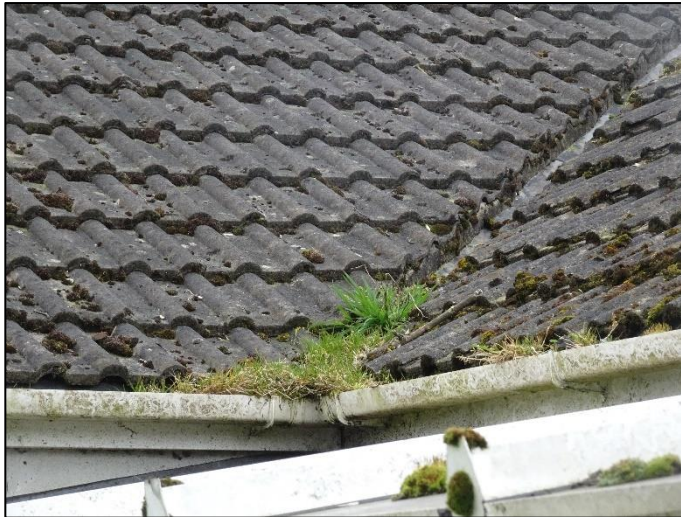
Photograph 8

- 3.1.12. The rear valley is lead lined and has significant vegetation growth to the base, requiring clearing out.

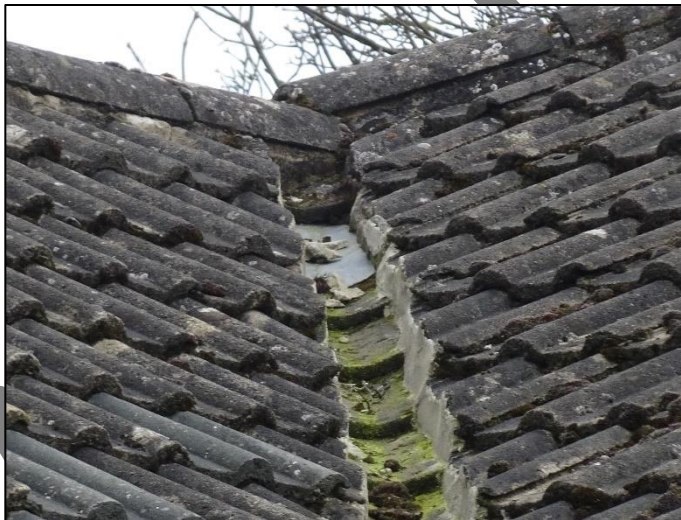
Photograph 9

- 3.1.13. There is some defective/loose mortar pointing to the underside of tiles bedded into the valleys which requires replacement.

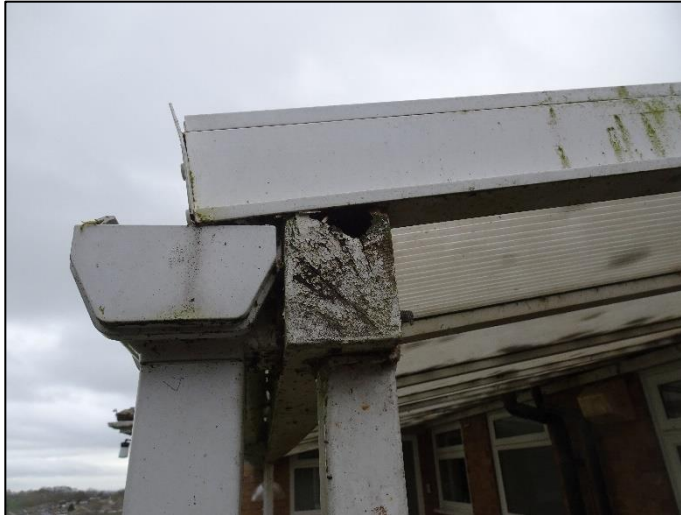
Photograph 11

- 3.1.15. There is a polycarbonate sheet roof to a canopy over the rear of the property.
- 3.1.16. The canopy is supported on steel posts and timber framework.
- 3.1.17. There is decay to some of the timber eaves beam on the left corner which will require repair/replacement in the short to medium term.

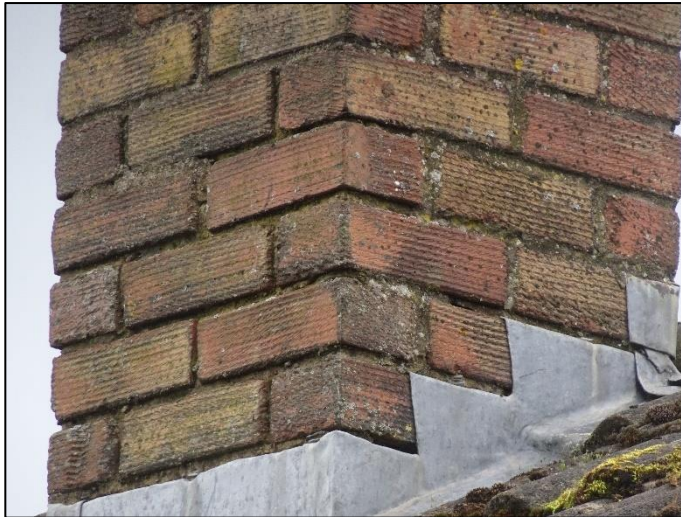
Photograph 13

- 3.2.2. Mortar joints to the brickwork are eroding and should be programmed for re-pointing.

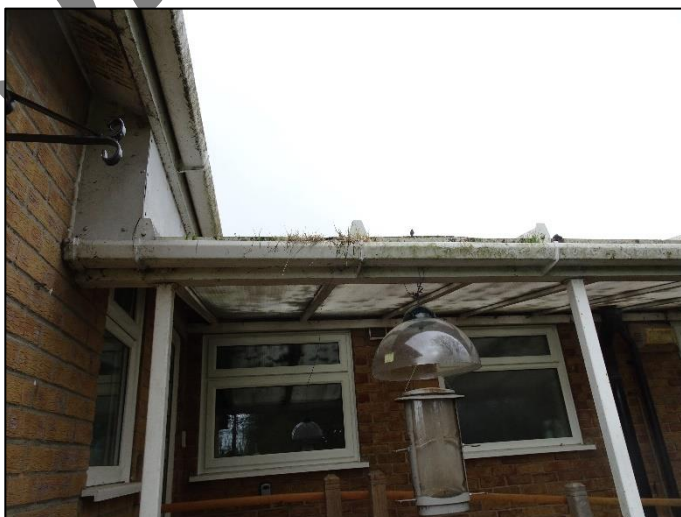
Photograph 14

- 3.3.2. The weather remained dry during the survey and therefore the rainwater goods were not seen under operational conditions.
- 3.3.3. There is vegetation visible in the gutters which should be cleaned out.

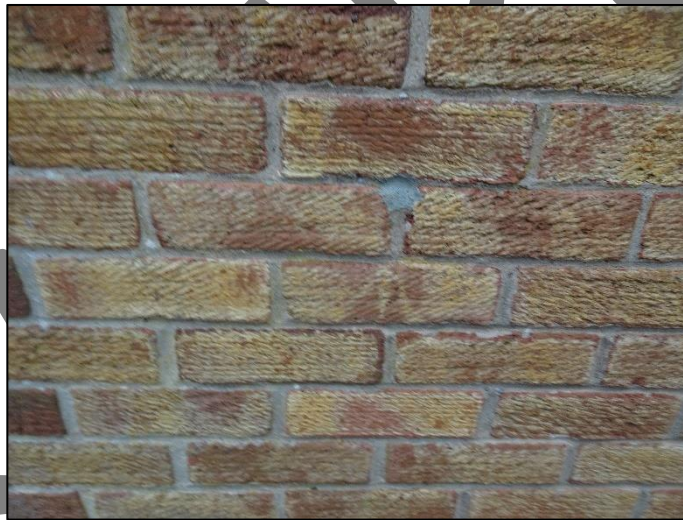
Photograph 16

- 3.4.9. Pointed up drill holes to the original walls indicate that cavity wall insulation has been injected, however this was undertaken prior to purchase by the vendors and I believe that there is no paperwork available.

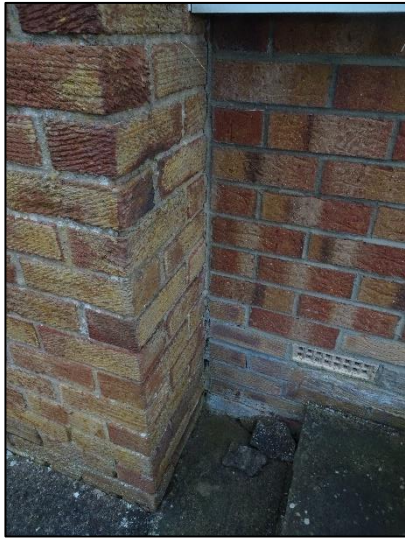
Photograph 17

- 3.4.10. Injected cavity wall insulation can cause problems of dampness internally however there were no such problems evident.
- 3.4.11. At the abutment of the conservatory dwarf walls and original walls there is hairline cracking which is not considered to be of structural significance and should be pointed up.

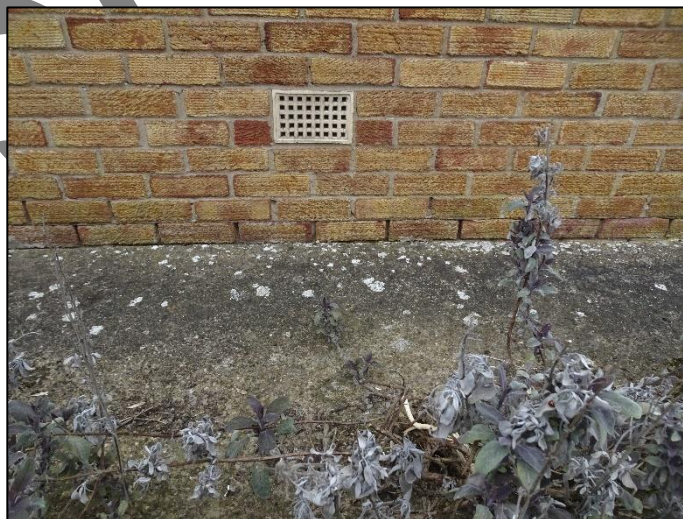
Photograph 19

3.4.12. Mortar joints are eroding at lower level to the original walls, requiring re-pointing.

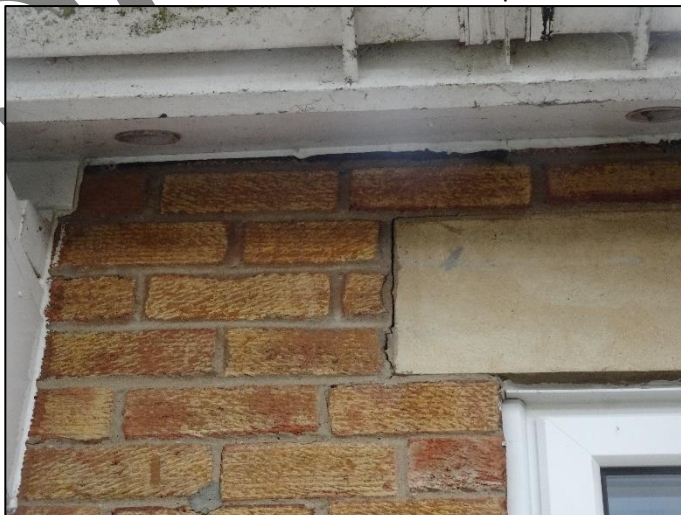
Photograph 22

3.4.14. At each end of the heads there is a crack in the mortar joint due to differential expansion and contraction of the art stone and brickwork, which is not considered to be a structural problem.

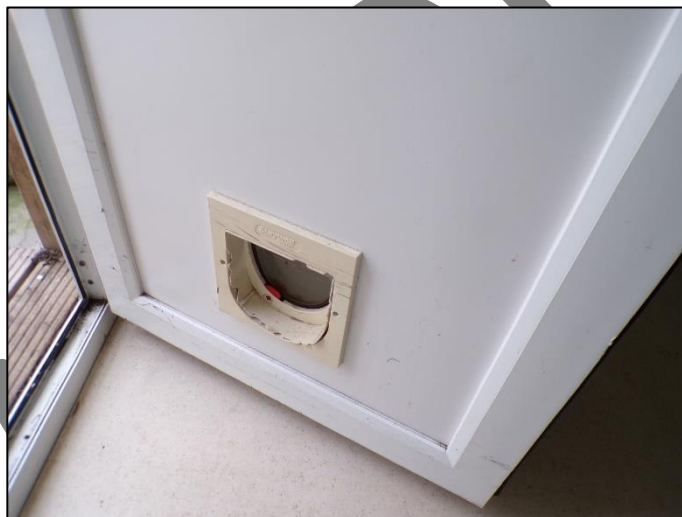
Photograph 23

3.5.5. There is a cat flap in the rear entrance door which is damaged.

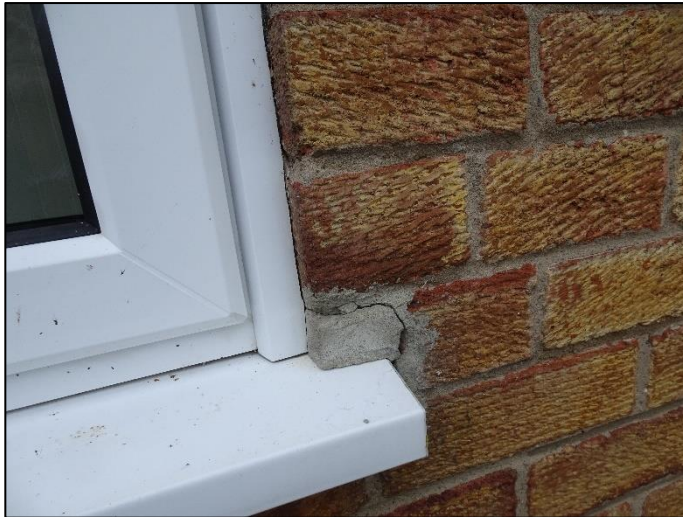
Photograph 24

3.5.9. Brick slips or mortar pointing has been provided to each side of the window cills, many areas of which are now loose, requiring replacement.

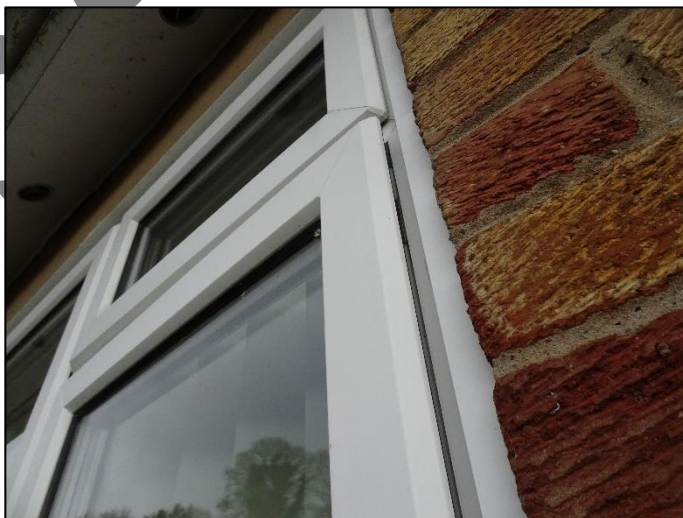
Photograph 26

- 3.5.10. The right-side opening sash to the front-left bedroom does not close properly, requiring adjustment.

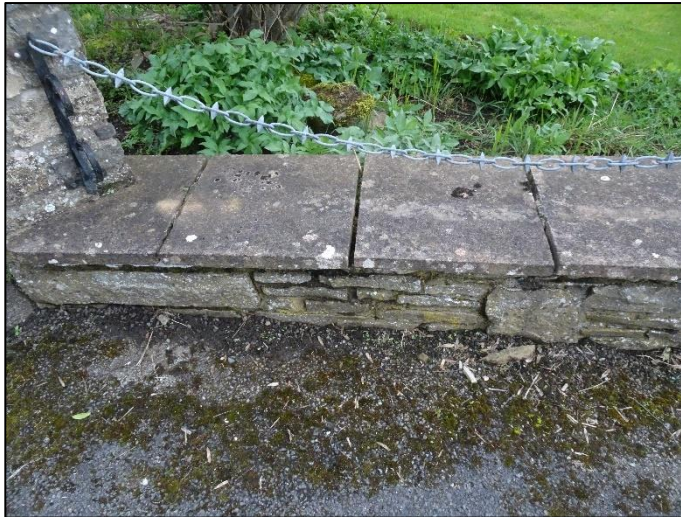
Photograph 29

3.6.3. There are concrete copings to the top of the wall which are loose and have eroded mortar joints requiring lifting and re-bedding.

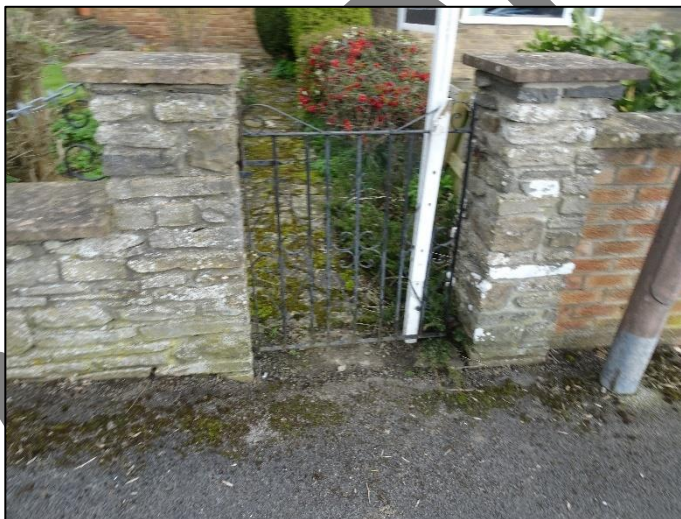
Photograph 30

- 3.6.4. There is an ornamental metal personnel gate and pair of vehicular entrance gates which are corroding, requiring fully cleaning down and re-decorating.

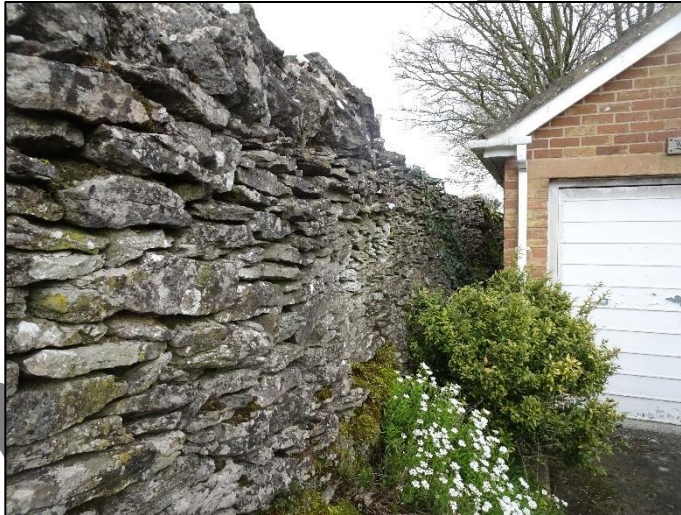
Photograph 33

- 3.6.5. The left-side boundary is a dry stone wall which leans, bows and bulges and will inevitably require repairs as part of ongoing maintenance.

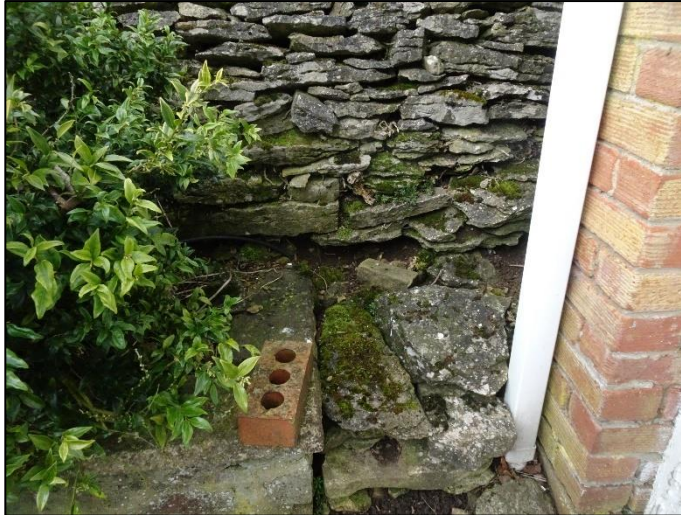
Photograph 35

- 3.6.6. The wall has been undermined to some areas which will reduce its stability and should be made good.

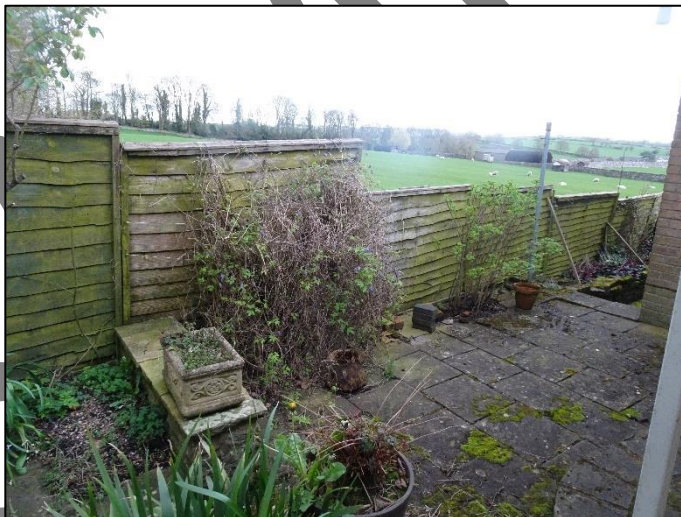
Photograph 36

- 3.6.7. To the right side, there is timber fencing, vertical overlapping boards to the front, post and rail and wire to the side of the house and vertical close board to the rear, the latter being very relatively new.
- 3.6.8. The fencing to the front right is deteriorating and has limited life remaining.
- 3.6.9. To the rear there is a woven lap fence which is in poor condition and should be replaced.

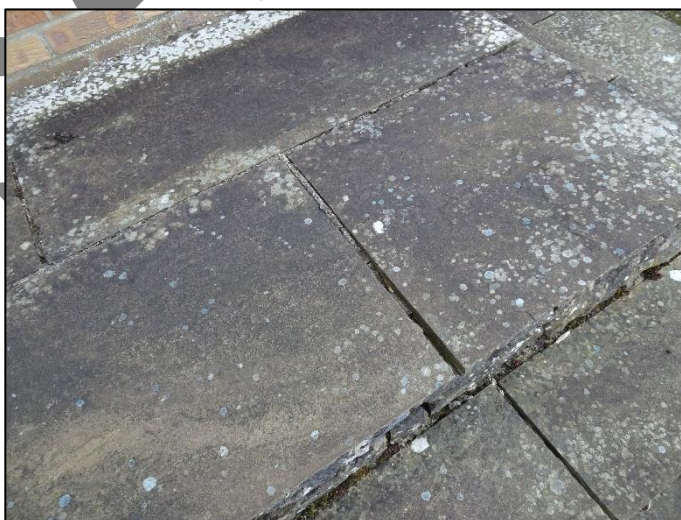
Photograph 39

- 3.6.12. There are cracks to the cast insitu concrete and defective joints to the majority of the concrete flagged areas.

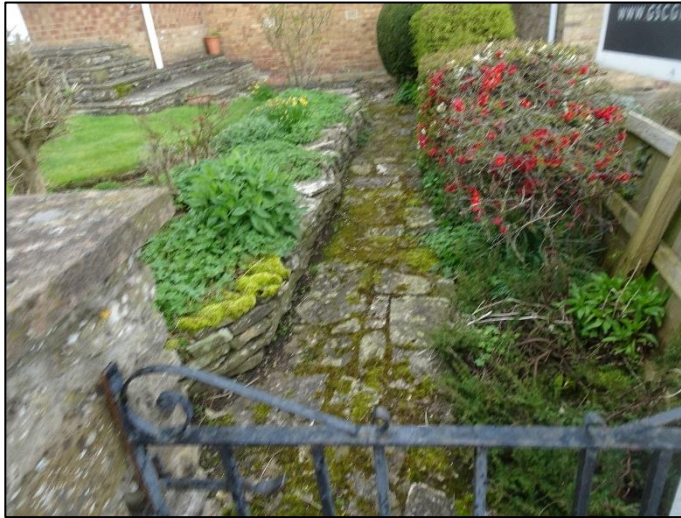
Photograph 43

- 3.6.16. There is random stone flags (crazy paving) to the right side of the front garden which has some eroded joints requiring re-pointing.

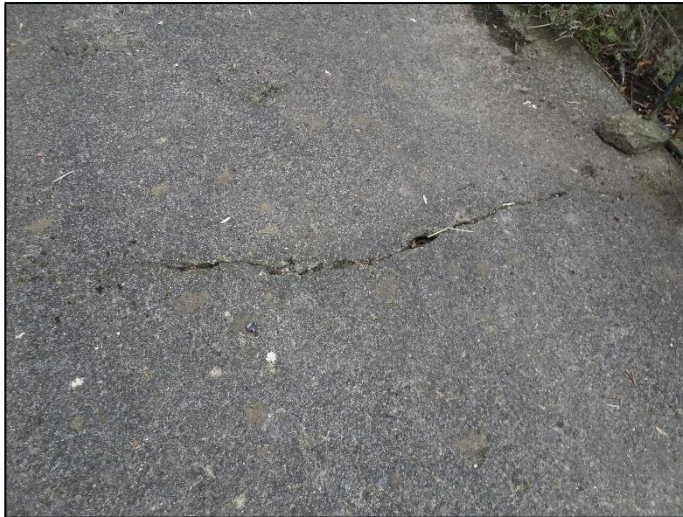
Photograph 45

- 3.6.18. The concrete is beginning to deteriorate and has isolated cracks, requiring repairs.

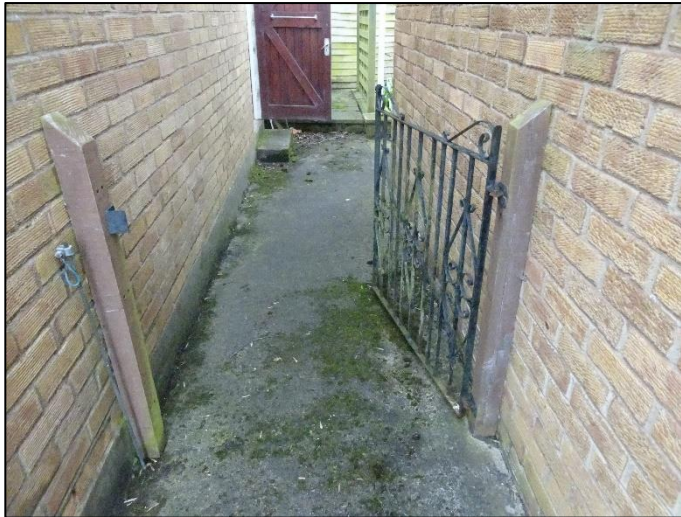
Photograph 48

- 3.6.21. The gate is corroding, requiring cleaning down and re-decoration.

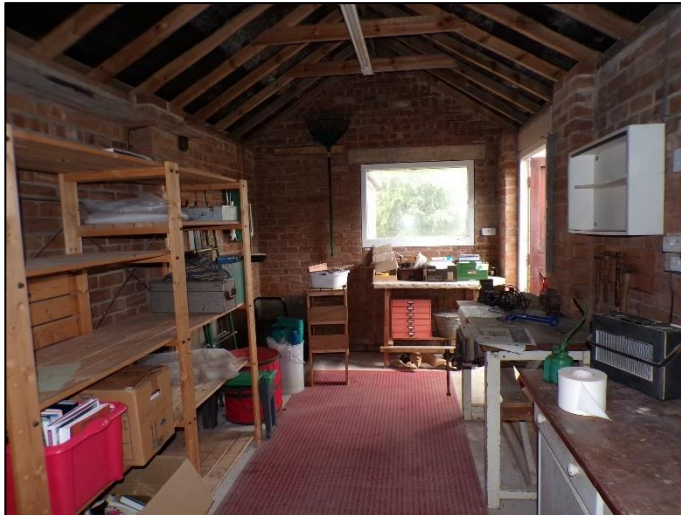
Photograph 53

- 3.7.8. The rafters are undersized, which has resulted in the deflection but which is unlikely to become any worse.
- 3.7.9. There was no evidence of any active woodworm infestation to roof timbers where these could be inspected.
- 3.7.10. There is a bitumen-based roofing underfelt beneath the tiled covering.
- 3.7.11. Underfelts provide a secondary barrier to water penetration.
- 3.7.12. Bitumen underfelts used in construction prior to the early 1990s are likely to contain asbestos fibres although these are bound up in bitumen and risk to health is minimal but I would recommend not to access the roof space unnecessarily and a particle mask should be worn.
- 3.7.13. Repairs have been undertaken at eaves level with polyethylene damp course and plywood evident.

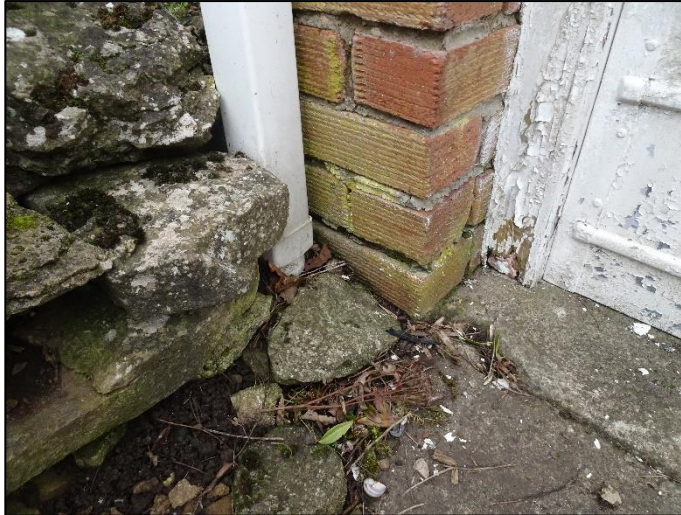
Photograph 56

- 3.9.3. To the left side, ground levels are higher, which is resulting in lateral damp penetration and a cementitious tanking solution has been applied to the walls to reduce the damp penetration.
- 3.9.4. The dampness cannot easily be resolved other than by reducing ground levels externally and constructing a retaining wall to hold back the higher ground.
- 3.9.5. There are eroded mortar joints to the base of the front-left corner requiring re-pointing.

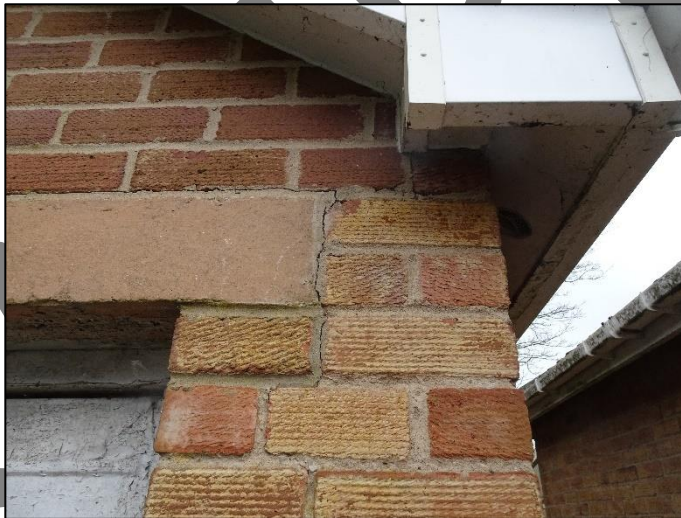
Photograph 57

- 3.9.6. There is a bitumen damp-proof course to the base of the walls
- 3.9.7. To the front there is a concrete lintel over the vehicular door entrance.
- 3.9.8. There is cracking at each end of the lintel and above the lintel as a result of differential thermal expansion.

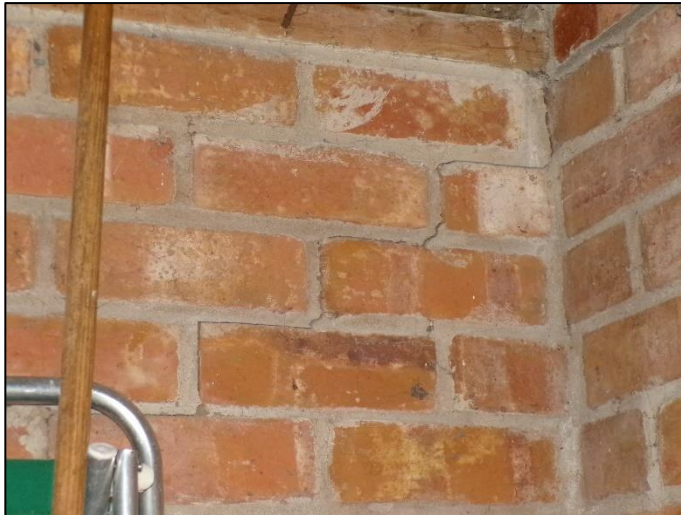
Photograph 58

- 3.9.9. Similarly, to the rear there is a concrete lintel over the window opening and personnel door on the right side.
- 3.9.10. To the rear-left corner there is stepped cracking at higher level but which is very localised and appears to be old standing.

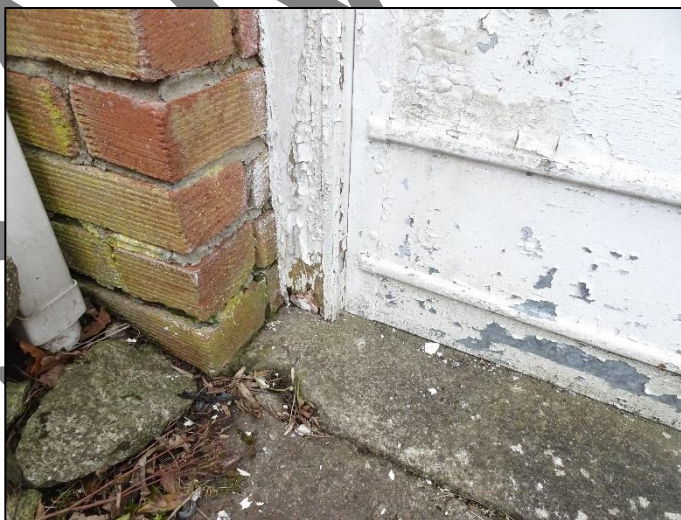
Photograph 59

- 3.10.1. There are PVCu fascias and soffits which may have been fitted to the older timber fascias and soffits and if so, the condition of the underlying timber is not known. Decay to the underlying timber could reduce the life of the PVCu and therefore you should anticipate that remedial works may be required in the future.
- 3.10.2. There is a galvanised pressed steel up and over door hung in a timber frame.
- 3.10.3. The frame is decaying to the base, particularly the left side, requiring splice repair.

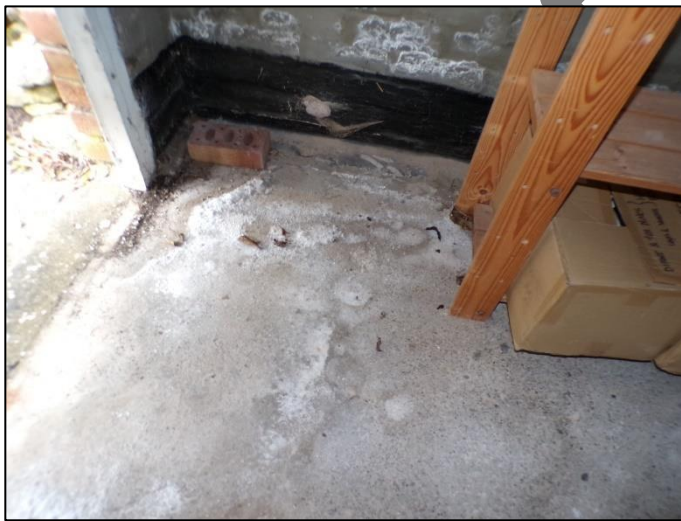
Photograph 60

3.11.2. There is some salting to the front-left corner as a result of the damp penetration.

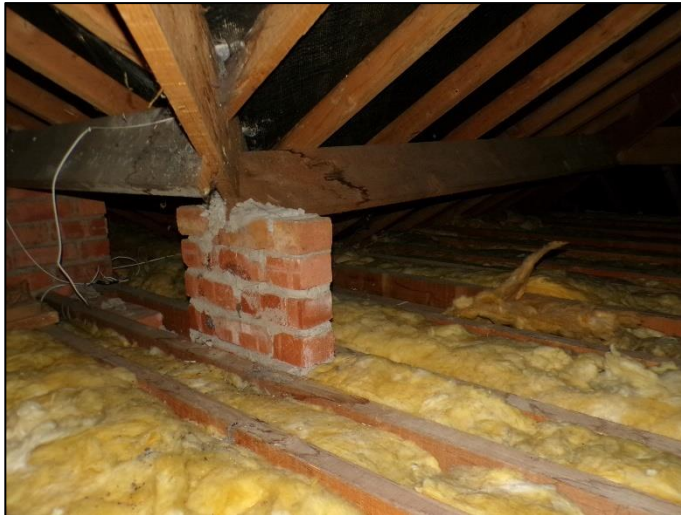
Photograph 66

- 3.12.7. The roof structure appeared to be free from significant defects and active woodworm infestation where timbers were inspected.
- 3.12.8. To the front left, there is water staining to the purlin where previous water penetration has occurred.

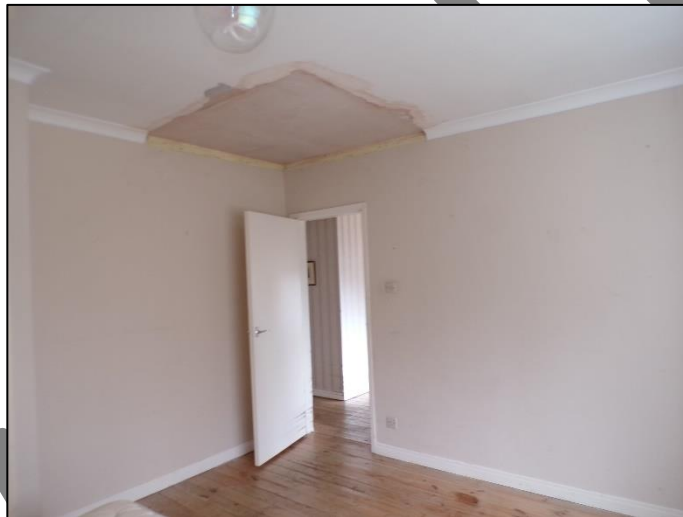
Photograph 68

- 3.13.1. Ceilings are of plasterboard and skim construction with emulsion, papered and polystyrene tile finishes.
- 3.13.2. There are cornices to virtually all rooms.
- 3.13.3. Polystyrene tiles are flammable and ideally would be removed.
- 3.13.4. The ceilings were seen to be free from significant defects.
- 3.13.5. Patch repair has been undertaken in the front-left bedroom, as previously reported.

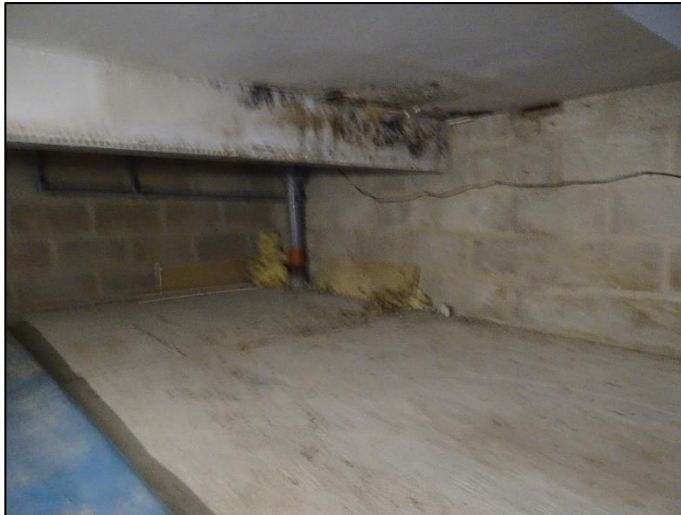
Photograph 69

- 3.13.6. The cornice has been cut to replace the plasterboard and not reinstated.
- 3.13.7. There are hairline cracks across some of the board joints which is not unusual and not a structural problem, but one which will prove difficult to resolve and often results in re-skimming or overboarding of ceilings.
- 3.13.8. There is mould growth above the window in the bathroom which will be due to condensation. There is no extractor fan in the bathroom and therefore there will have been high moisture levels.
- 3.13.9. The ceiling within the undercroft is stained which the vendor advised is due to a previous leak from the wet room but which, the vendor advised, has been resolved.

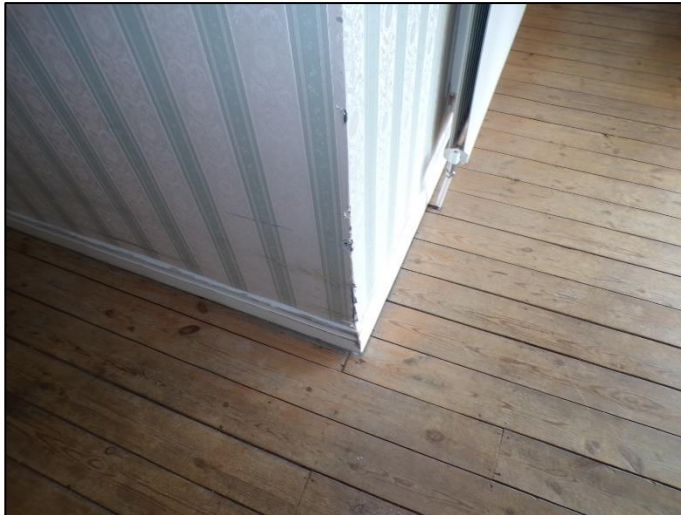
Photograph 70

- 3.14.6. There is some damage to the walls as a result of impact by wheelchair which will require repair.

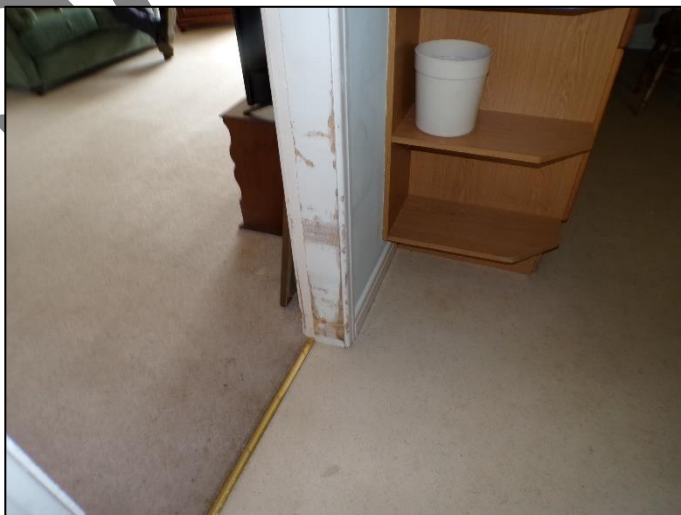
Photograph 73

- 3.16.1. Internal doors are of varying styles, original doors being flush, typical for the period.
- 3.16.2. Multi-paned doors with bevelled glass have been fitted to the kitchen between the hall and dining room and there is a multi-paned, obscured glazed door between the kitchen and utility.
- 3.16.3. One of the panes is cracked.
- 3.16.4. There is a sliding, hollow core 4-panelled door to the wet room.
- 3.16.5. Skirtings and architraves are painted with a simple profile.
- 3.16.6. There is significant damage to the lower sections of the doorframes, doors and architraves as a result of wheelchair use.

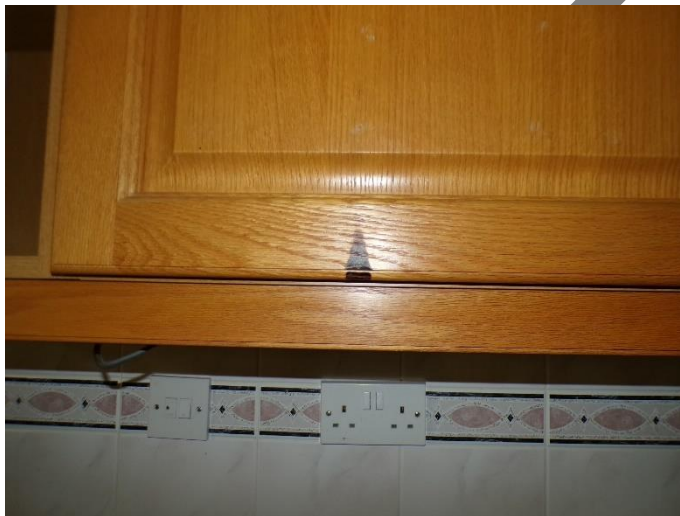
Photograph 74

- 3.17.1. Within the kitchen there is a range of fitted wall and floor units with laminate worktop and single drainer stainless steel sink with mono-block mixer tap.
- 3.17.2. The units have oak door and drawer fronts which are in reasonably good condition although dated.
- 3.17.3. There is minor burn to one of the wall unit doors.

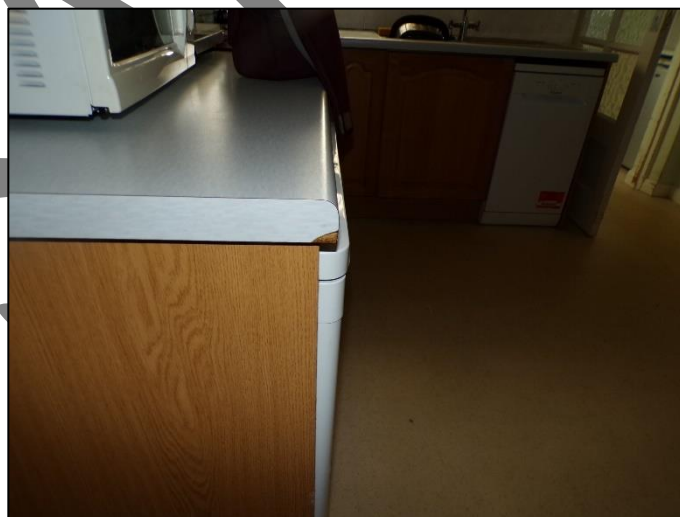
Photograph 75

- 3.17.4. The capping to the end of one of the worktops is damaged.

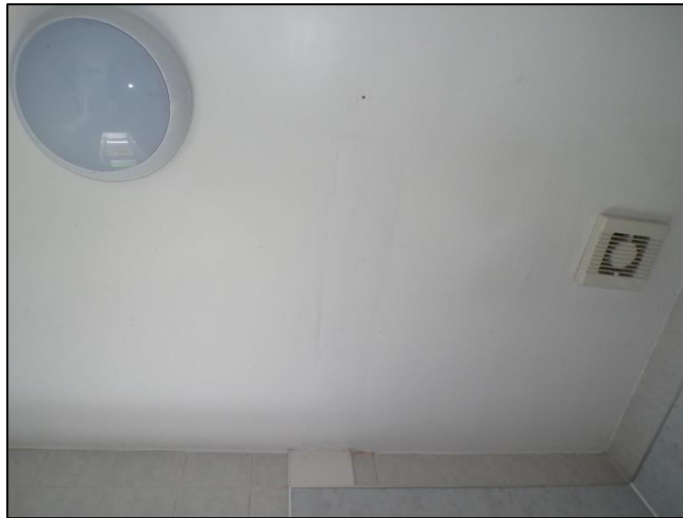
Photograph 76

- 3.17.7. The wet room contains a WC pan with close coupled cistern, pedestal wash hand basin and thermostatic shower.
- 3.17.8. There is laminate wall cladding around the shower area and walls are tiled elsewhere.
- 3.17.9. I understand that there as previously a shower cubicle in the room which has been removed to create the wet room. the outline of the cubicle wall is visible on the ceiling.

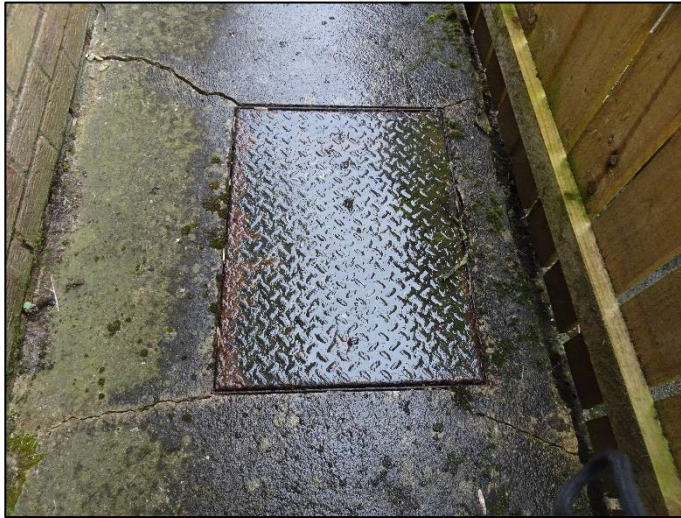
Photograph 89

- 3.22.7. The cover and frame are badly corroded and should be replaced.
- 3.22.8. The chamber is brick built with clay channels and mortar benching.
- 3.22.9. Although in reasonably good condition, there is spalled brickwork blocking the channel, which has caused backing up of water and which requires cleaning out.
