I R Johnson MRICS, Chartered Building Surveyor

IRJ/AH/S1597/SA

Instructions received are to carry out a Structural Appraisal of the property which were accepted and confirmed in my letter of the

- 2.1. The property is a Grade II listed corn water mill, believed to date to 1817.

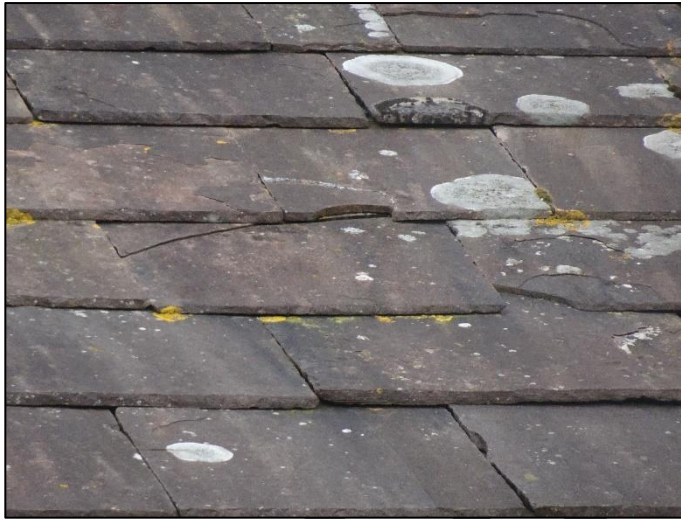
Photograph 11

3.1.6. There are missing/broken slates to the following areas:

- 1No. to the front slope of the left-side roof
- 2No. to the rear slope of the left-side roof
- 1No. to the left-side slope of the main high level roof
- 2No. to the right-side slope of the main high level roof

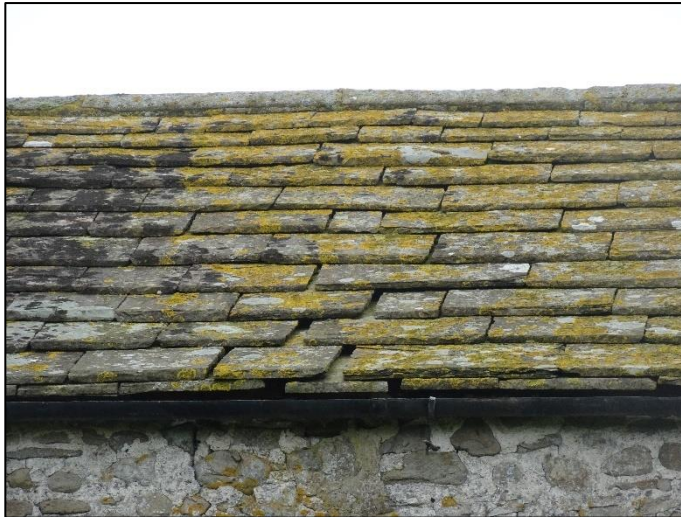
Photograph 16

- 3.1.7. There are large gaps between some of the slates on the right-side slope which is due to poor workmanship, but has not resulted in water penetration.

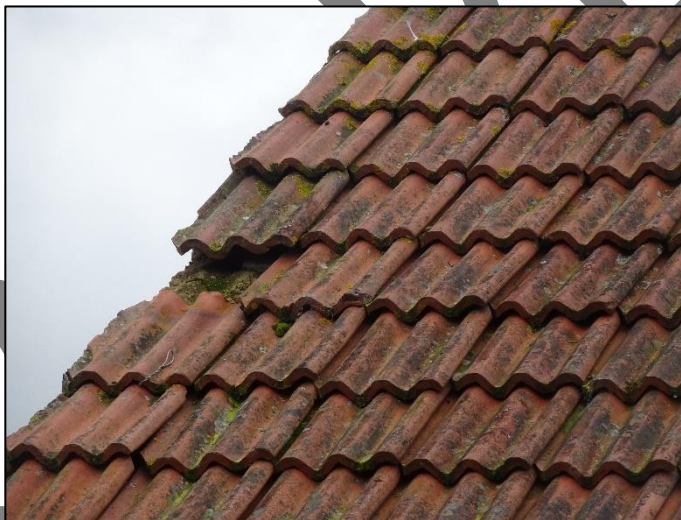
Photograph 17

- 3.1.8. There is slight undulation to the high level roof but not of a significant nature.
- 3.1.9. The cart shed roof has one missing and four broken clay tiles to the left-side slope.

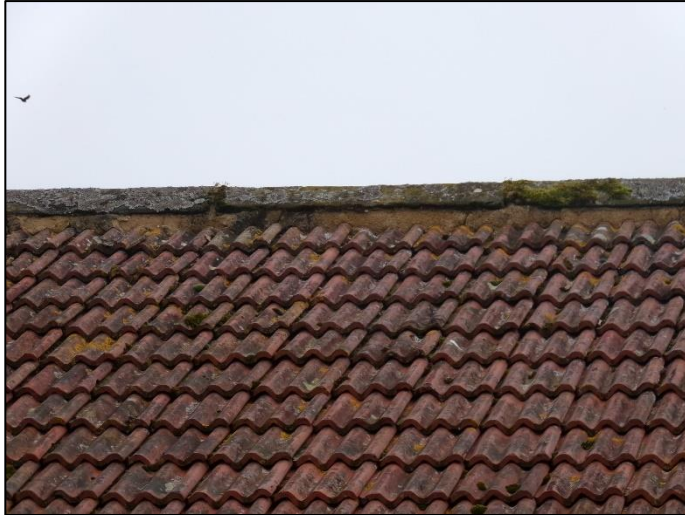
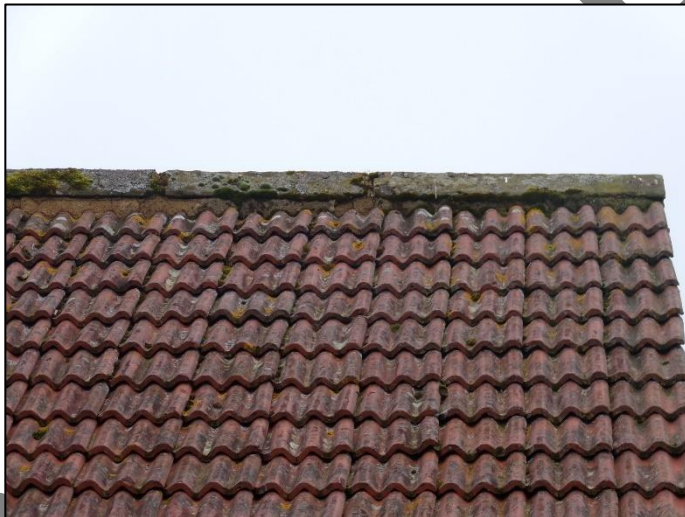
- 3.1.10. There is erosion of mortar to the ridges which should be replaced and will involve lifting, re-bedding and re-pointing of the ridges.

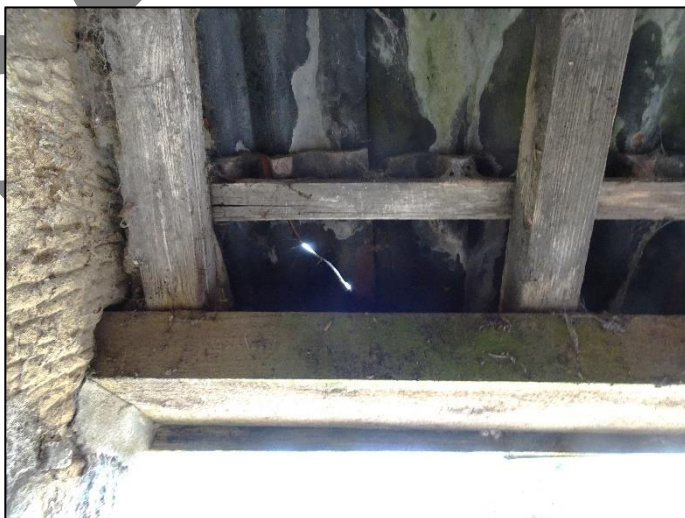
Photograph 20

- 3.1.11. One of the broken tiles is resulting in rainwater making its way onto the supporting timberwork below, causing decay.

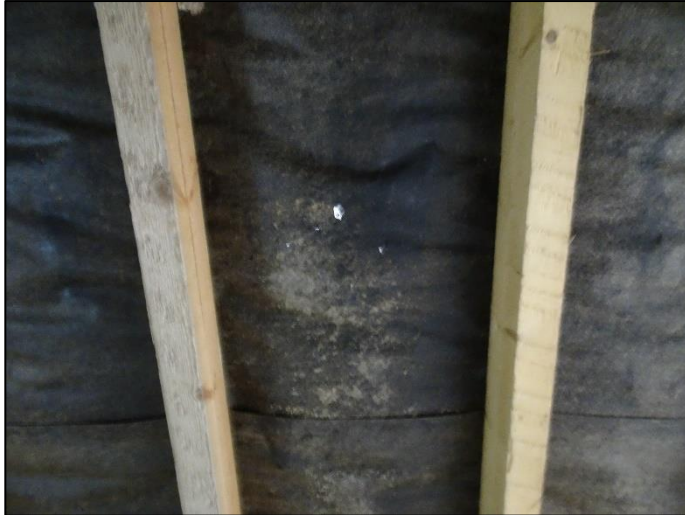
Photograph 25

- 3.1.18. Underfelts provide a secondary barrier to water penetration.
- 3.1.19. Bitumen underfelts used in construction prior to the early 1990s are likely to contain asbestos fibres although these are bound up in bitumen and risk to health is minimal.
- 3.1.20. There is an isolated hole in the underfelt.

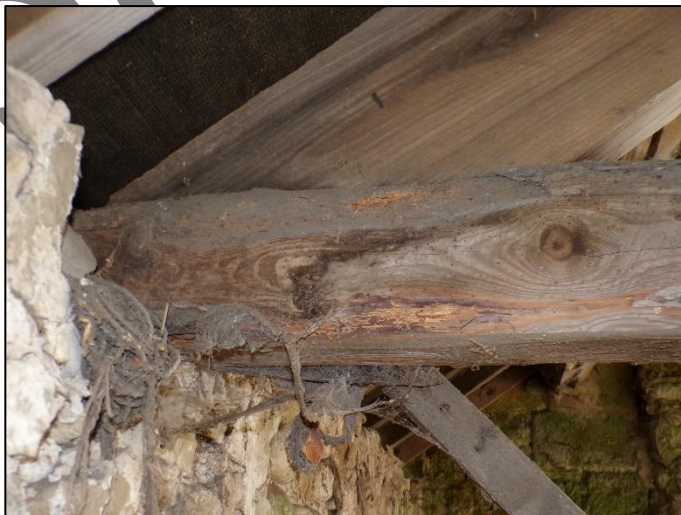
Photograph 29

3.1.24. The structure is softwood and there is significant woodworm infestation evident to some areas.

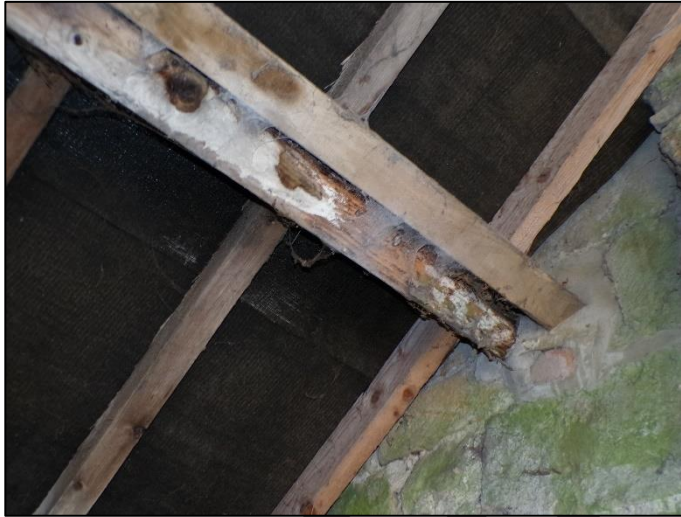
Photograph 30

- 3.1.25. When probed with a pen knife, sound heartwood was evident to the accessible parts of the truss.
- 3.1.26. One of the lower purlins to the right side has decayed where it is built into the rear wall of the Mill building and consequently a replacement purlin has been fixed alongside.

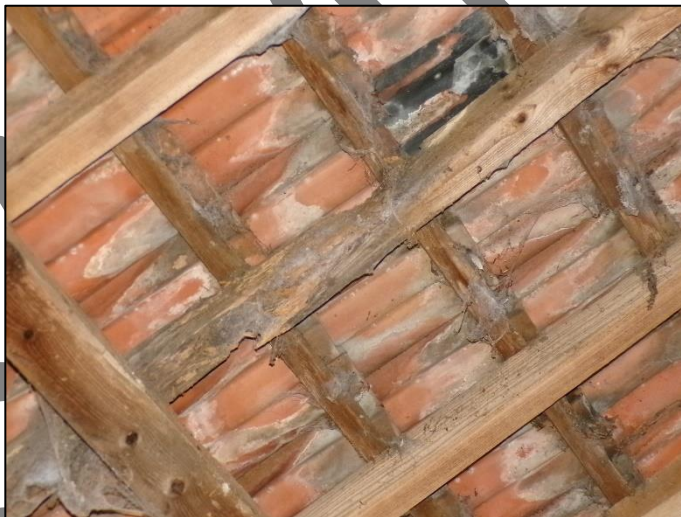
Photograph 31

- 3.1.27. There is a snapped rafter close to ridge level on the left-side slope which should have a new rafter fitted alongside.

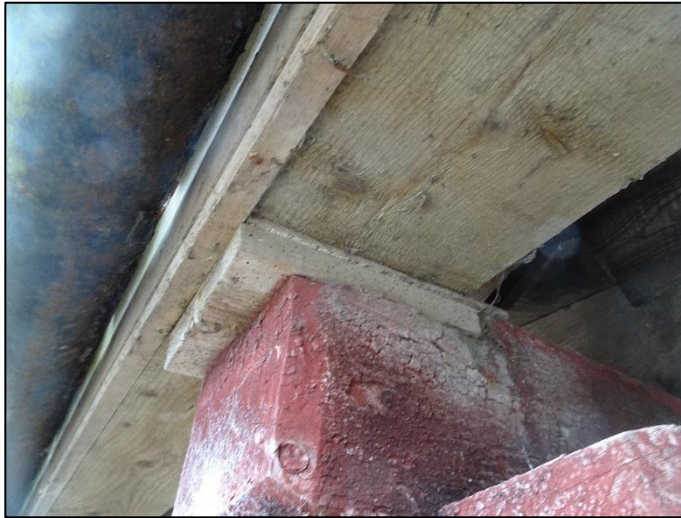
Photograph 32

- 3.1.31. At mid-span of the eaves beam, there is a softwood packer which has significant woodworm infestation and should be replaced.

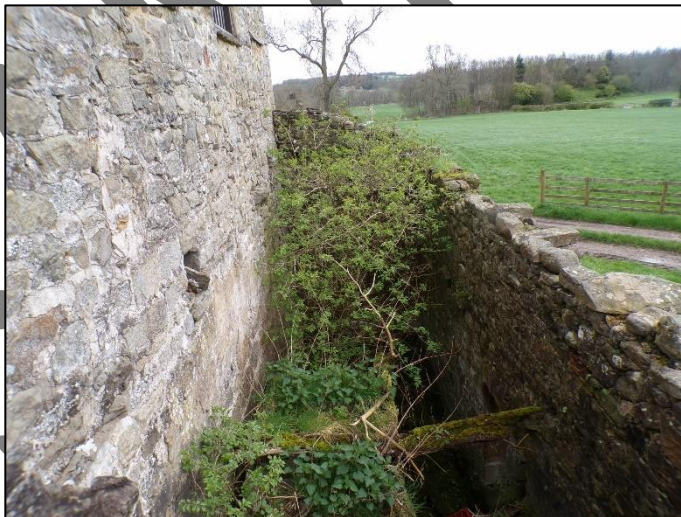
Photograph 33

- 3.1.32. To the front-left corner, there is water penetration from a broken tile (as previously reported) which will result in decay of the timber eaves beam.
- 3.1.33. A general overhaul of the roof coverings is required to replace defective slates and tiles.
- 3.1.34. There has originally been a roof over the water wheel but which has collapsed many years ago, requiring re-instatement.

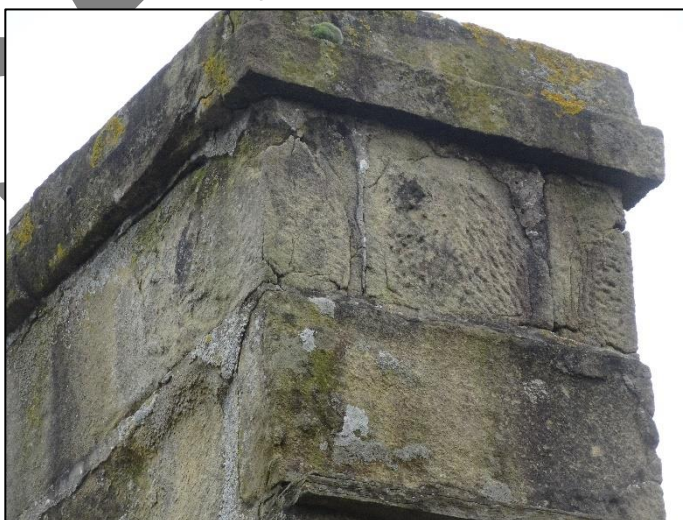
Photograph 36

3.2.2. The stonework has visible deterioration and will require replacement in the medium-long term.

- 3.2.3. Although re-pointing has been undertaken many years ago, cement mortar has been used. Cement mortar is unsuitable and lime mortar should be used for all future re-pointing.

- 3.2.4. There is erosion and cracking of some of the mortar joints and further re-pointing is required.
- 3.2.5. The stones will have deteriorated significantly internally due to flue gasses and the full condition cannot be confirmed.

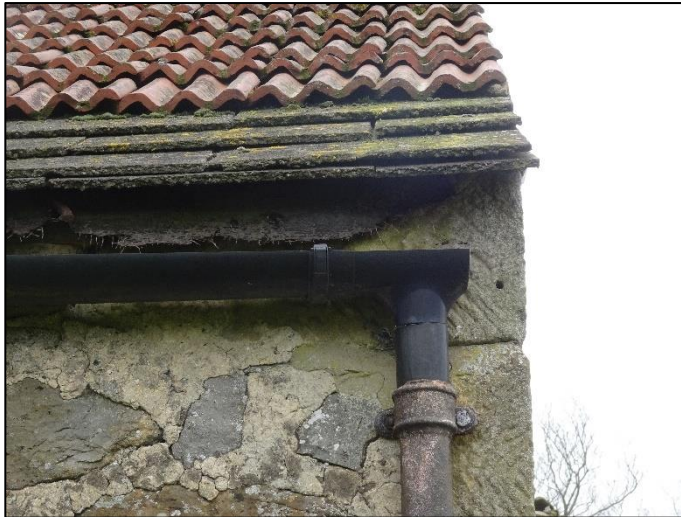
Photograph 37

- 3.3.6. I understand that the plastic gutters have been fitted prior to the property being listed.
- 3.3.7. The gutter does not extend the full length of the roof, which will result in water missing the gutter altogether.

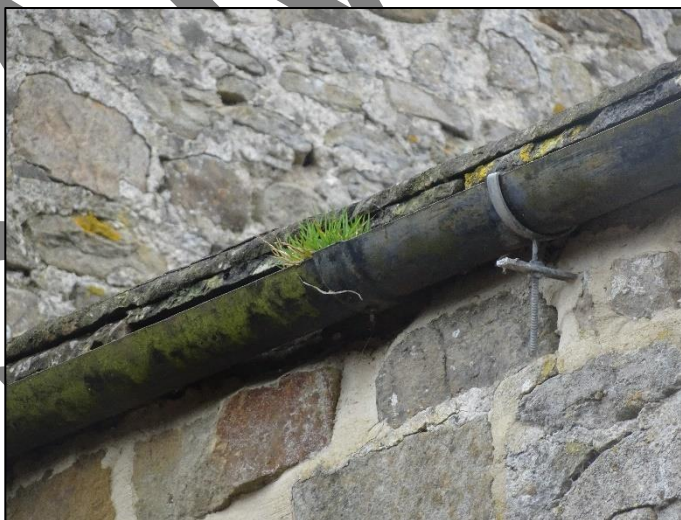
Photograph 38

- 3.3.8. It is also likely that water will oversail and miss the gutter during periods of heavy rainfall, given the significant projection of the eaves slates.
- 3.3.9. The gutters should be altered/adjusted and would ideally be replaced with cast ironware.
- 3.3.10. Rainwater downpipes discharge directly onto the ground. This results in localised wetting and can lead to problems of localised subsidence, however there were no such problems evident.
- 3.3.11. There is some vegetation growing in the gutters which will require periodically cleaning out.

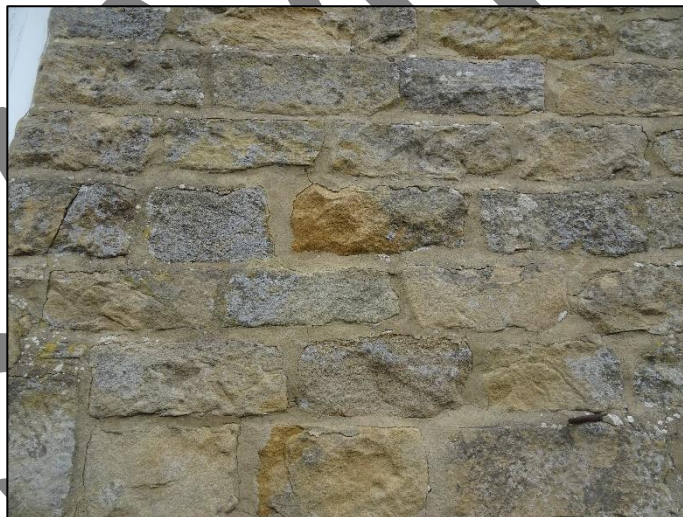
Photograph 39

- 3.4.5. There are stone heads and cills to the window and door openings.
- 3.4.6. The front elevation has been re-pointed with a cement-based mortar although the old lime joints have not been raked out prior to re-pointing, resulting in significant areas of cracked and loose mortar.

3.4.8. The cement mortar should be removed and replaced with traditional lime mortar.

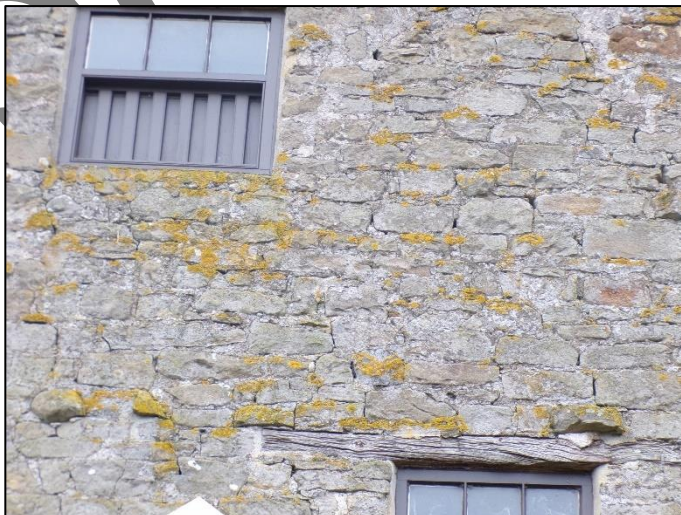
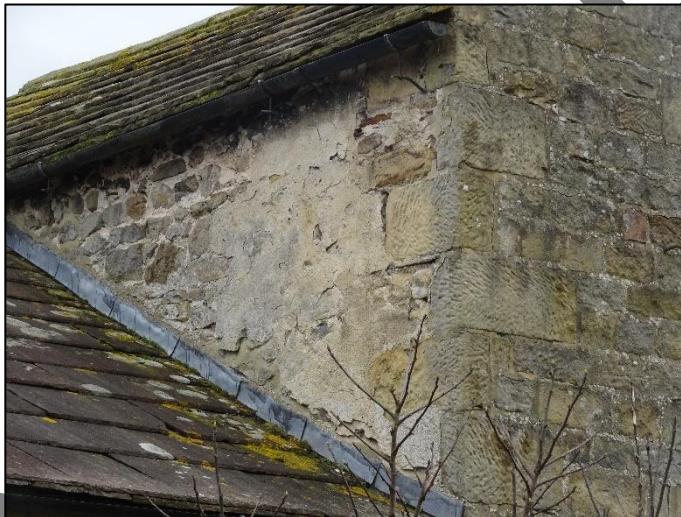
3.4.9. There is general erosion of mortar pointing and the building should be re-pointed with a traditional lime mortar as part of a programme of future repairs and maintenance.

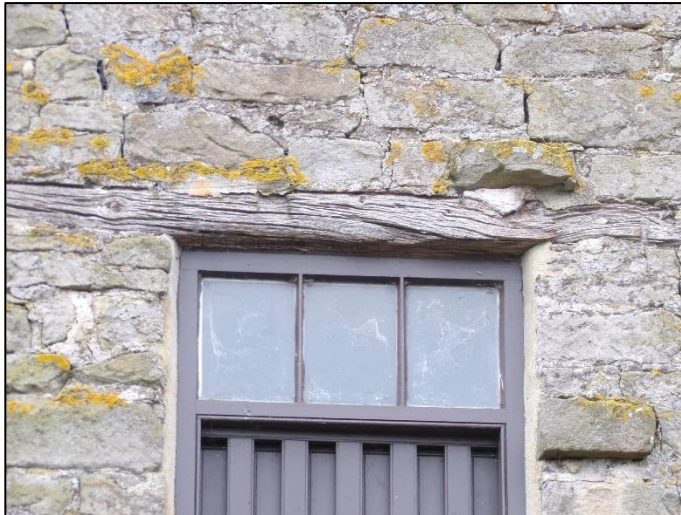
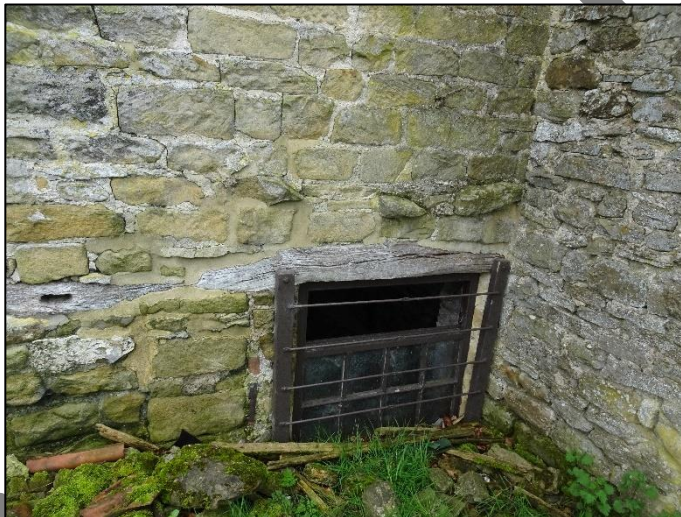
3.4.10. There are numerous openings to the rear elevation which have oak lintels externally.

- 3.4.11. Although the oak is aged and deteriorating, it still appears to be structurally sound.
- 3.4.12. Where the opening to the rear of the left-side, first-floor room (drying/hopper) has been built in, the built-in stonework has not been tied into the reveals although there is no evidence of any ongoing problems.
- 3.4.13. An opening in the basement has been previously built in.

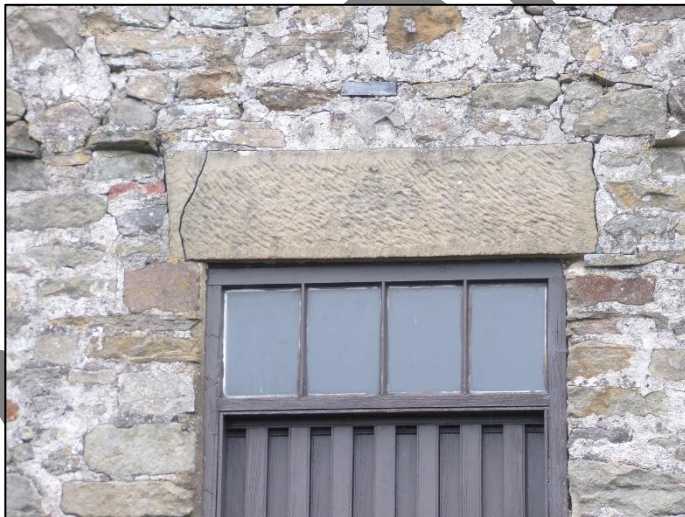
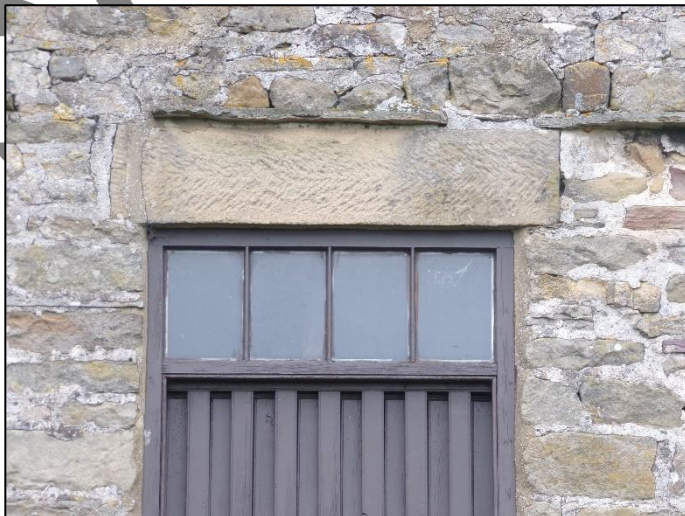
- 3.4.14. There are fractured stone heads to window openings in the first floor in the right-side elevation which is where the principal Mill workings are located and most likely due to vibration.

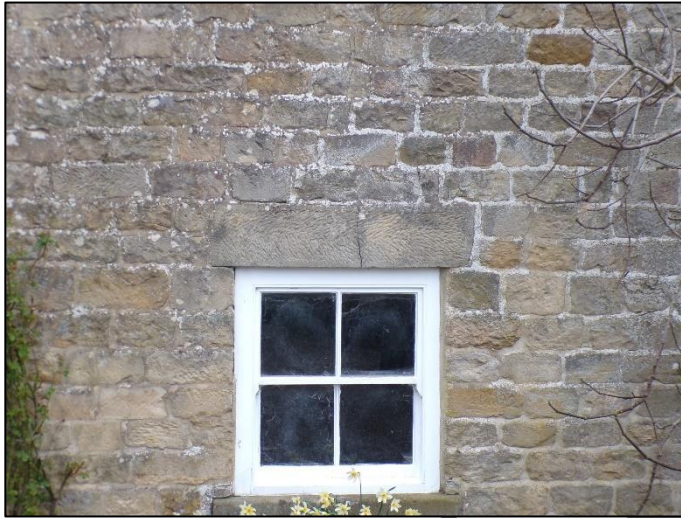
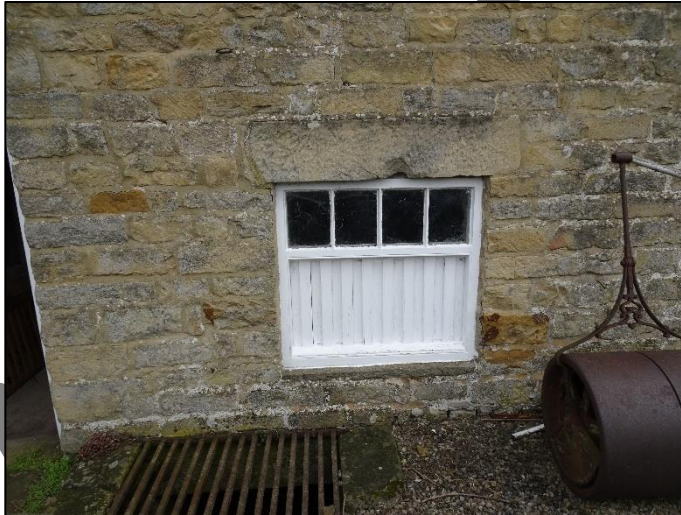
- 3.4.15. There are fractured heads to the ground-floor openings in the front elevation.

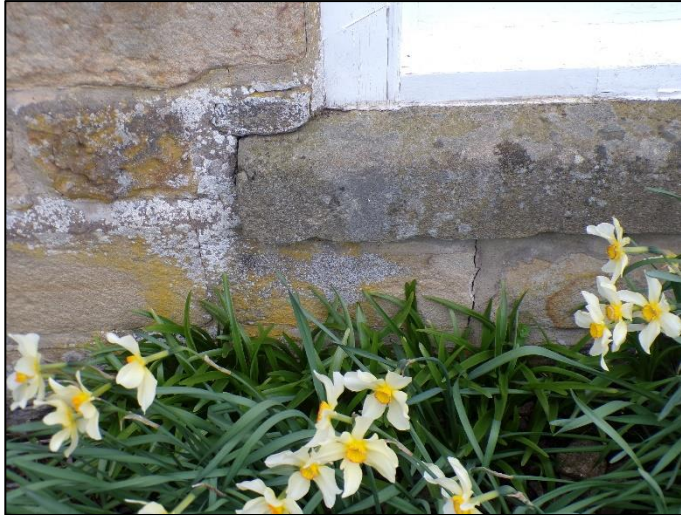
Photograph 52

- 3.4.16. The right-side opening has a slip cill which has also fractured.
- 3.4.17. Whilst there is no cracking or displacement of masonry above, the fractured heads should be repaired or replaced.
- 3.4.18. Isolated cracking is visible below the left-side opening which has opened since re-pointing, but is considered to be of a minor nature and not of significant concern.

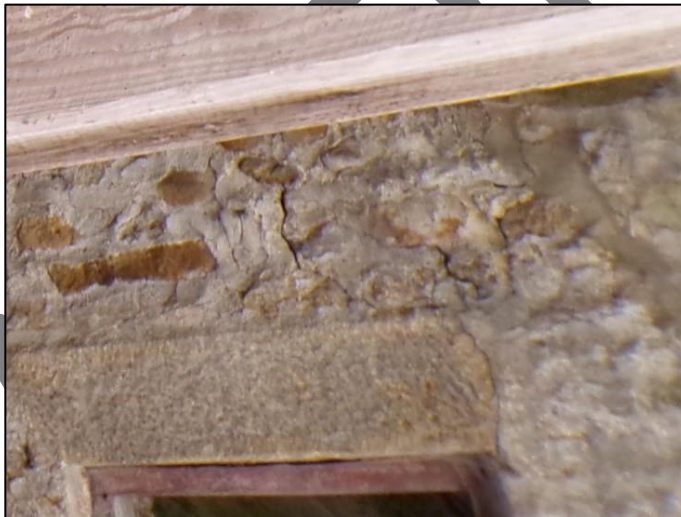
Photograph 53

- 3.4.19. To the rear, the ground-floor window head has virtually no end bearing, being supported by the timber window frame. Repairs/remedial works are required which would have to be agreed with the local authority conservation officer/Historic England.

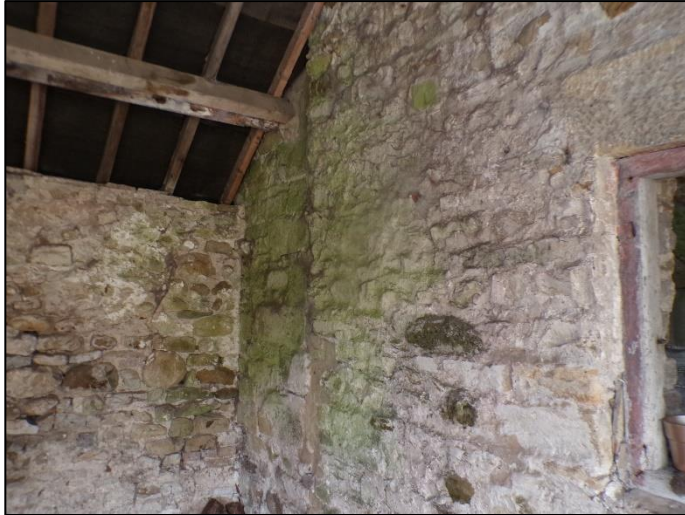
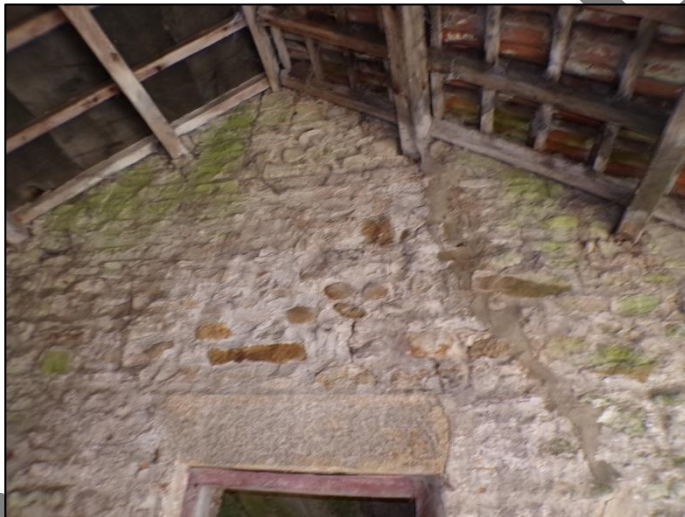
- 3.4.20. When sighted through, there is distortion evident to the left-side gable and rear wall of the two-storey part of the building.

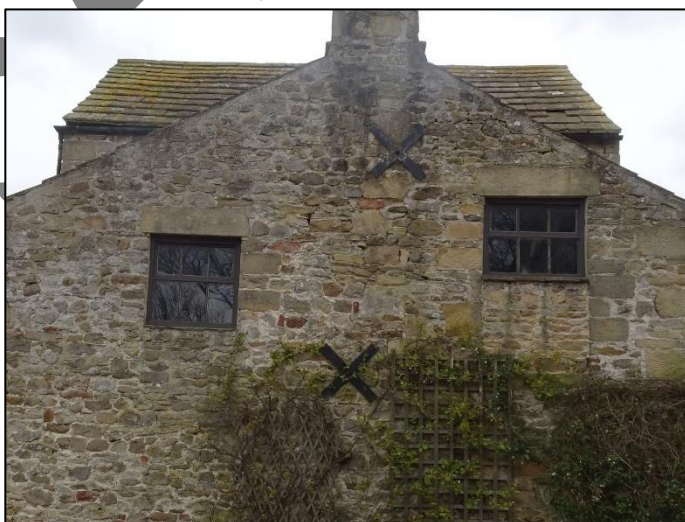
Photograph 56

3.4.21. Tie bars have been fitted at first-floor level and above the window head height in the left-side gable to provide lateral restraint.

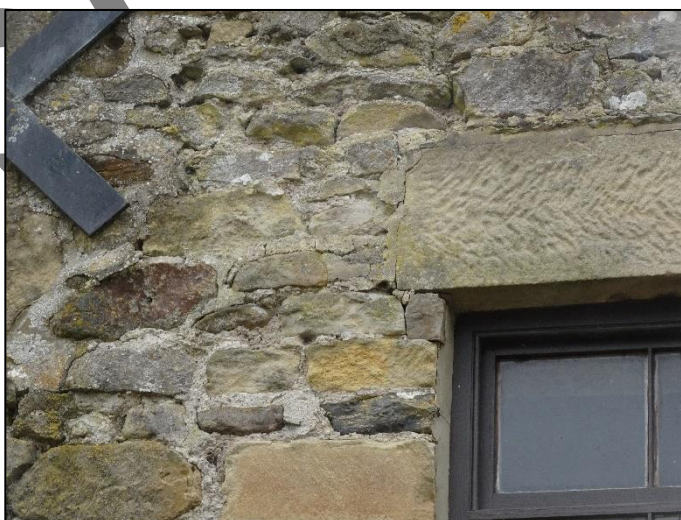
Photograph 58

- 3.4.26. There is a first-floor door opening to the front of the left-side elevation which has been built up to form a window opening.
- 3.4.27. The bearings to the head are poor to the left side and require making good.

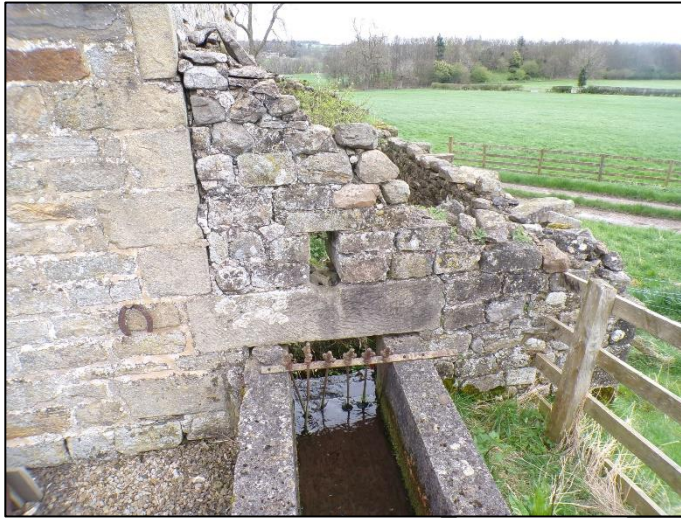
Photograph 59

- 3.4.28. The wall tops to the part of the building containing the water wheel are loose, requiring consolidating/re-building.

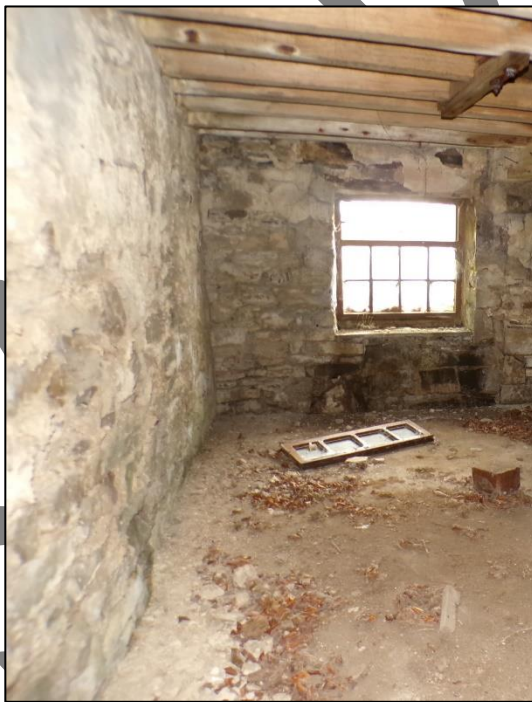
Photograph 60

- 3.4.29. Internally to the basement, there is bowing and bulging of the left-side wall which is a retaining wall.

- 3.4.30. No remedial works are required at present but cannot be ruled out in the future, especially if the building is converted to habitable use.
- 3.4.31. There appears to be a built-in door opening to the rear-left corner, although this may be a straight joint in the stonework.

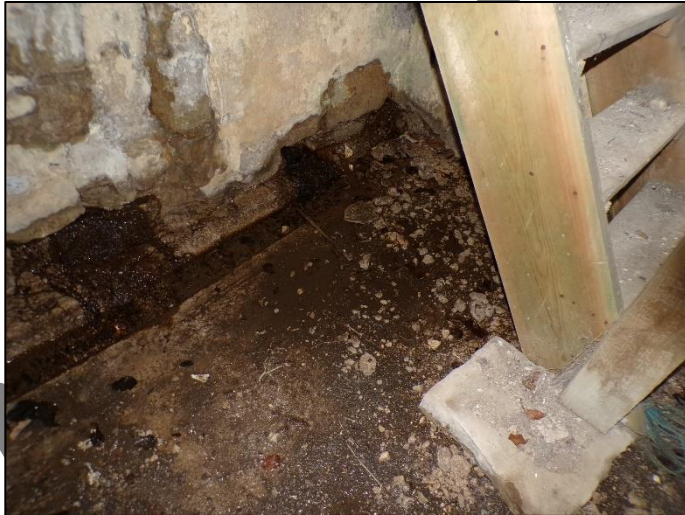
Photograph 62

- 3.4.32. Water penetration is a problem to the front and a channel has been cut to discharge water into the water wheel area.

- 3.4.33. It will be necessary to intercept and divert the water externally.
- 3.4.34. Ground levels to much of the perimeter of the building appear to have been raised over time and this is resulting in damp ingress. Ideally the ground levels would be lowered.
- 3.4.35. The walls have originally had a lime plaster finish internally, although much of this is missing and remaining areas are cracked, loose and friable.

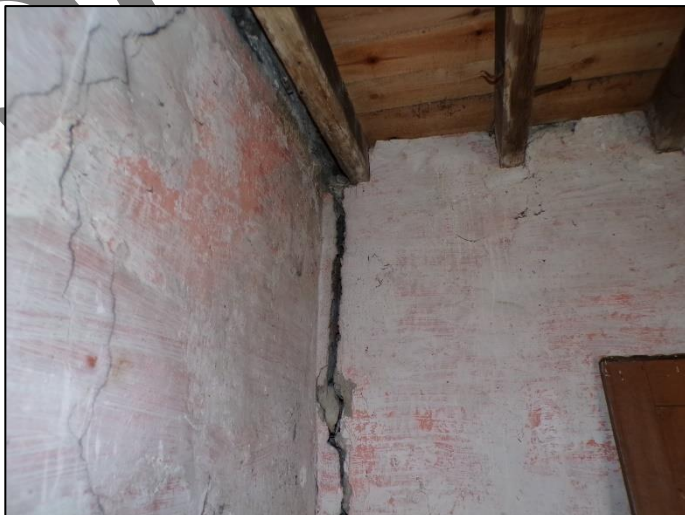
Photograph 65

- 3.4.36. There is a substantial gap between the internal cross wall and left-side elevation as a result of outward movement of the external wall although there does not appear to have been any progression since the tie bars were installed and the roof structure replaced.

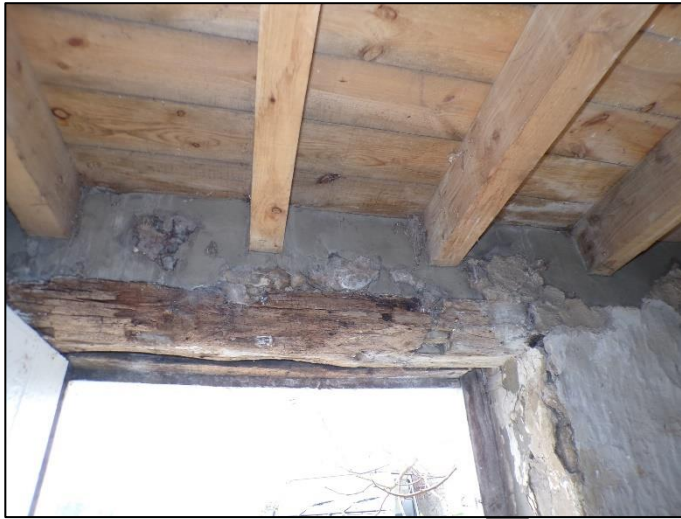
Photograph 69

- 3.4.37. To the internal side of the external door and window openings and to the internal door openings, there are timber lintels which have woodworm infestation but when probed with a pen knife, appeared to be reasonably sound.

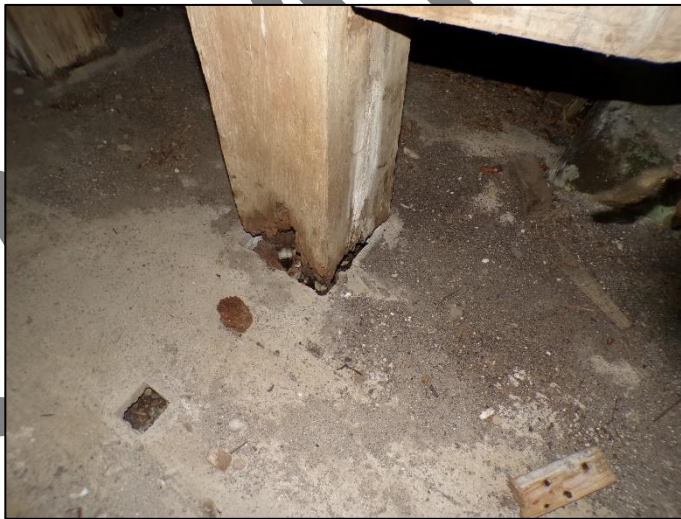
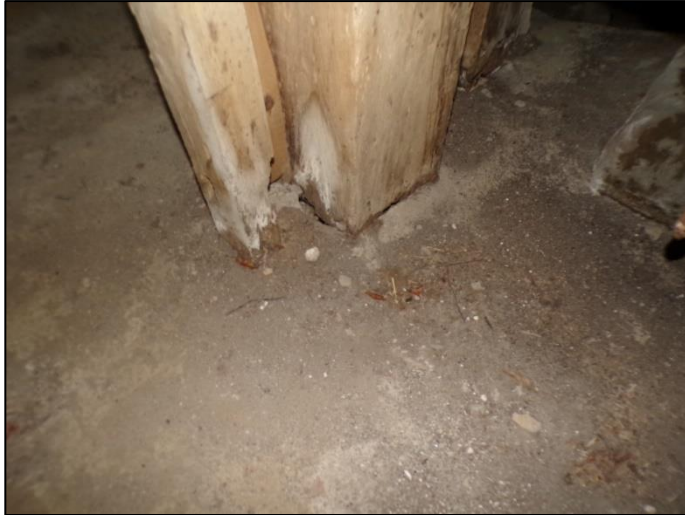
- 3.5.8. The base to the posts supporting the floor is significantly decayed and will require repair involving replacement of the lower sections.

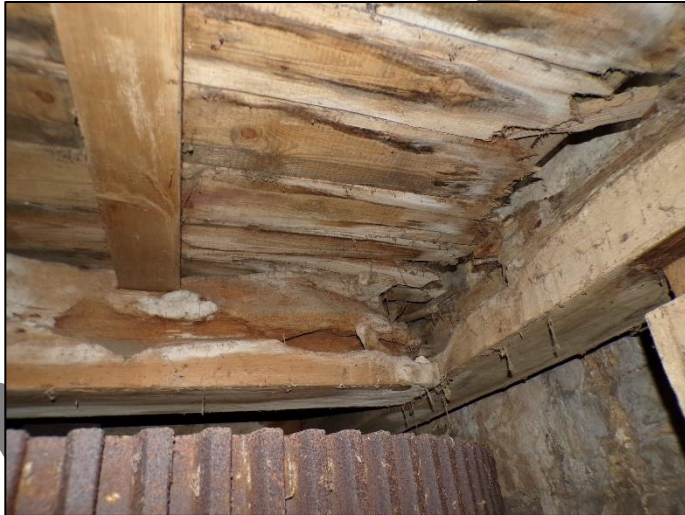
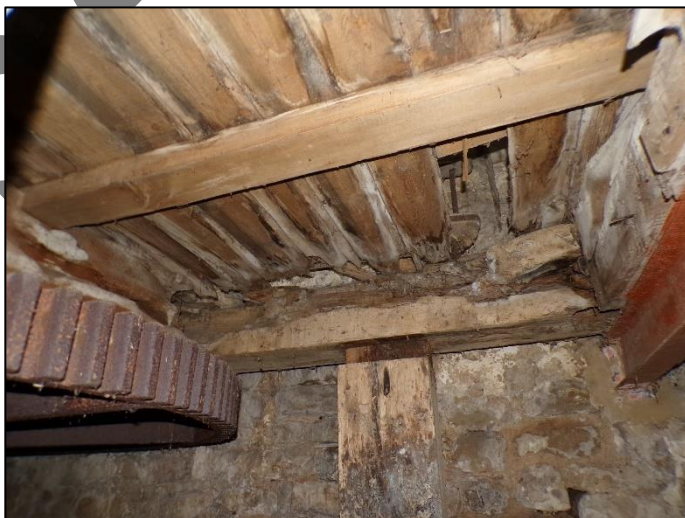
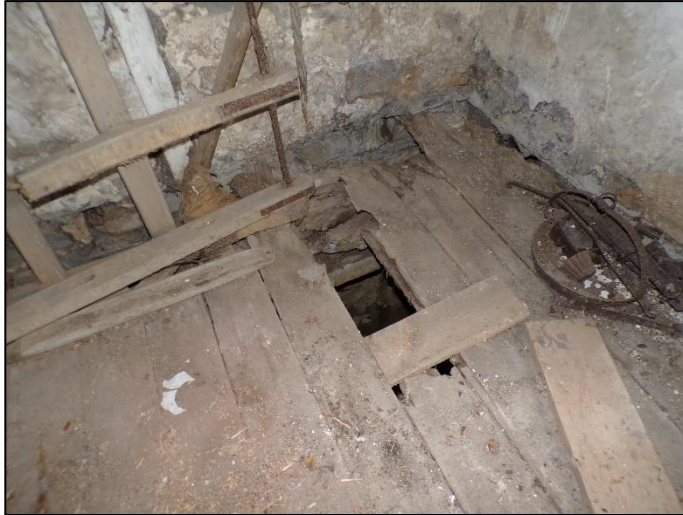
- 3.5.9. To the right side, the timber beams are deteriorated to such an extent that replacement will be necessary.

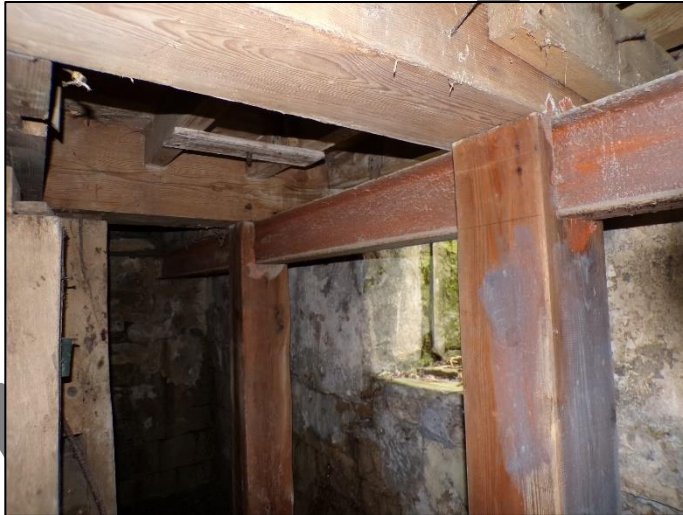
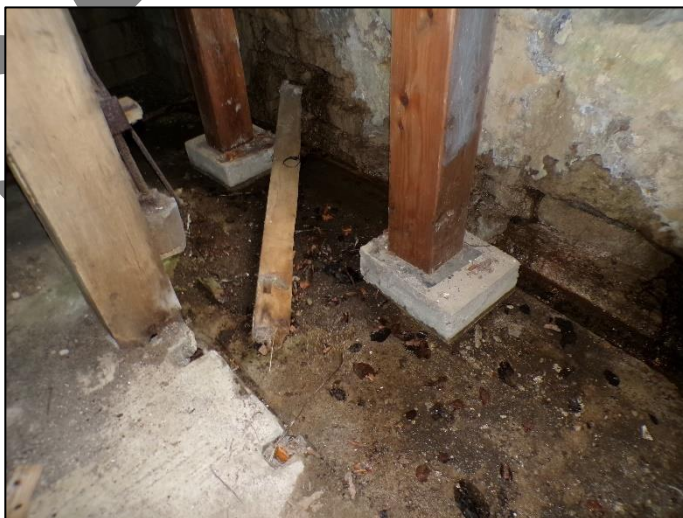
- 3.5.10. To the front-right corner, a steel beam and timber posts have been installed to provide support to the failed ends of the principal beams.

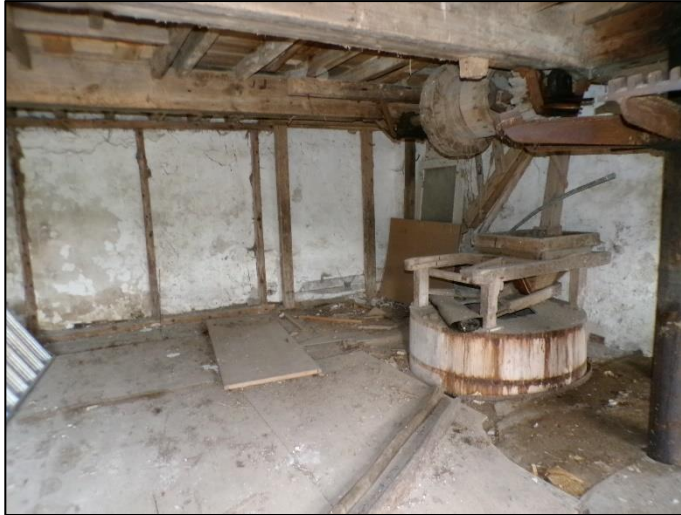
Photograph 81

- 3.5.11. A substantial area of the right-side, ground floor has been overboarded with plywood due to deterioration of floorboards.

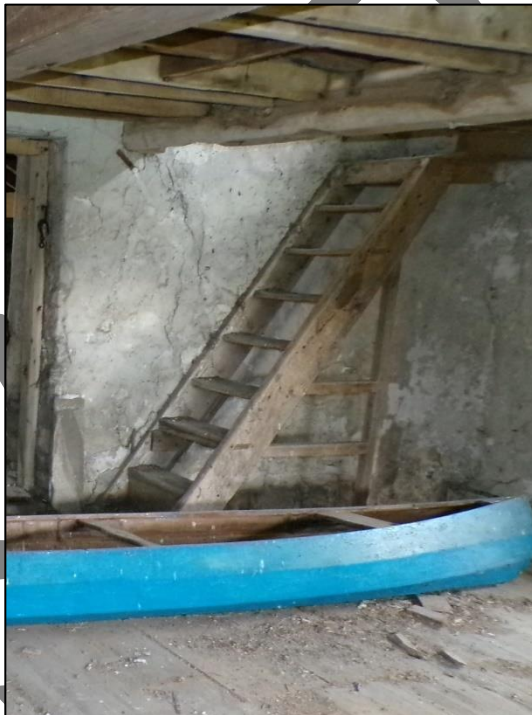
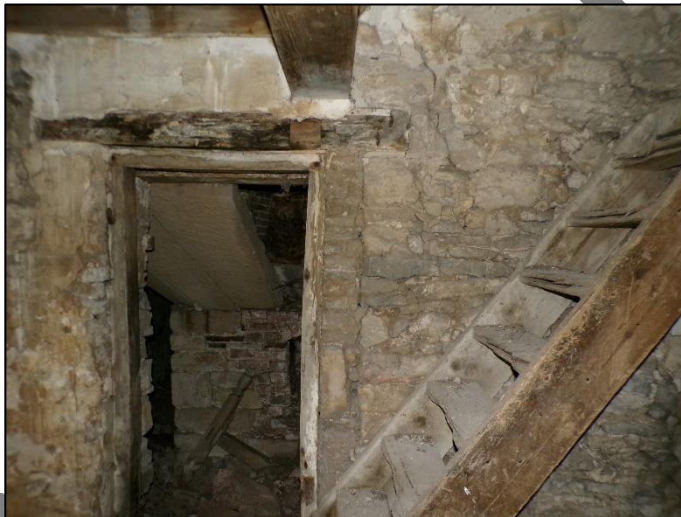
- 3.5.12. There are timber stairs between each storey. These have significant woodworm and wear between the upper floors and should be replaced/strengthened, by agreement with the local conservation officer and Historic England.

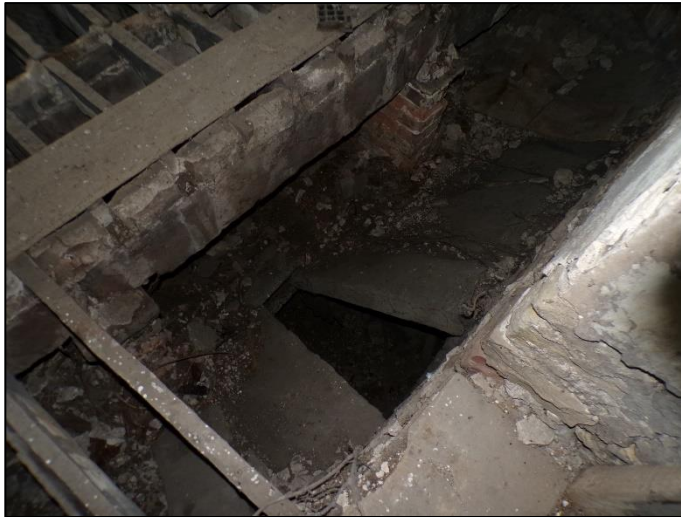
Photograph 90

3.5.20. Some of the stone slabs and stone joists have collapsed or been removed.

- 3.5.21. There is debris in the hopper which requires cleaning out.
- 3.5.22. Brickwork is deteriorating and some of the columns lean out of plumb.
- 3.5.23. Some of the stone joists are broken and missing and extensive repairs are required.
