IRJ/AH/S1603/L2

**Introduction to the Report**

Instructions received are to carry out an RICS Level 2 Building Survey of the property which were accepted and confirmed in my letter of the

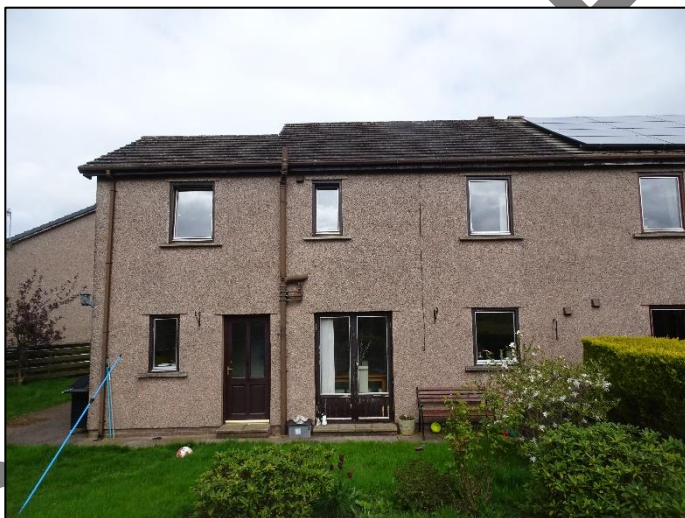
**Photograph 1**

- 2.1. The property is the right side of a pair of semi-detached houses built, I would anticipate, in the region of 25-30 years ago, although the exact date of construction may be confirmed by examination of the Title Deeds.

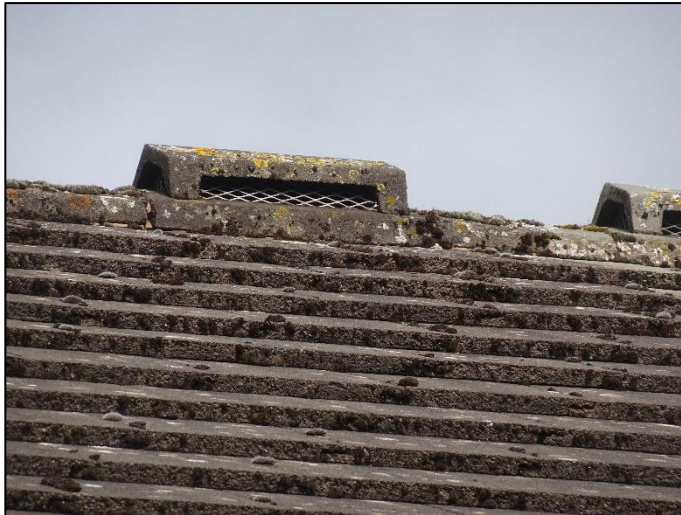
**Photograph 3**

- 3.1.6. There is light moss growth to the roof slopes which should be periodically cleaned off and has prevented inspection of the pointing to the ridges.
- 3.1.7. There is some erosion and cracking of mortar to the ridges which should be replaced as necessary as part of ongoing maintenance and repairs.

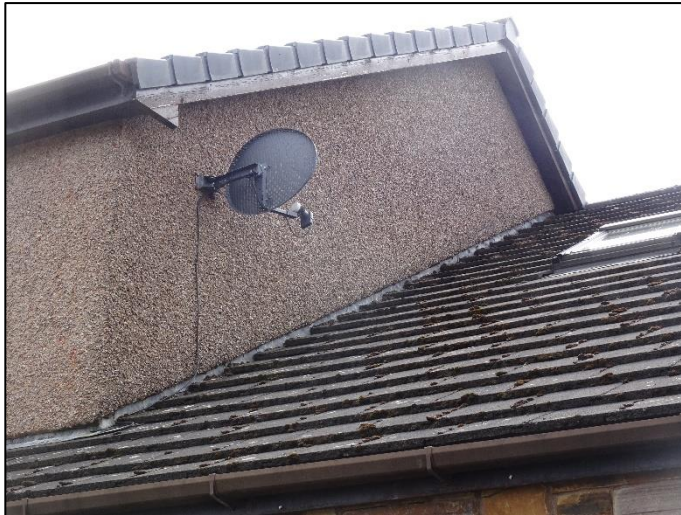
**Photograph 6**

- 3.2. **Chimney Stacks and Flashings**
  - 3.2.1. There is no chimney stack to the property although previously as reported, there is a ridge vent.
  - 3.2.2. There are lead flashings at the abutment of the lower-level roofs.

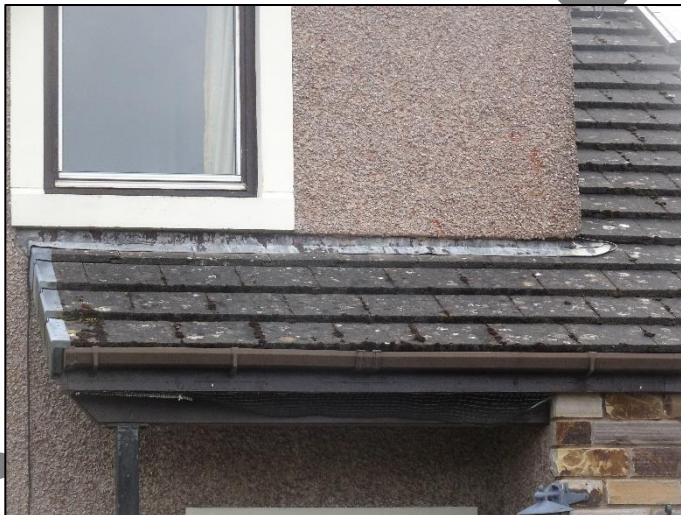
**Photograph 7**

- 3.2.3. The lead to the entrance porch is fitted in a single section, in excess of 1.5m long, which will reduce its life expectancy.

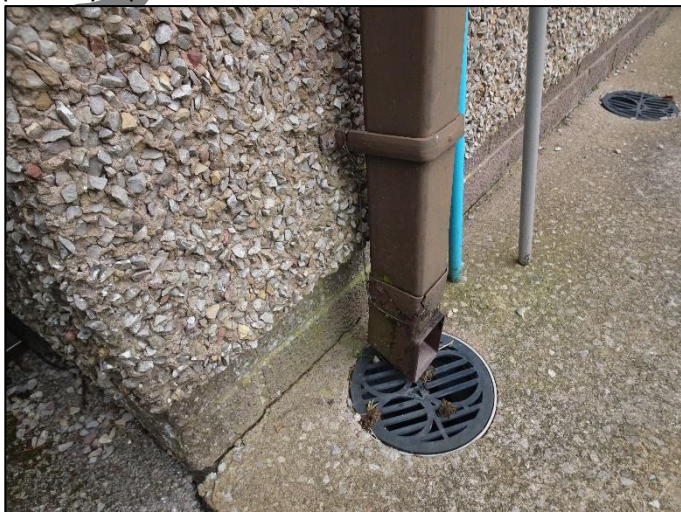
**Photograph 10**

- 3.3.3. I would recommend that a bend or shoe is fitted to ensure that rainwater discharges properly into the gulley.
- 3.3.4. The shoe to the rear-right rainwater downpipe is damaged and held in place by a piece of wire.

- 4.6. The rainwater goods were not seen under operational conditions and I anticipate that there may be leaking joints.
- 4.7. At this stage, allowance should be made for replacement of the seals and replacement shoes to the front and rear-right side downpipes.

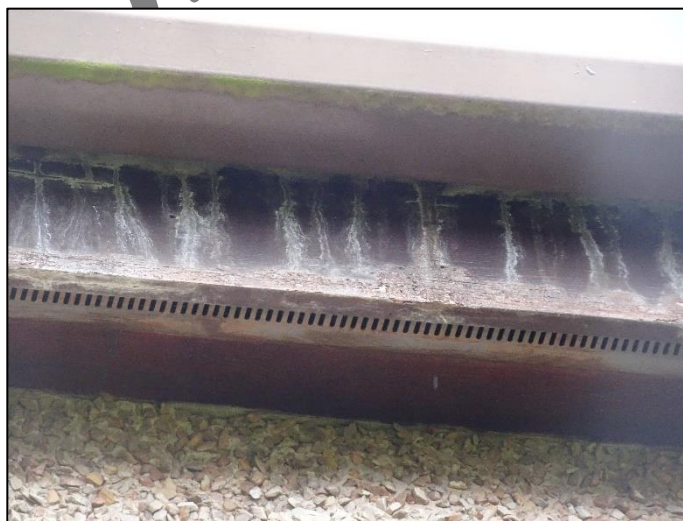
**Photograph 14**

- 3.5.7. To the rear left there is significant water staining. The area should be observed during rainfall to determine whether there is an ongoing problem of water run off from the roof or gutters and remedial works may be required.

- 4.9. There is staining to the fascias on the rear left which require observation during rainfall to confirm whether or not there is an ongoing problem.

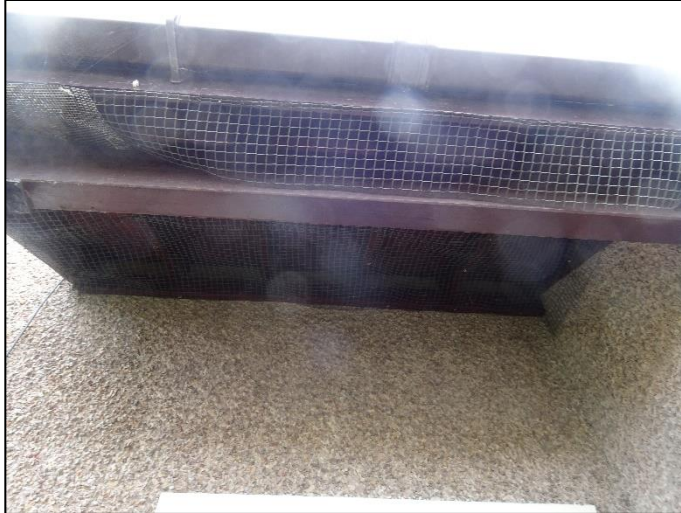
**Photograph 15**

- 3.5.8. There are ventilators within the soffit providing ventilation to the roof voids.
- 3.5.9. To the front entrance, mesh has been applied to the underside of the roof to prevent birds nesting.

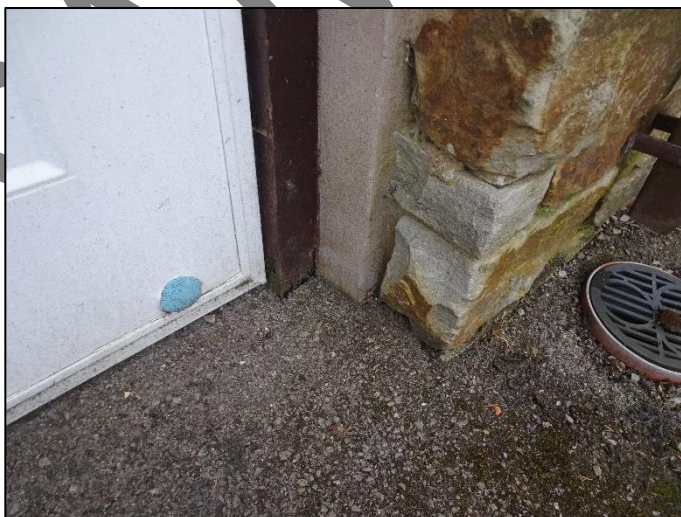
**Photograph 17**

- 3.5.19. To the front entrance, there is a steel post supporting the roof structure.
- 3.5.20. There is surface corrosion beginning to set into the post, which requires re-decoration.
- 3.5.21. There is a pressed steel up and over garage door hung in a timber frame.
- 3.5.22. The door is insulated internally and has been taped shut.
- 3.5.23. There is decay setting into the base of the framework which will require splice repairs as part of ongoing maintenance.

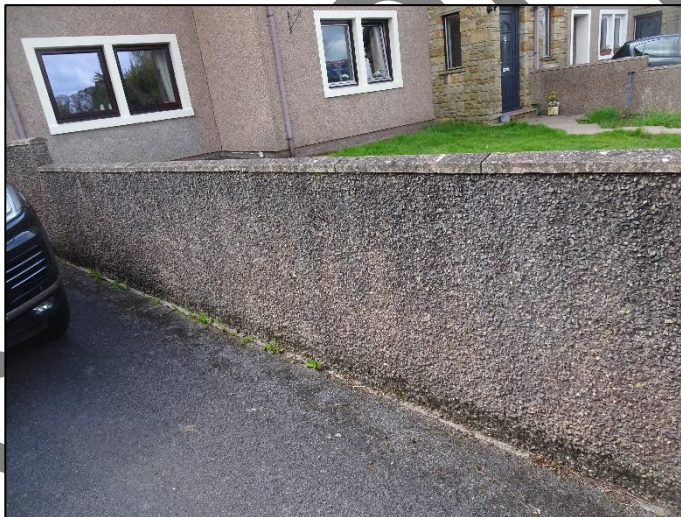
**Photograph 18**

- 3.6.3. The mortar pointing between the copings is eroded and should be replaced.

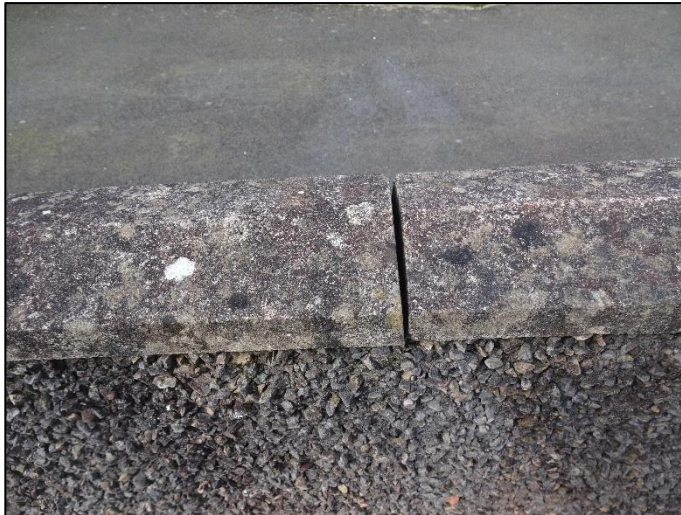
**Photograph 19**

- 3.6.4. There is isolated cracking to the wall but which is not significant enough to require repairs.

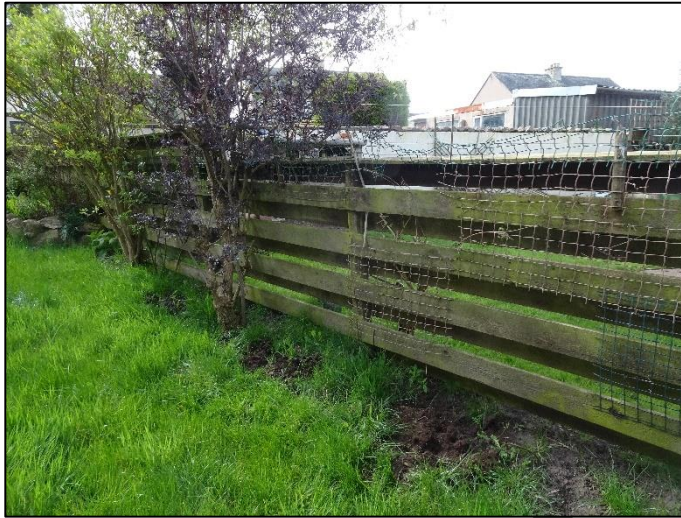
**Photograph 22**

- 3.6.6. The fence is wobbly, indicative of decay to the posts below ground.
- 3.6.7. To the front left, there is a timber post and horizontal rail fence which is within a hedge, the only visible bit being close to the house, where it is seen to be in reasonable condition.

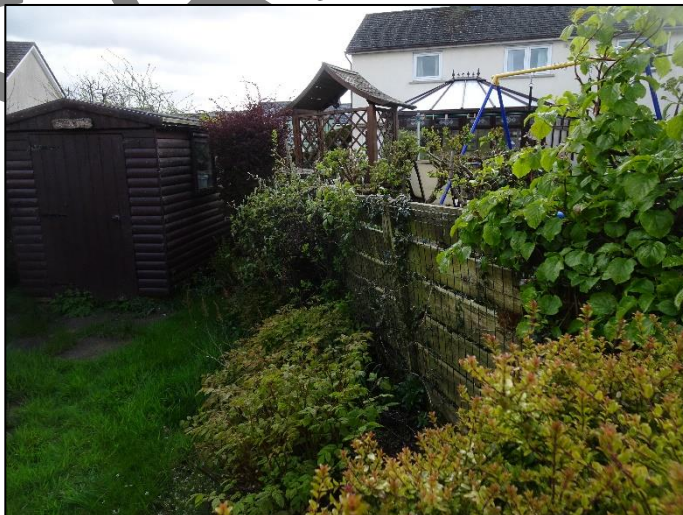
**Photograph 26**

3.6.9. The fence is suffering decay and will have limited life remaining.

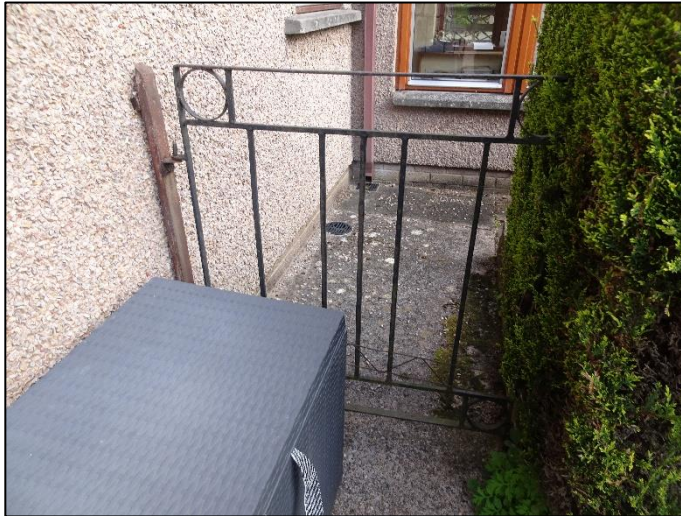
**Photograph 27**

- 3.6.12. The gate and posts are in reasonable condition but require re-decoration.
- 3.6.13. The ownership of the boundaries should be ascertained in order that repairing liabilities are known.
- 3.6.14. To the front-right corner of the house there are a pair of ornamental steel gates and a short section of stone wall, to which the right-side gate is fixed.

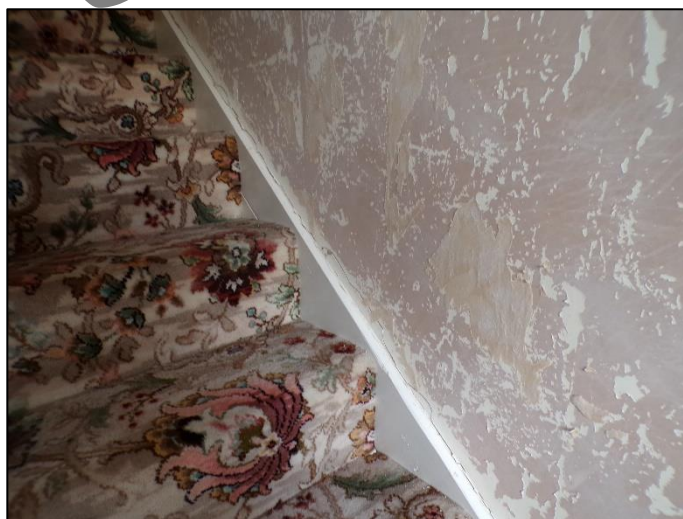
**Photograph 35**

3.9.6. There is minor cracking around the string to the staircase, which will require making good as part of re-decoration.

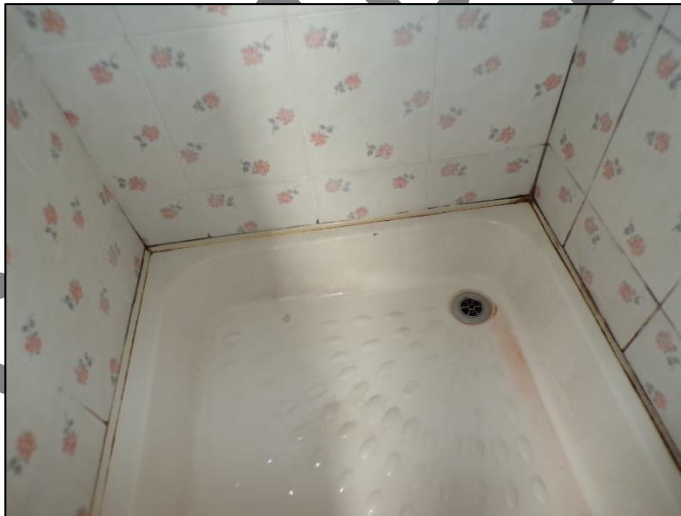
**Photograph 41**

- 3.12.7. Within the bathroom there is a full suite comprising WC pan with close coupled cistern, pedestal wash hand basin, acrylic bath and separate shower tray with tiled walls, shower rail and curtain and thermostatic shower.
- 3.12.8. The grouting to the tiles is stained and deteriorating, requiring cleaning out and re-grouting.

- 4.10. Tile grout within the shower is stained and deteriorating, requiring replacement, but otherwise the sanitaryware is noted to be in good condition for its age.

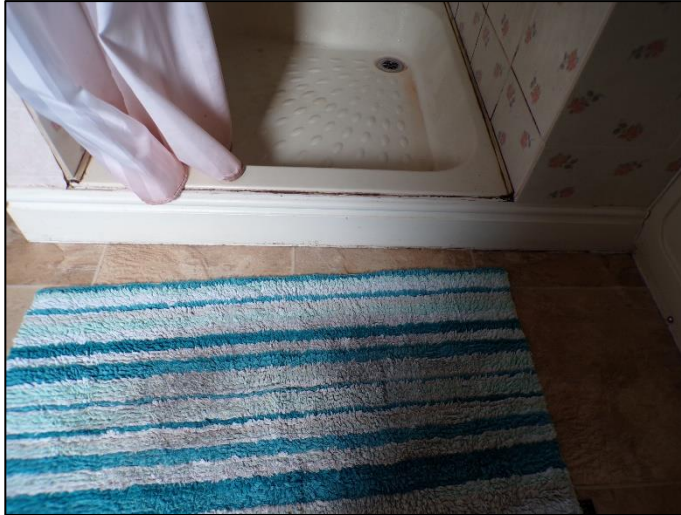
**Photograph 42**

- 3.12.9. There is staining to the skirting indicative of water making its way under the bottom of the curtain and ideally a door would be fitted.

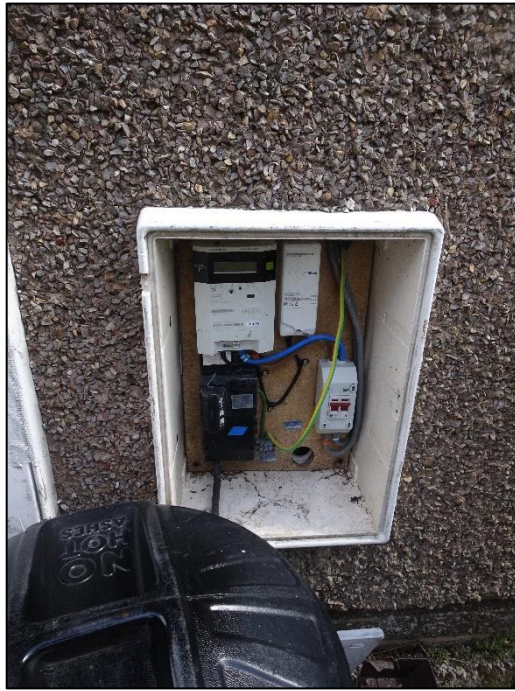
**Photograph 49**

- 3.15.4. The door to the cabinet has been damaged and is laid on the ground beneath and should be replaced immediately.
- 3.15.5. The door should be replaced.
- 3.15.6. The consumer unit is located within the garage and has mini circuit breakers.

- 4.14. I do not anticipate that there would be any significant works required.
- 4.15. The electrical meter cabinet has a defective door which requires replacement.

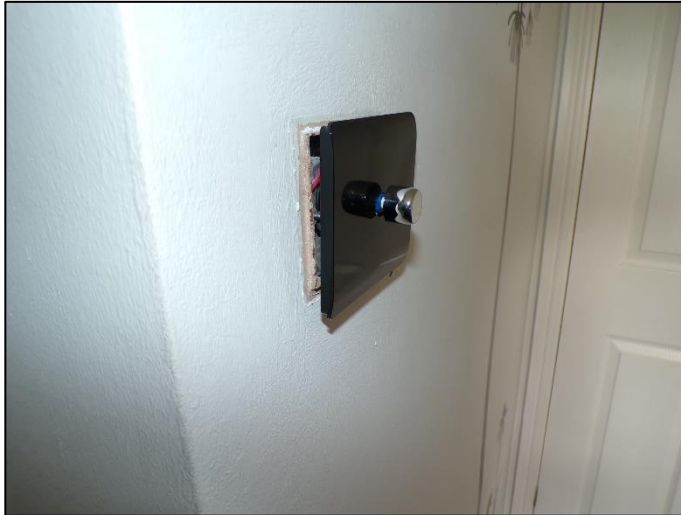
**Photograph 51**

- 3.15.9. The sockets and switch covers within the kitchen/diner have been replaced as part of refurbishment of the kitchen.
- 3.15.10. There is a dimmer switch adjacent to the door into the utility room which is not securely fixed back to the wall and I suspect that the back box will require replacement.

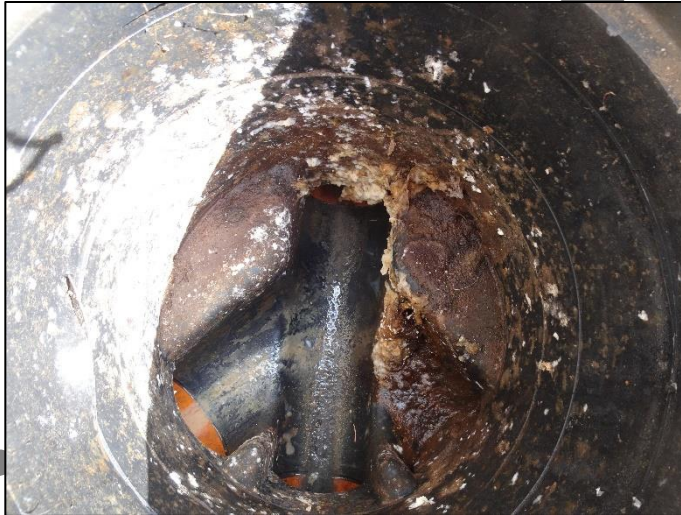
**Photograph 56**

- 3.17.4. The chamber was running freely at the time of the survey but requires general flushing and cleaning.

- 4.12. The drainage gullies require routinely cleaning out and I would recommend that the drainage inspection chamber is flushed and cleaned.
- 4.13. The electrical installation should be tested and upgraded as necessary.

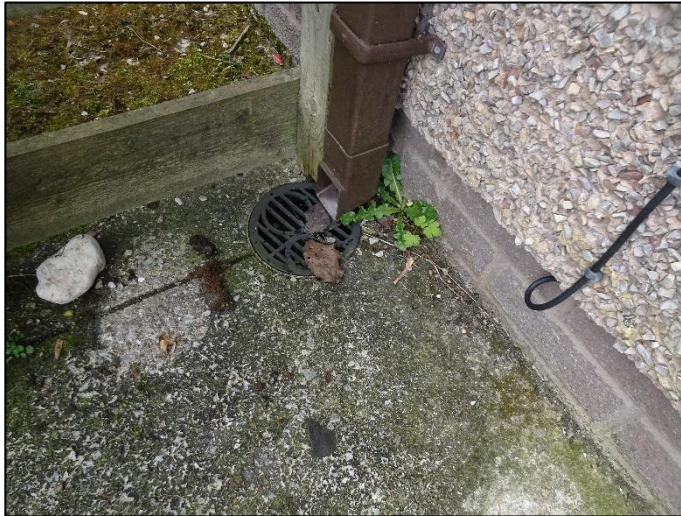
**Photograph 58**

- 3.17.6. The gulley to the front right appears to be blocked with water close to the grating.
