I R Johnson MRICS, Chartered Building Surveyor

IRJ/AH/S1147/FBS

Introduction to the Report

*STREATLAM AND STAINTON STAINTON VILLAGE NZ O1 NE 13/216
Former farmhouse at West Farm*

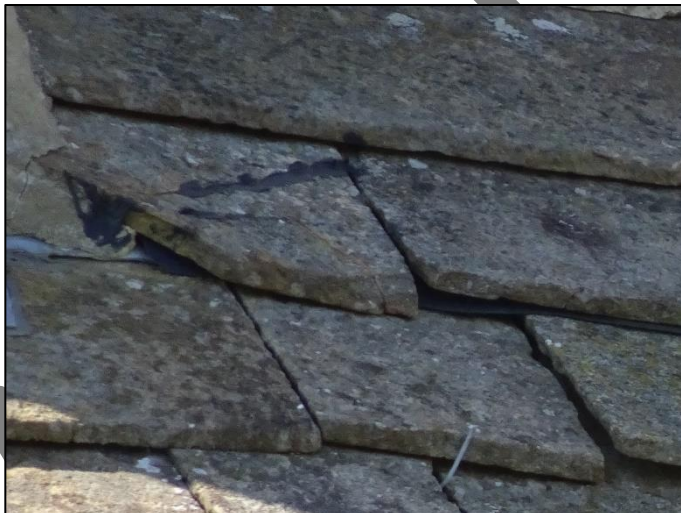
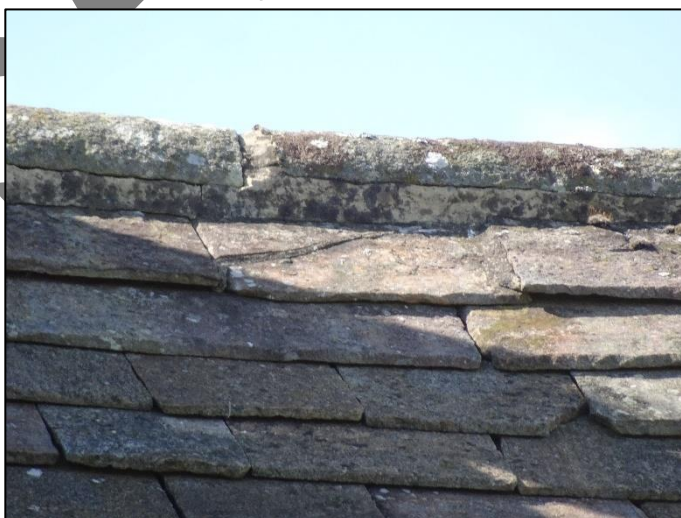
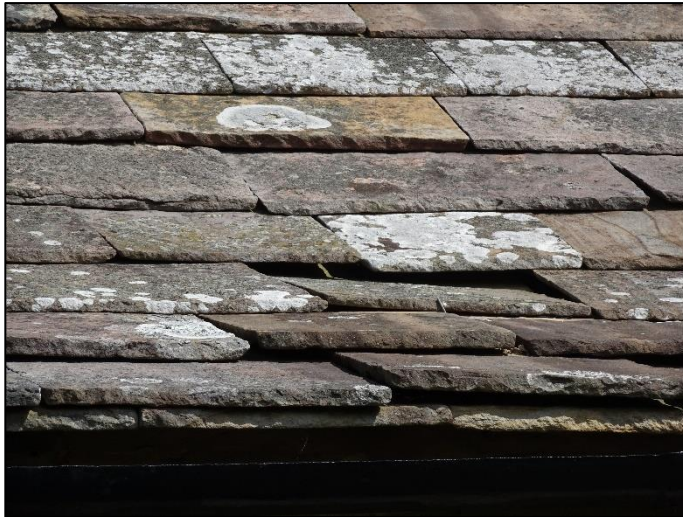
- 3.1.5. There are numerous re-fixed slates and isolated damaged stone slates which should be programmed for replacement.

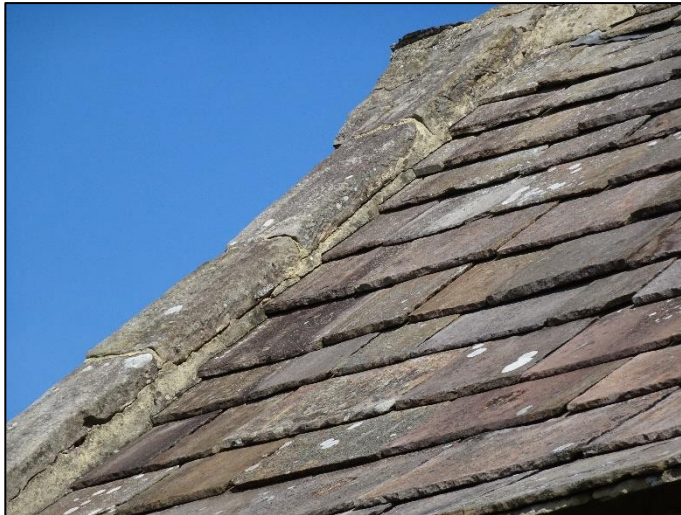
Photograph 15

- 3.1.15. The pointing/bedding to the front right has been replaced but to the rear there is cracked and eroding mortar which will require replacement.

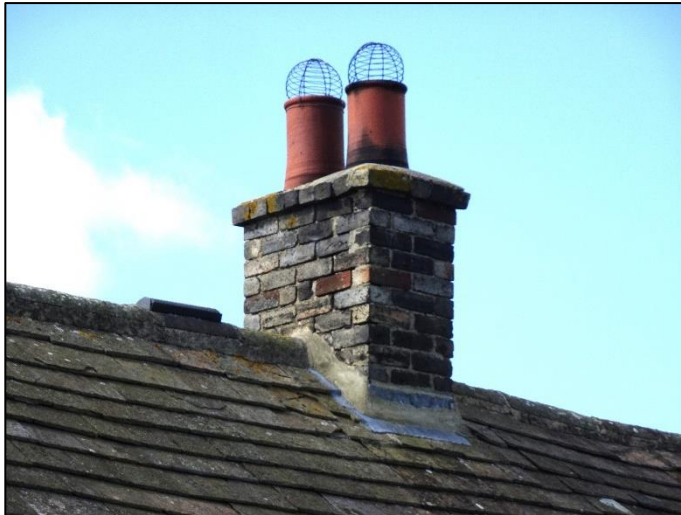
Photograph 17

- 3.2.3. There are some eroded mortar joints to the brickwork stacks requiring re-pointing.

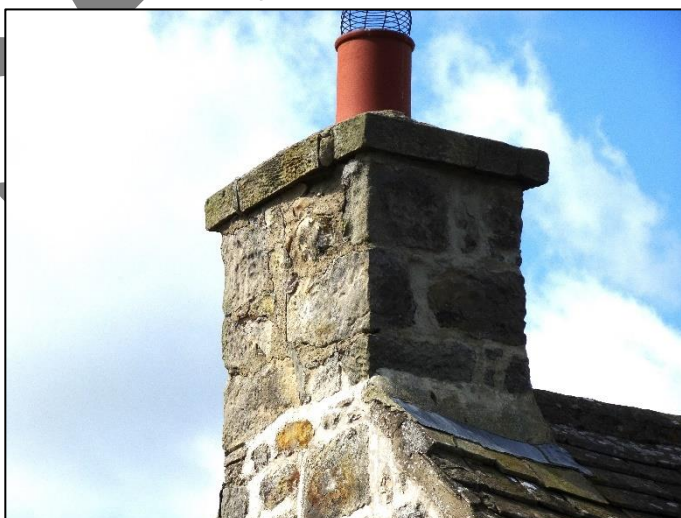
Photograph 19

3.2.4. There is some cracked and loose mortar pointing to the left-side stone-built stack, requiring replacement.

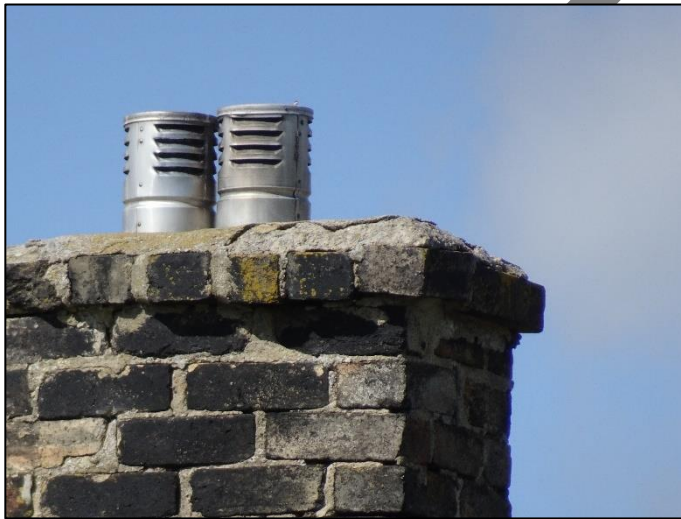
Photograph 20

- 3.2.5. Old chimney stacks can suffer extensive erosion from the flues which is not visible externally and potential re-building cannot be ruled out in the future.
- 3.2.6. The right-side stack has two stainless steel vent terminals, the centre stack two clay pots and the left-side stack a single clay pots.
- 3.2.7. The clay pots have wire bird cages.
- 3.2.8. The pots are mortar bedded and flaunched.
- 3.2.9. There is some deterioration of the flaunching around the stainless steel flue terminals, requiring replacement.

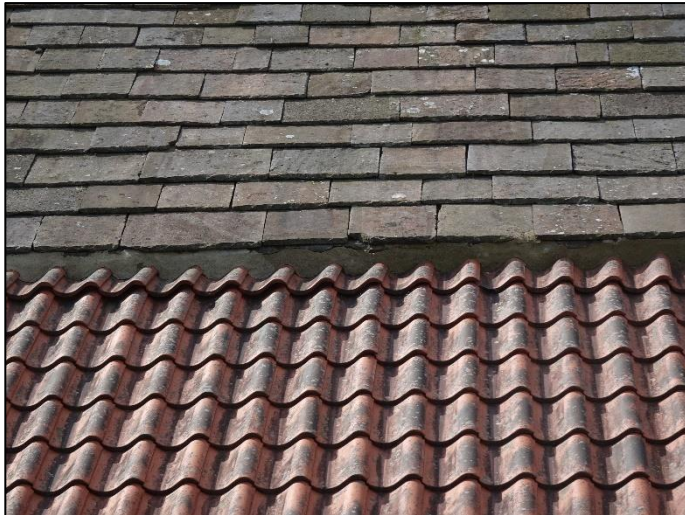
Photograph 21

- 3.2.10. There are mortar flaunchings and some lead flashings to the base of the stacks.
- 3.2.11. Mortar flaunchings are inclined to shrink and crack and will require replacement from time to time. The flaunchings appear to have been replaced relatively recently.
- 3.2.12. As part of future repairs and maintenance, consideration should be given to the fitting of lead flashings as a more durable, long-term solution, although this will require listed building consent.
- 3.2.13. At the abutment of the lean-to roof there is a mortar flaunching taken up to the underside of the stone slates above.
- 3.2.14. There is an area of cracked/loose mortar which will require replacement in the future.

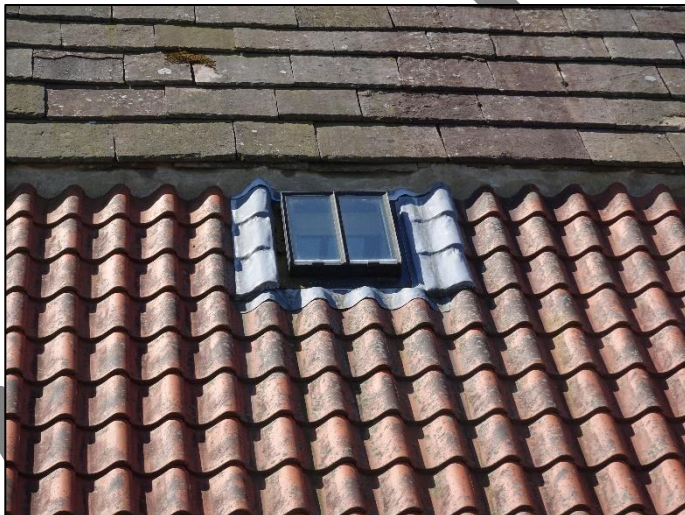
Photograph 22

- 3.2.15. There are lead flashings around a roof window in the lean-to roof which are in satisfactory condition.

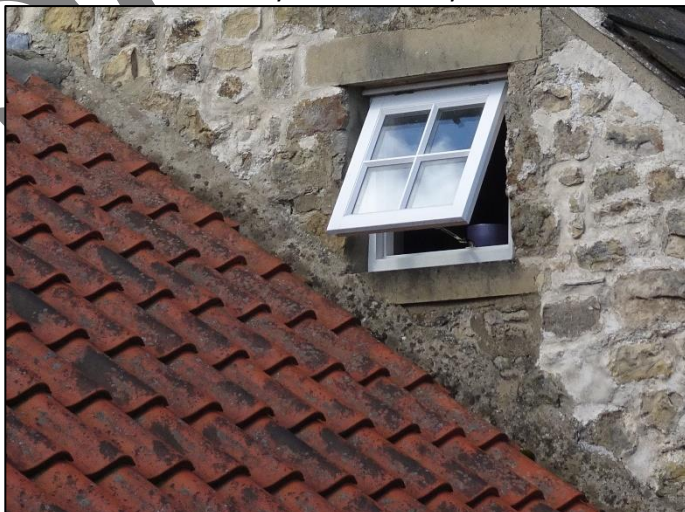
Photograph 23

- 3.2.16. To the front slope of the single-storey roof there is a mortar flaunching detail which is currently in satisfactory condition.

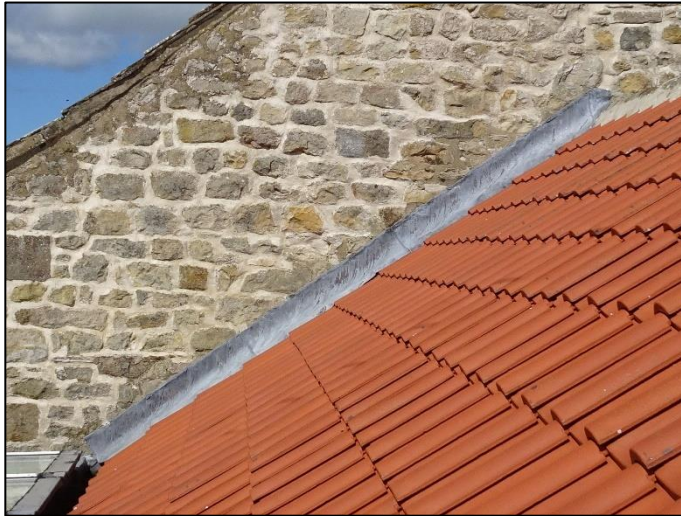
Photograph 24

- 3.2.17. To the rear slope there is a lead flashing which is in satisfactory condition.

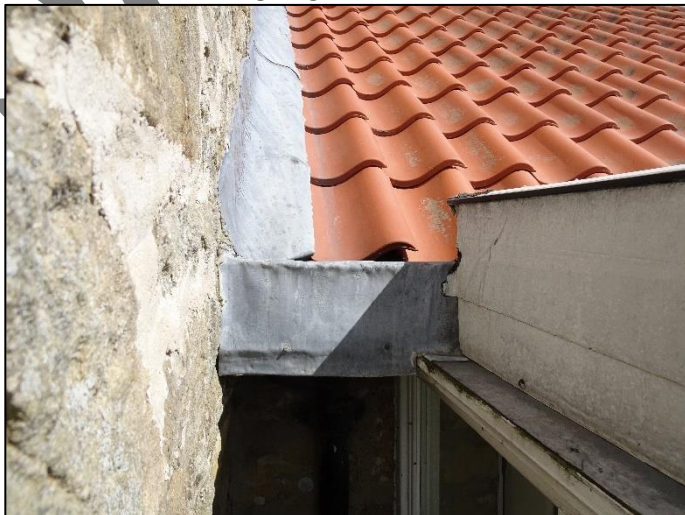
Photograph 27

- 3.3.7. The gutters are also positioned significantly below the level of the roof slates and I would recommend that these are adjusted accordingly.
- 3.3.8. There is no evidence of any leaks to the rainwater gutter joints.
- 3.3.9. The cast iron gutters are fixed on traditional drive-in brackets to the main roof and fascia brackets to the single-storey roofs.
- 3.3.10. There is a lead lined abutment gutter where the garden room roof abuts the rear of the garage and boot room.

- 3.3.11. The lead lining was seen to be in satisfactory condition, however it does not appear to have been installed in accordance with The Lead Association, Guide to Good Site Practice and will have limited life expectancy.

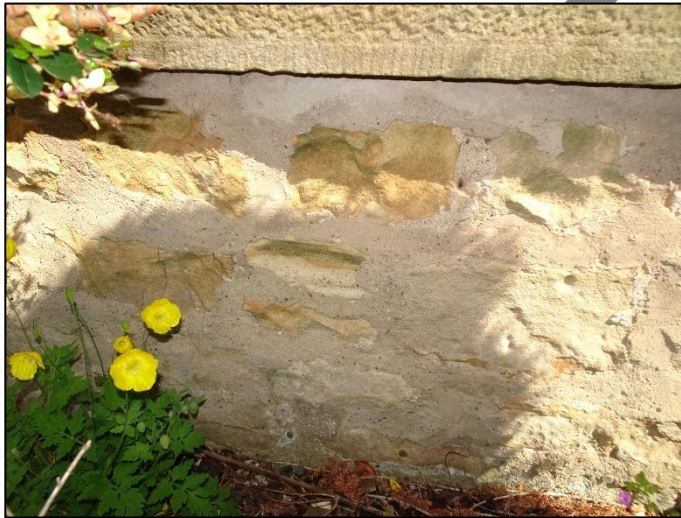
Photograph 31

- 3.4.10. There is an ashlar stone door surround to the rear entrance door to the kitchen.
- 3.4.11. The entrance doors to the front have stone heads.
- 3.4.12. The external walls have been completely re-pointed using a cement-based mortar.
- 3.4.13. Cement-based mortars are hard and impervious and can lead to or exacerbate dampness problems and erosion of stonework.
- 3.4.14. There is some isolated deterioration of stones and cracked mortar as a result.

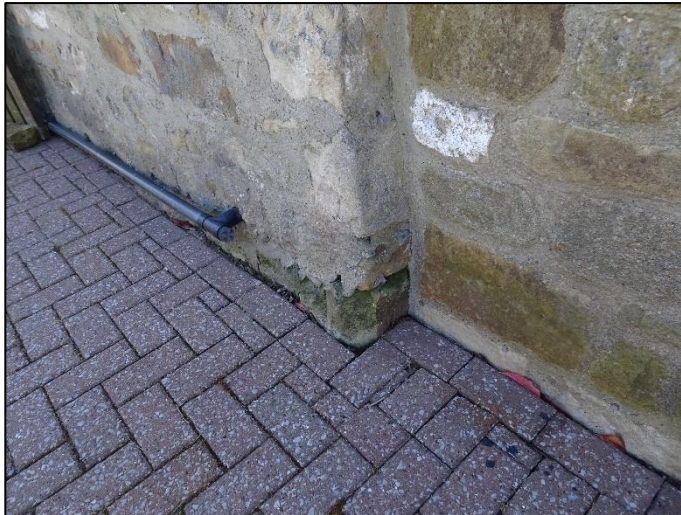
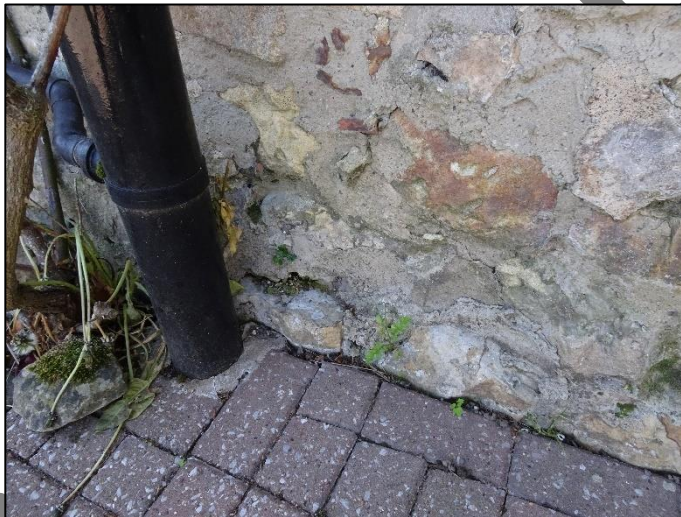
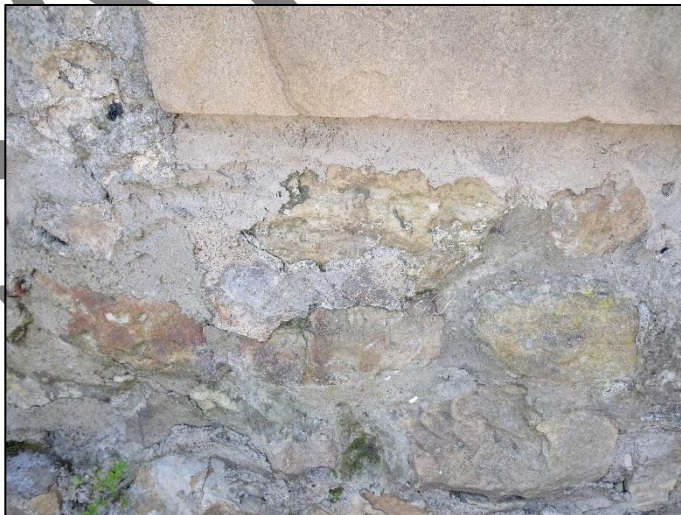
- 3.4.15. There are isolated areas of open and loose mortar joints requiring re-pointing.

- 3.4.16. Any re-pointing in the future should be undertaken using a traditional lime mortar.
- 3.4.17. The extension walls have a damp-proof course to the base and the old walls have had injected chemical damp-proof course.

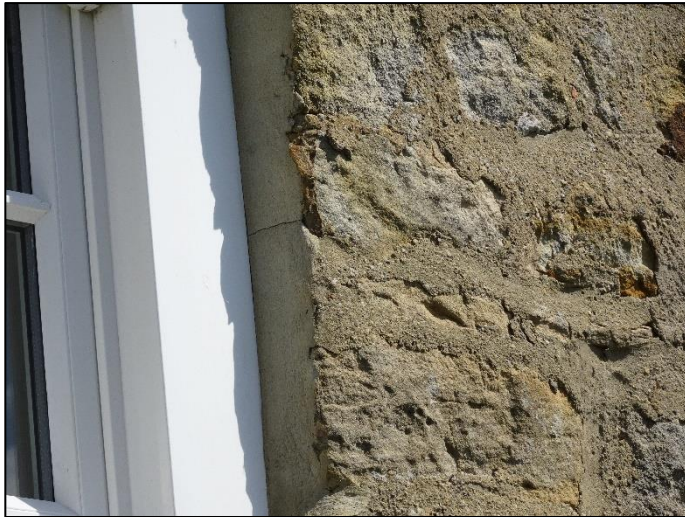
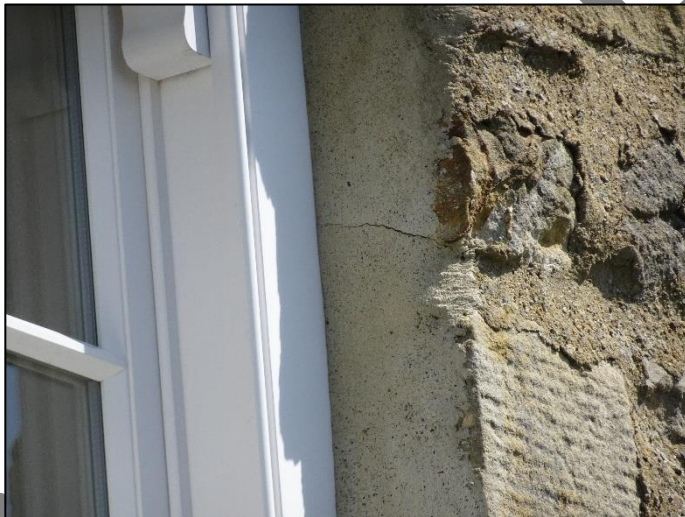
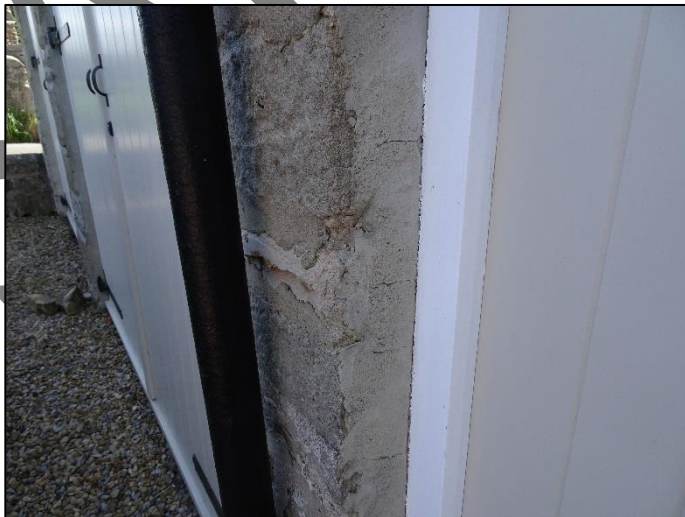
- 3.4.27. Window and door reveals are mortar pointed.
- 3.4.28. There is isolated cracking to some of the pointing which will require replacement as part of future maintenance and repairs.

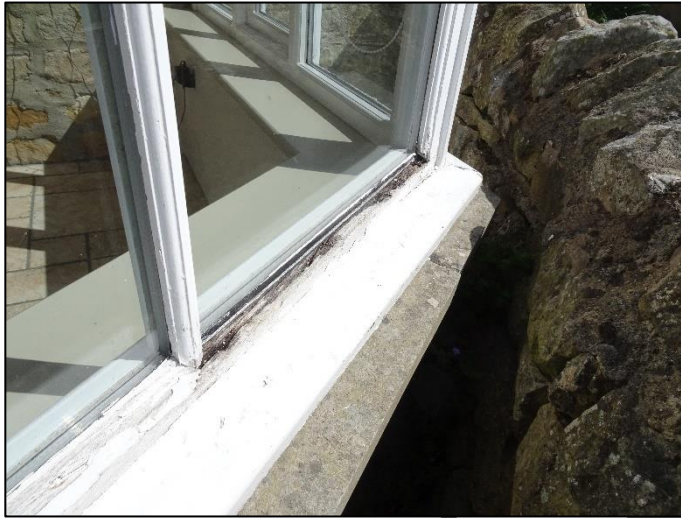
Photograph 41

- 3.5.10. There is decay to the timberwork which requires repair, although I anticipate replacement will prove to be necessary.

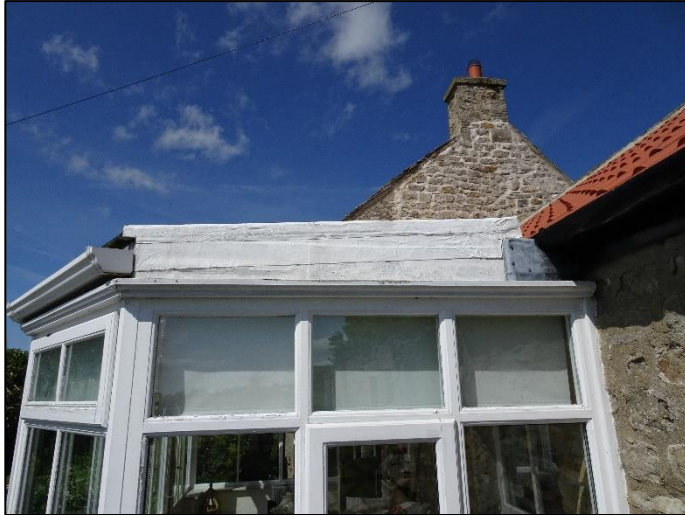
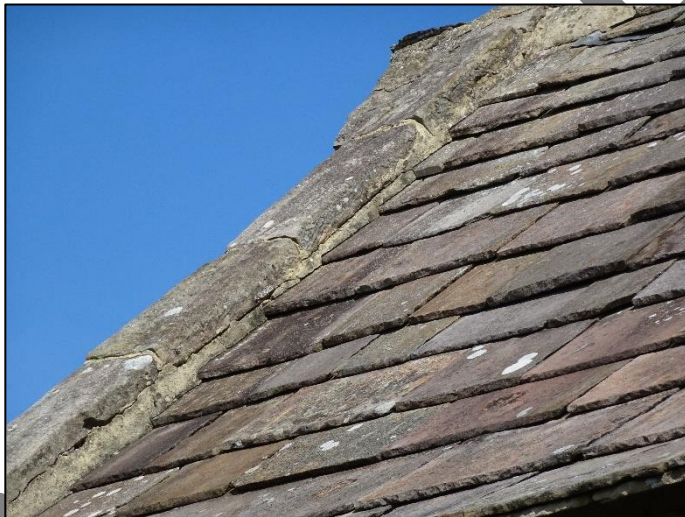
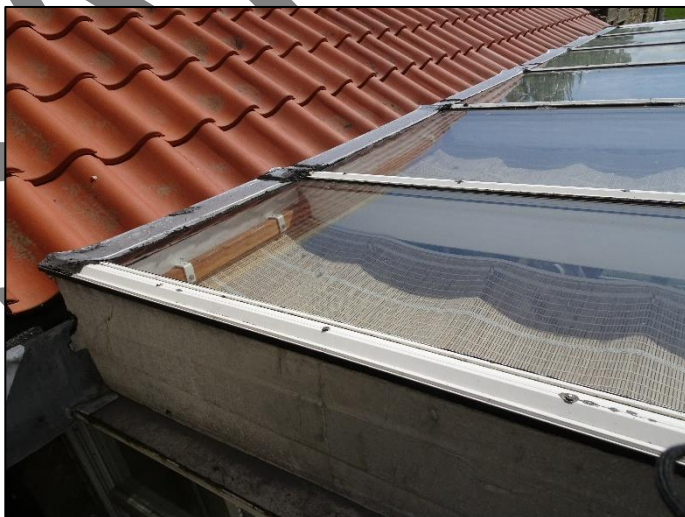
- 3.5.11. Numerous glazed units have failed and should be replaced.
- 3.5.12. The roof is of timber frame construction with double-glazed units.
- 3.5.13. Flash band has been installed over the timbers to prevent water penetration.

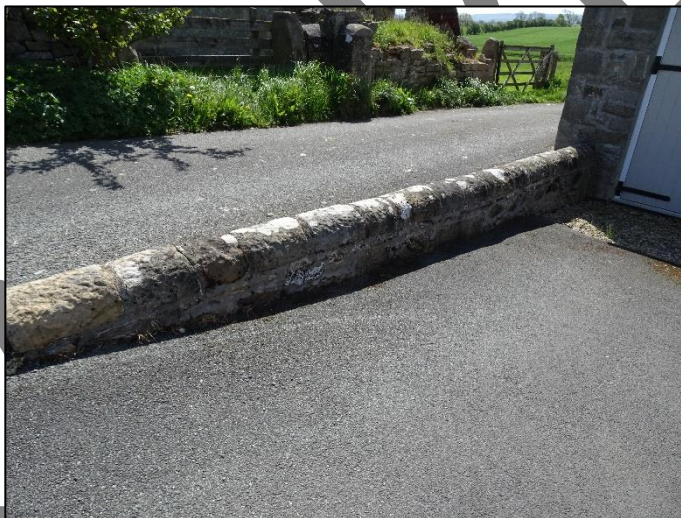
Photograph 53

- 3.6.5. There is a stone-built boundary wall to the front right which is in satisfactory condition.
- 3.6.6. There is a small stone-built retaining wall to the front left which is in satisfactory condition.

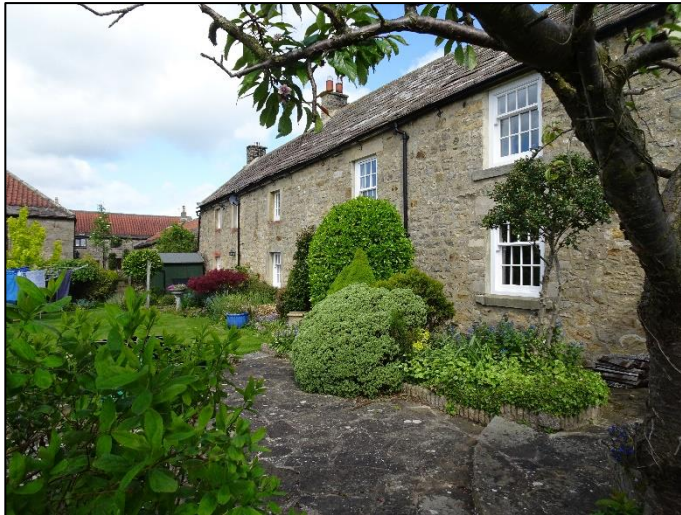
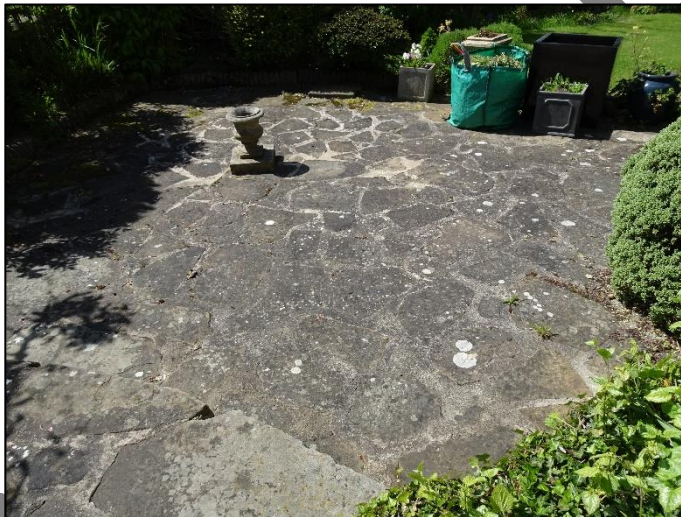
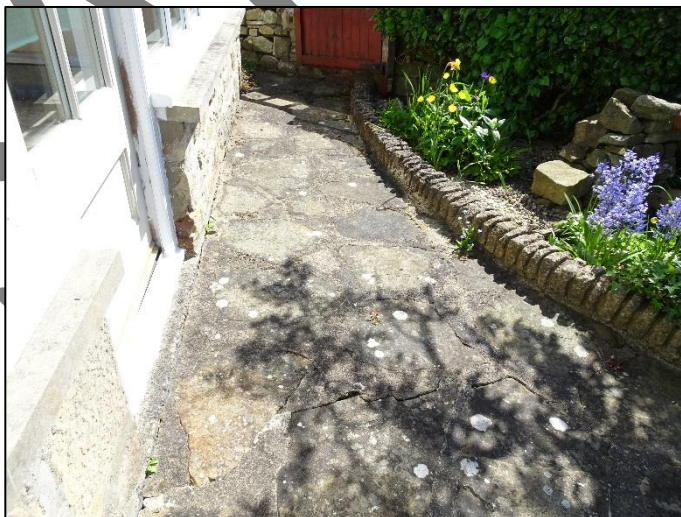
- 3.6.8. The ownership of the boundaries should be ascertained in order that repairing liabilities are known.
- 3.6.9. There are random stone flagged paths and terraces to the rear which are in reasonable condition, suffering isolated erosion of mortar pointing which should be replaced.

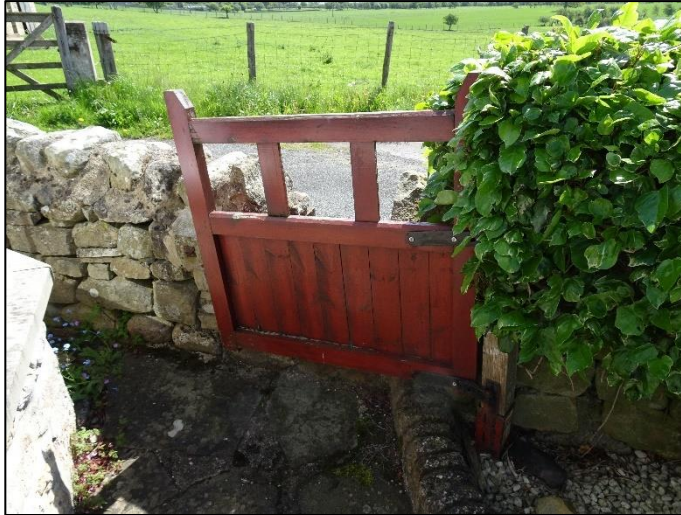
Photograph 59

- 3.6.10. There is a timber personnel gate hung on a timber post to the rear left giving access over a small style through the wall.

3.6.11. The gate is hung to self-close and requires re-decoration.

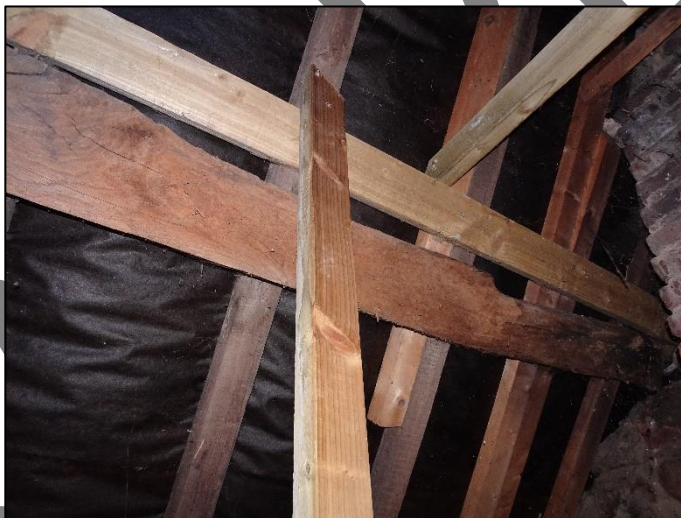
Photograph 64

- 3.7.8. There is evidence of significant woodworm infestation to some of the principal roof timbers, although none of this was noted to be active.
- 3.7.9. Strengthening has been undertaken and numerous rafters have been replaced.

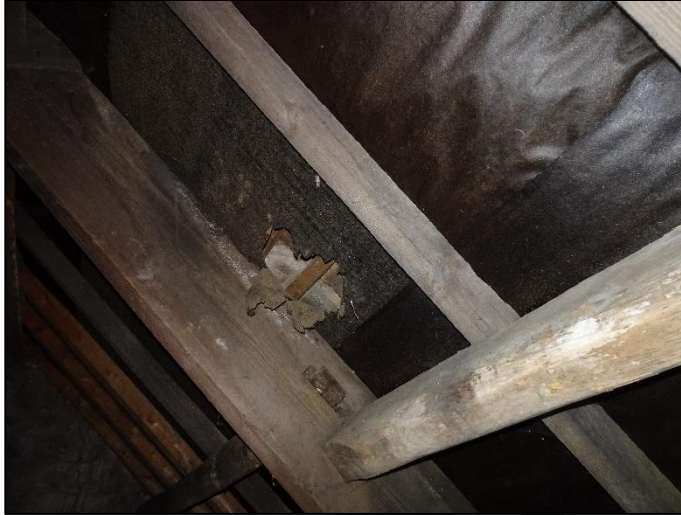
Photograph 70

- 3.7.19. There is old woodworm infestation noted to the timbers.
- 3.7.20. There is a bitumen-based roofing felt draped over the rafters which has a hole to one area and ideally would be patch repaired, although this is difficult.

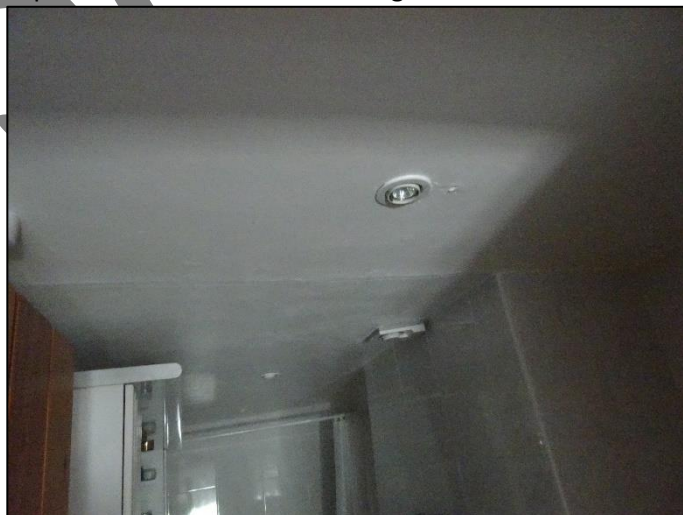
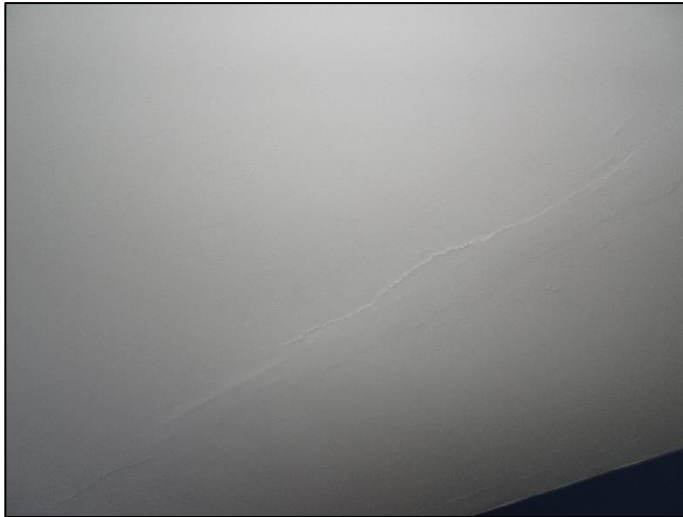
- 3.8.3. There is some undulation and cracking to the lath and plaster ceilings, in particular the bathroom ceiling.

- 3.8.5. The ceiling joists could not be inspected due to the insulation laid between and over them.
- 3.8.6. Lath and plaster ceilings deteriorate over time due to corrosion of the nail fixings holding the laths to the joists and plaster becoming debonded from the laths. It is almost inevitable that replacement or overboarding of the ceilings will be necessary in the future.
- 3.8.7. To the living room there is plasterboard between exposed first-floor joists.

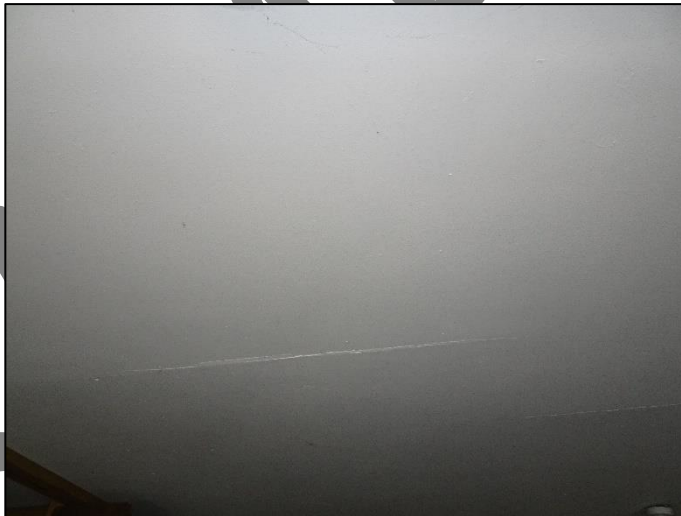
Photograph 82

- 3.8.8. The plasterboard ceilings have some isolated cracks to board joints which is not unusual and is not a structural problem.
- 3.8.9. The vendor advised that a section of the dining room ceiling has been recently replaced as a result of a leak from the bathroom above.
- 3.8.10. There is cracking to the garage ceiling as a result of stored goods.

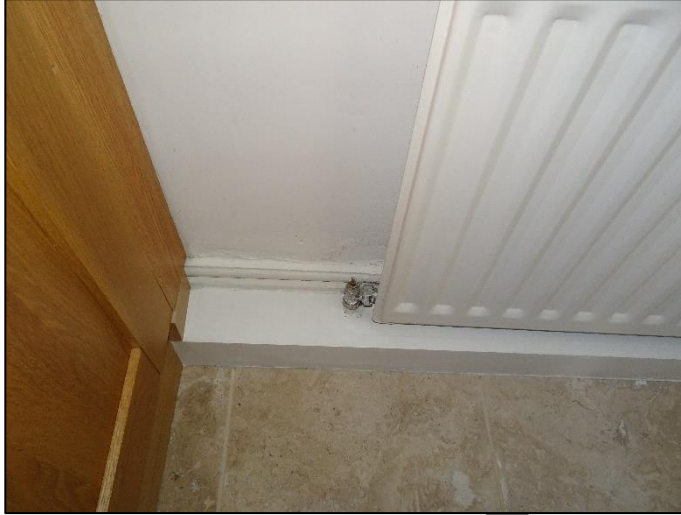
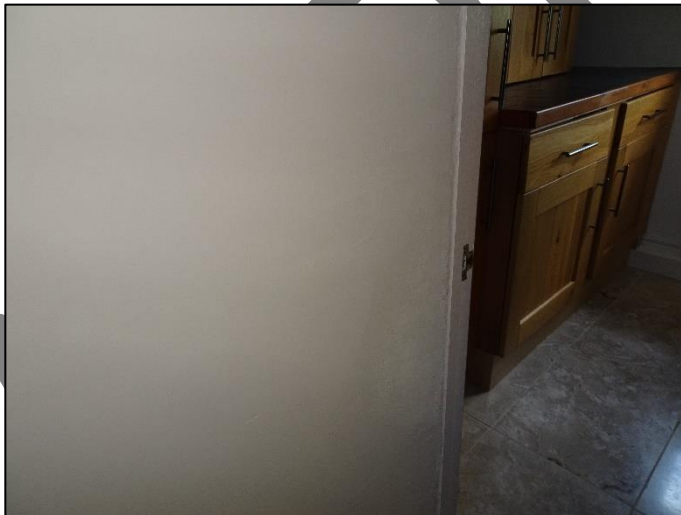
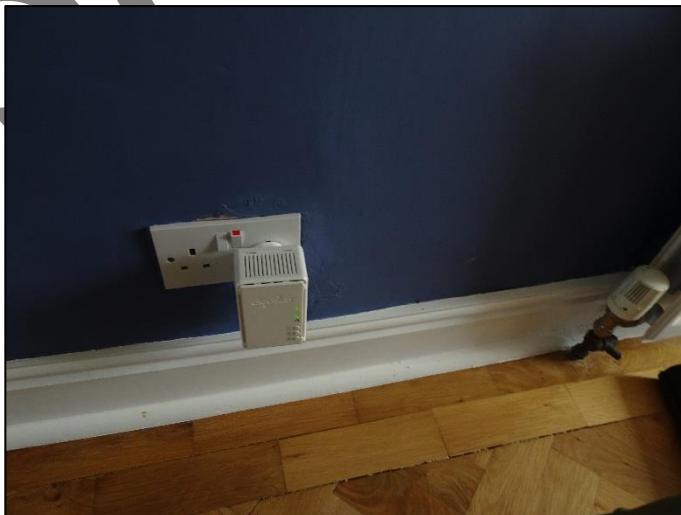
- 3.9.5. There is exposed pointed stonework to the living room, kitchen wall and study walls.
- 3.9.6. There is some minor deterioration of paint finishes in the cloakroom, the arched doorway into the cloakroom, kitchen and pantry.

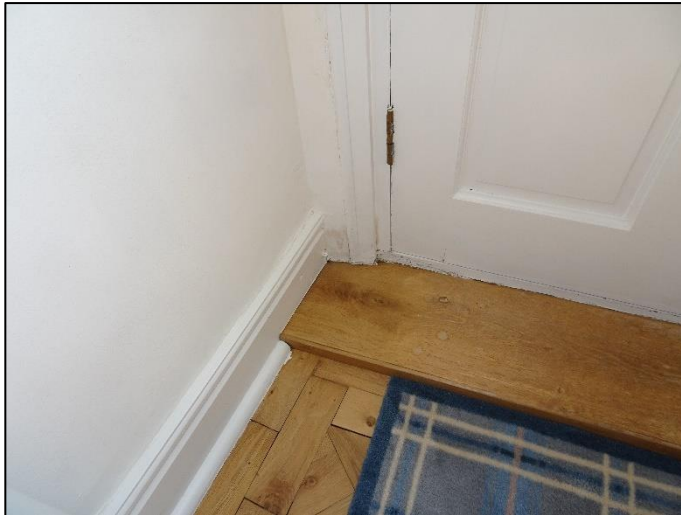
Photograph 88

- 3.9.9. There is some damp staining either side of the kitchen entrance door.

- 3.9.10. There is a stone jamb in this area and the wall is reduced in thickness, consequently the dampness will be very difficult to eliminate.
- 3.9.11. There is no significant smell of dampness in the property and I do not consider that remedial works are essential, particularly given that it is a Grade II listed building and technically listed building consent should be obtained for damp-proofing.

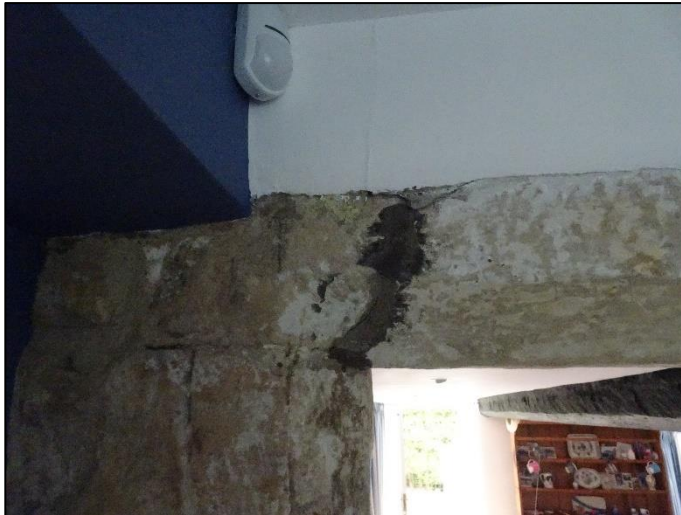
Photograph 92

- 3.9.17. There is an old stone door surround between the utility room and kitchen which would formerly be an entrance door.
- 3.9.18. The head has fractured but replacement is not considered to be necessary.

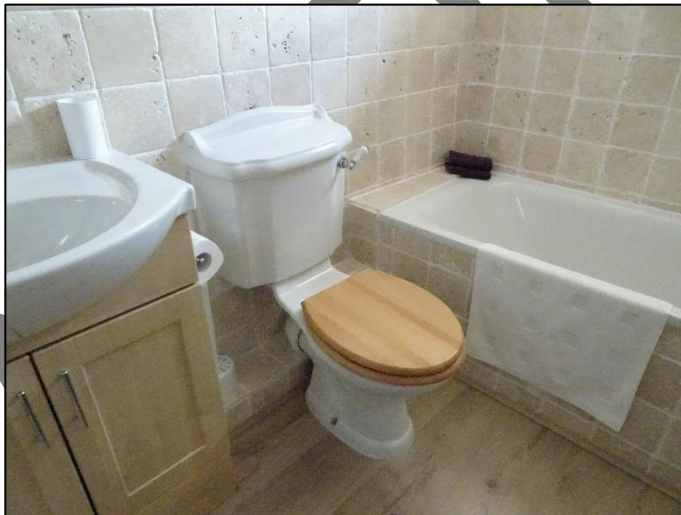
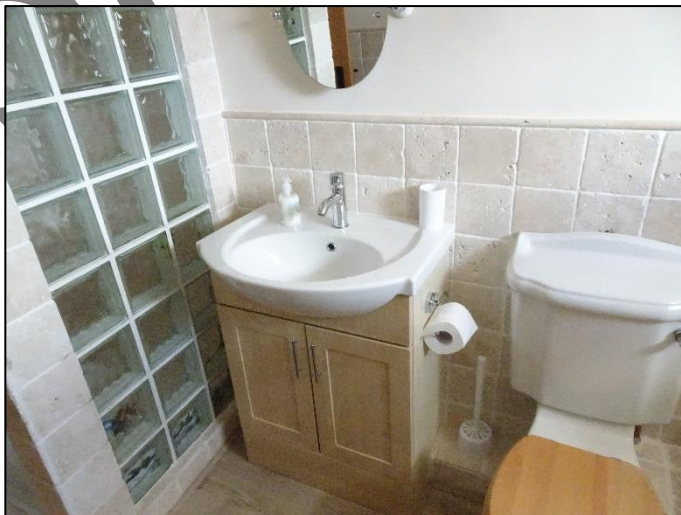
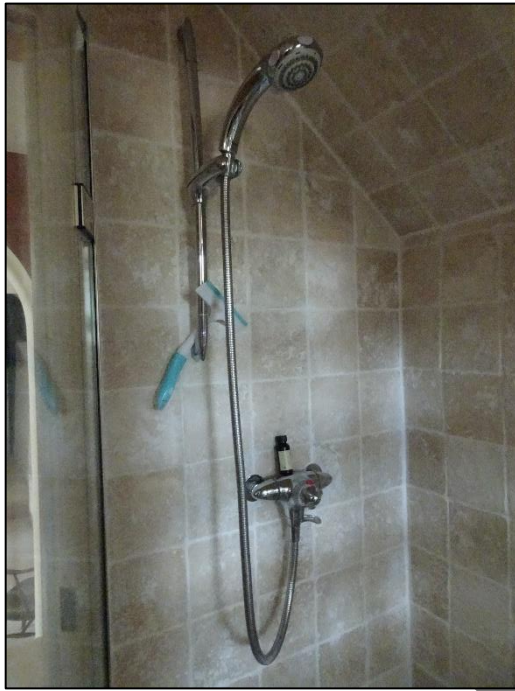
- 3.12.9. The left-side bathroom contains a WC pan with close coupled cistern, pressed steel enamel bath with mixer taps and shower fitting, vanity top, wash hand basin with cupboards below, shower tray and thermostatic shower with glass pivot door and tiled glass blocks to the wall.

- 3.12.10. The bathroom walls are tiled to half height with travertine tiles and to the shower area completely including the ceiling.
- 3.12.11. The left-side bathroom and cloakroom have been re-fitted by the previous owners and are in good condition.
- 3.12.12. Sanitaryware was generally in satisfactory condition throughout and operating at the time of the survey.

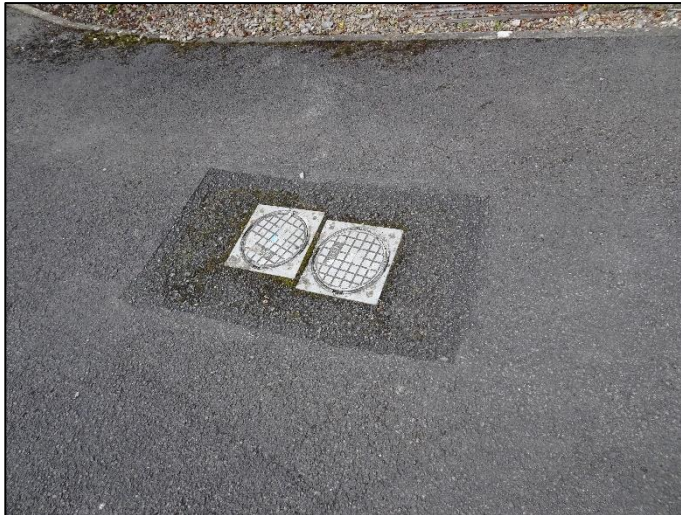
Photograph 108

- 3.13.1. The property is connected to mains water which is an unmetered supply.
- 3.13.2. The external stop tap is located at the bottom of the tarmac drive in the footpath close to one of the neighbouring properties.

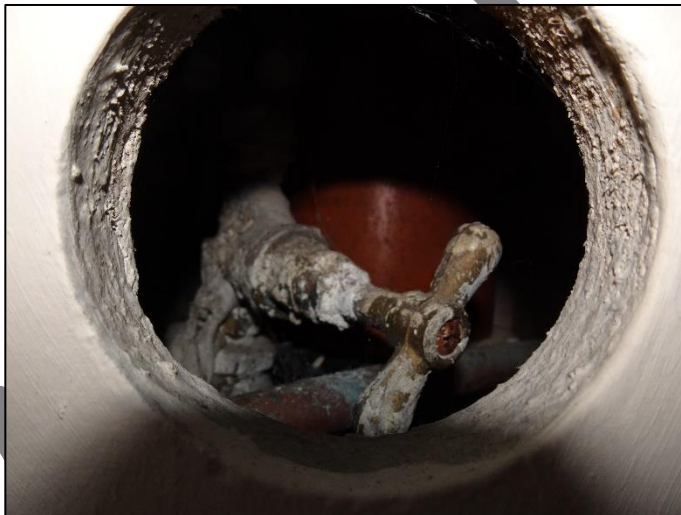
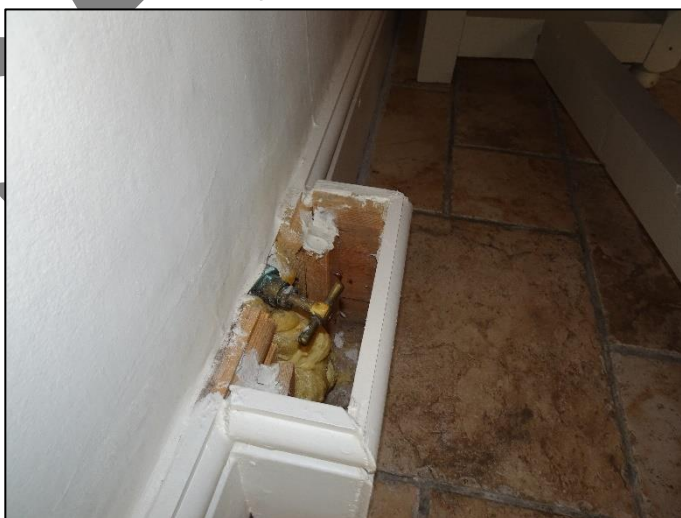
- 3.13.3. There are two internal stop taps; one within the cloakroom and one in the boot room.

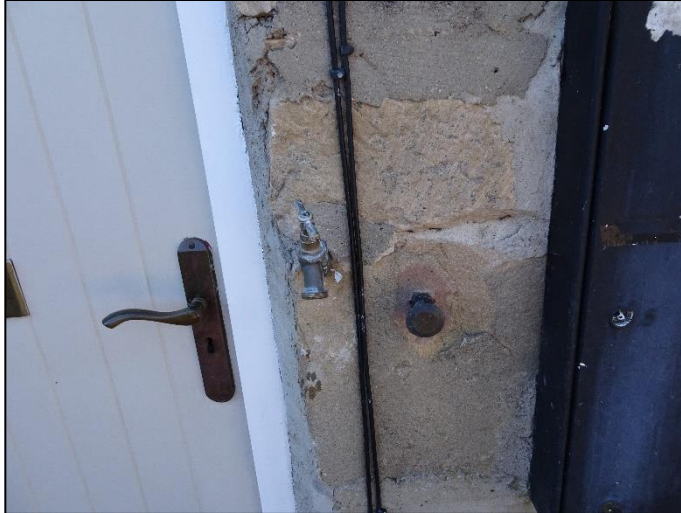
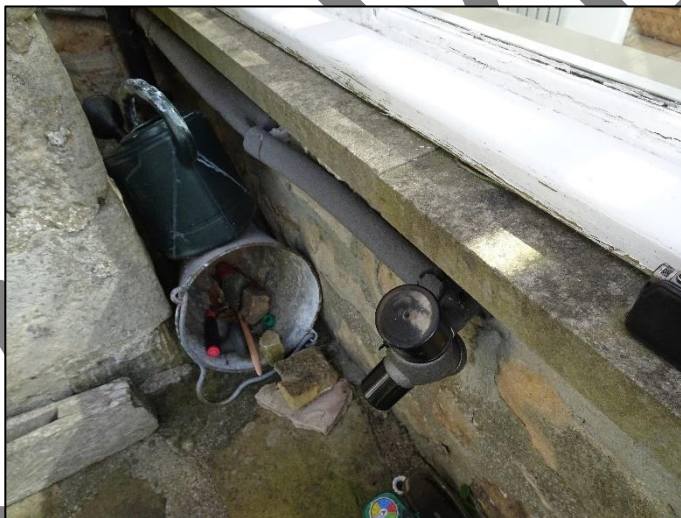
- 3.13.5. Service pipework is copper and there was no evidence of any leaks.
- 3.13.6. There is an external tap to the right side of the boot room door, to the left side of the garden room and a redundant tap beneath the dining room window.

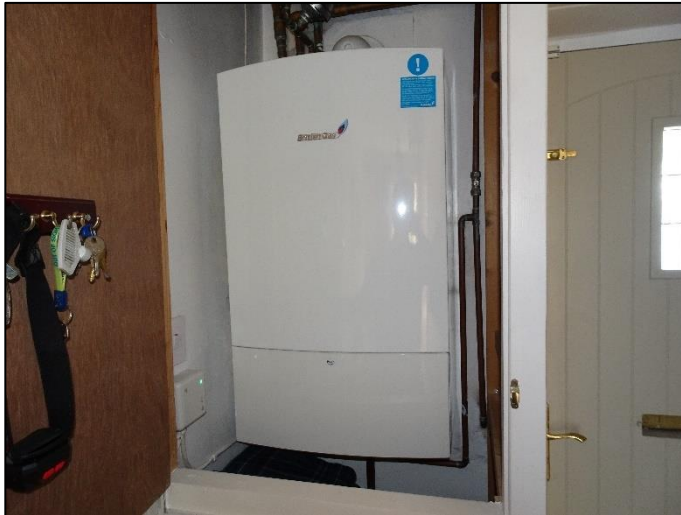
Photograph 113

- 3.14.1. All gas and oil appliances and equipment should regularly be inspected, tested and maintained and serviced by a registered "competent person" and in line with the manufacturer's instruction. This is important to make sure that the equipment is working correctly, to limit the risk of fire and carbon monoxide poisoning and to prevent carbon dioxide and other greenhouse gases for leaking into the air. For more advice contact the Gas Safe Register for gas installations, and OFTEC for oil installations.
- 3.14.2. The property has central heating which comprises a British Gas wall-mounted, gas-fired boiler with balanced flue located within a cupboard in the boot room connected to pressed steel radiators with small bore copper pipework.

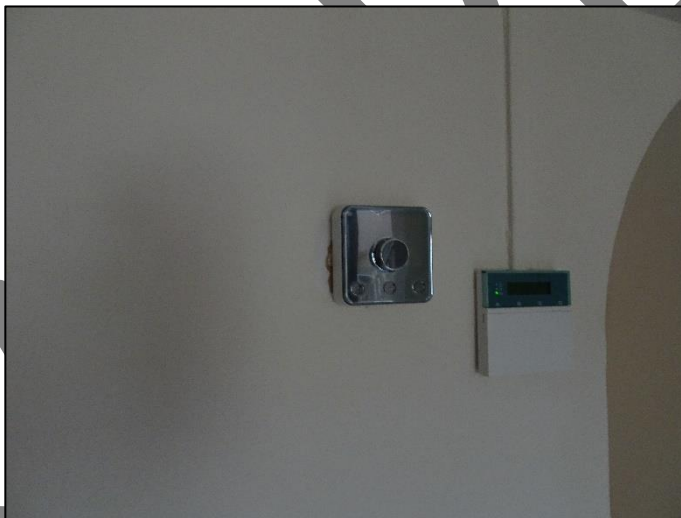
Photograph 114

- 3.14.3. The heating system was installed in the early 1990s.
- 3.14.4. Control is now via a Hive system and there are thermostatic radiator valves fitted to radiators.

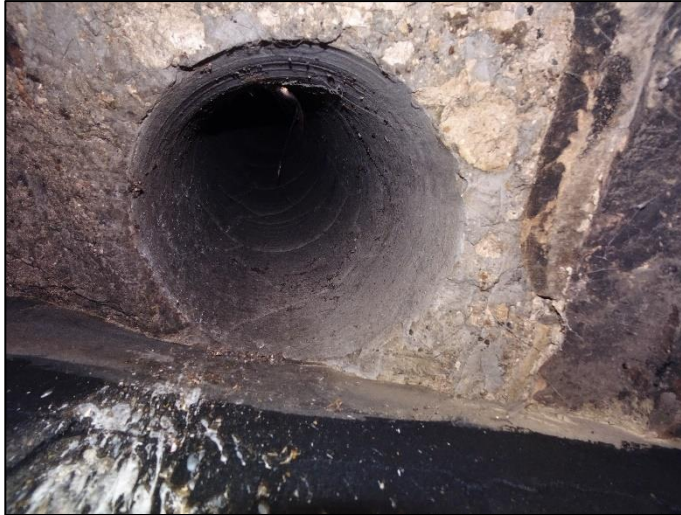
Photograph 115

- 3.14.5. The vendor advised that the boiler is approximately 15 years old and is serviced annually. The boiler was operating at the time of the survey.
- 3.14.6. The boiler is at the end of its design life expectancy but may continue to operate for years to come, however you should anticipate to have to replace it at any time.
- 3.14.7. There is an open fire in the living room which has a coal-effect gas fire in a Georgian grate.
- 3.14.8. The flue has been lined.

- 4.17.4. The boiler is 15 years old and essentially at the end of its design life expectancy.
- 4.17.5. It may continue to operate for years to come, however you should anticipate to have to replace it at any time.

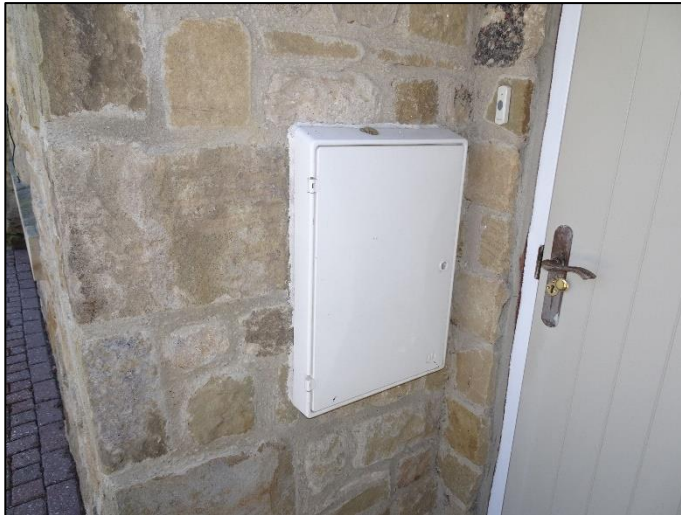
Photograph 116

- 3.15.1. The property is connected to mains electricity.
- 3.15.2. The meter is located within a proprietary housing built into the study wall within the open porch area.

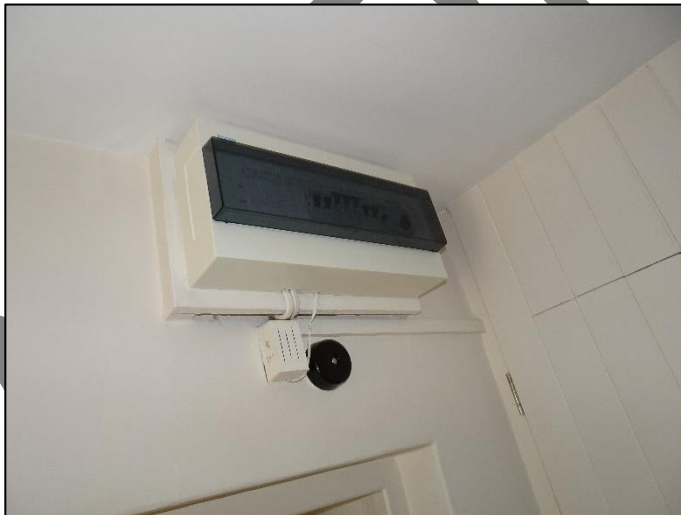
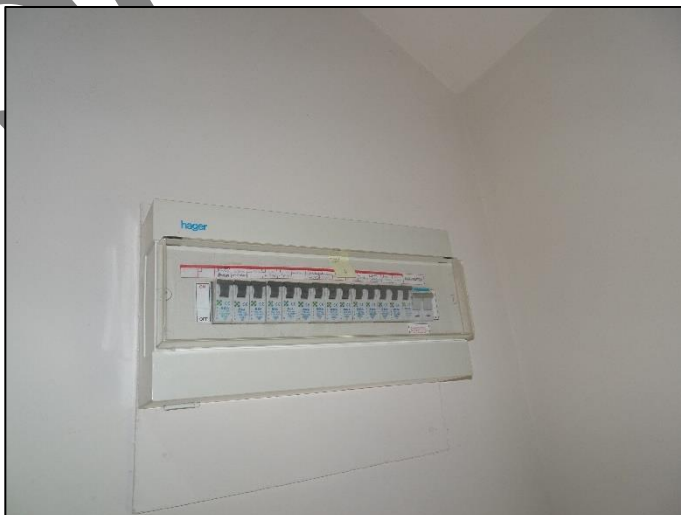
- 3.15.3. The property was completely re-wired as part of refurbishment in the early 1990s.
- 3.15.4. There are two consumer units, one within the boot room and one within the front entrance lobby.

- 3.15.5. The units have mini circuit breakers fitted.
- 3.15.6. Power outlet sockets and switches are flush fitting and have white plastic covers.
- 3.15.7. The provision of sockets throughout the property is to a reasonable standard by current expectations.
- 3.15.8. Sockets installed in damp walls are at risk of corrosion to the metal back boxes.
- 3.15.9. There is an external socket to the rear right beneath the kitchen window.

- 4.17.7. There were no significant defects evident however I would recommend that the system is tested and upgraded as necessary.
- 4.17.8. I would also recommend that you consider the installation of mains-wired, interconnected smoke detectors and mains-wired carbon monoxide detectors, in accordance with current guidelines.

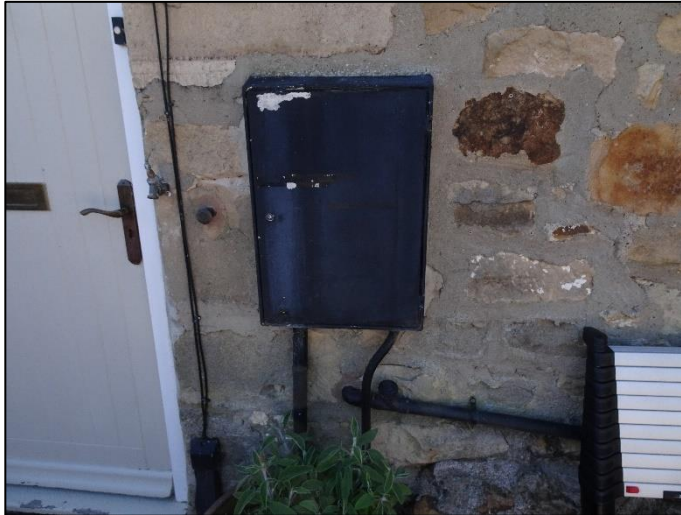
Photograph 120

3.16.2. The meter is located within a proprietary cabinet to the front left of the property.

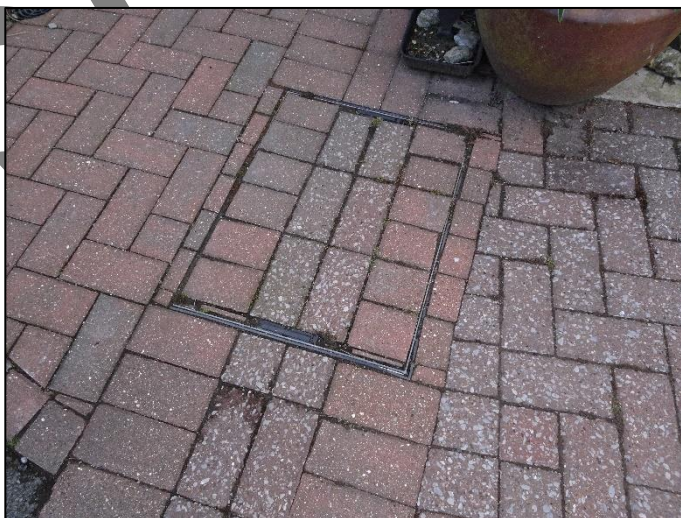
Photograph 121

3.17.3. There is an inspection chamber to the front left which has a cover inset with block pavements and could not be lifted.

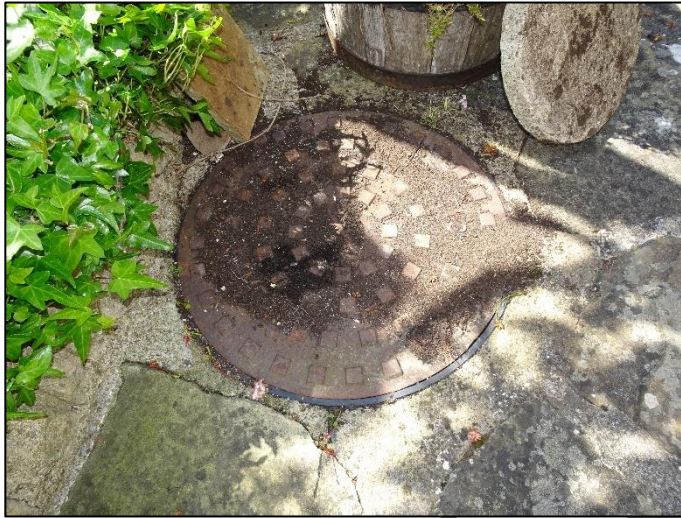
Photograph 122

- 3.17.4. To the rear there is a chamber with light duty cast iron cover and frame.
