I R Johnson MRICS, Chartered Building Surveyor

IRJ/AH/S1147/FBS

Introduction to the Report

*STREATLAM AND STAINTON STAINTON VILLAGE NZ O1 NE 13/216
Former farmhouse at West Farm*

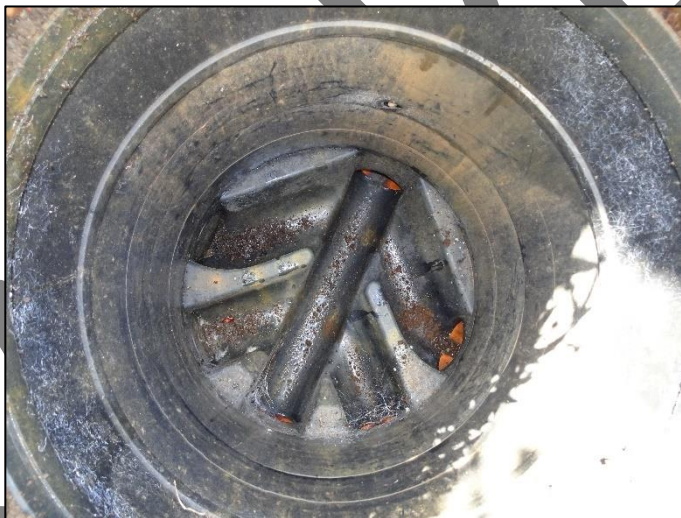
Photograph 123

- 3.17.5. The chamber is pre-formed plastic and was noted to be clean and running freely at the time of the survey.

- 4.17.11. There is no evidence to suggest that there are any problems with the below ground drainage system and the chamber in the rear garden was noted to be clean and running freely.

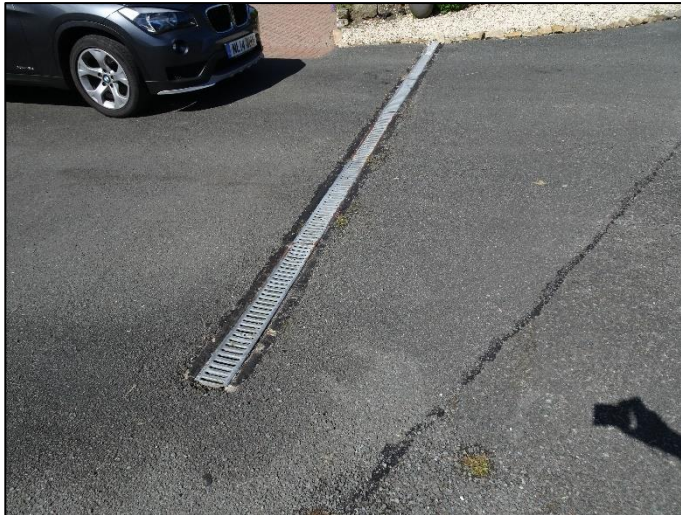
Photograph 124

- 3.17.6. There are numerous plastic gullies taking waste water and rainwater, all of which were noted to be in satisfactory condition where possible to inspect.
- 3.17.7. To the front of the property there is a channel drain across the parking area which has galvanised steel slotted grating.

3.17.8. The grating is beginning to corrode.
