IRJ/AD/AH/EC/S1214/L3

Introduction to the Report

Instructions received are to carry out an RICS Level 3 Building Survey of the property which were accepted and confirmed in my letter of the

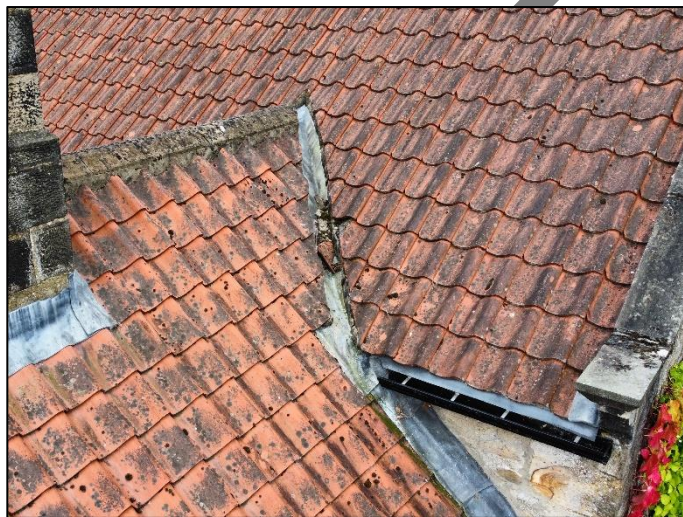
Photograph 9

- 3.1.2. The main roofs are of duo-pitched construction with ridges running parallel and perpendicular to the front elevation.
- 3.1.3. There is a catslide to the rear slope of the right-side wing.
- 3.1.4. There is a flat roof over the entrance vestibule.
- 3.1.5. The vendor advised that all of the pitched roofs were stripped and re-covered approximately 15 years ago.
- 3.1.6. The pitched roofs are covered with natural clay pantiles and have mortar bedded and pointed stone ridges.
- 3.1.7. There is a slipped pantile in the valley to the 1906 extension and also slipped pantiles to the left-side valley where the 1906 extension joins the original roof, which require re-fitting.

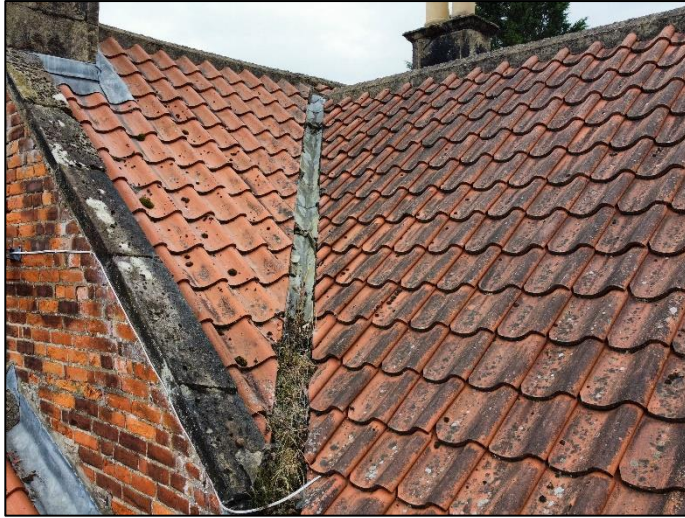
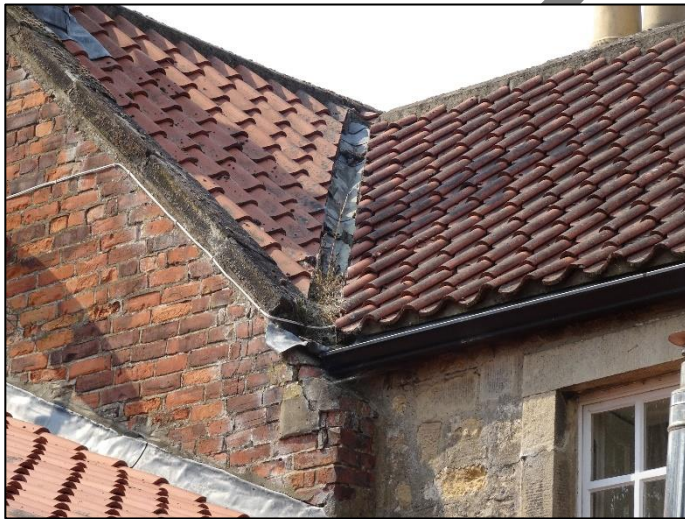
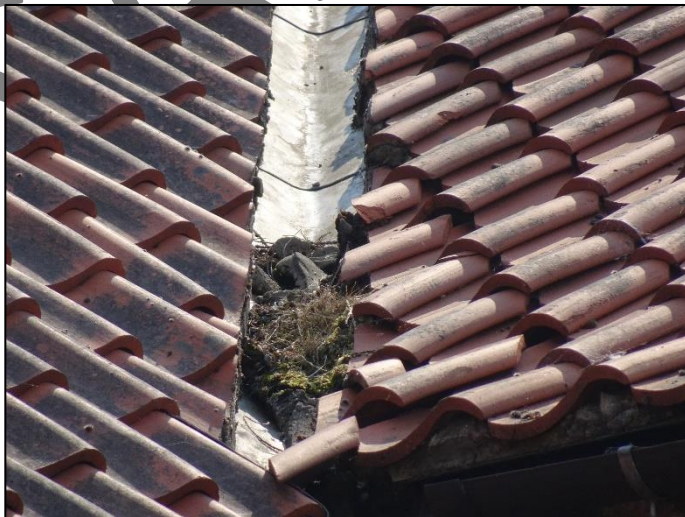
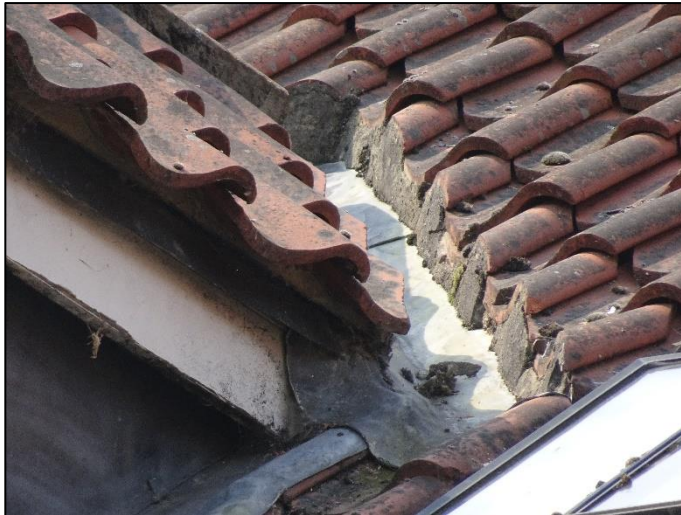
- 3.1.8. Mortar pointing to some of the tiles bedded onto the valley is loose/missing and there are isolated broken/damaged tiles which should be replaced where necessary.

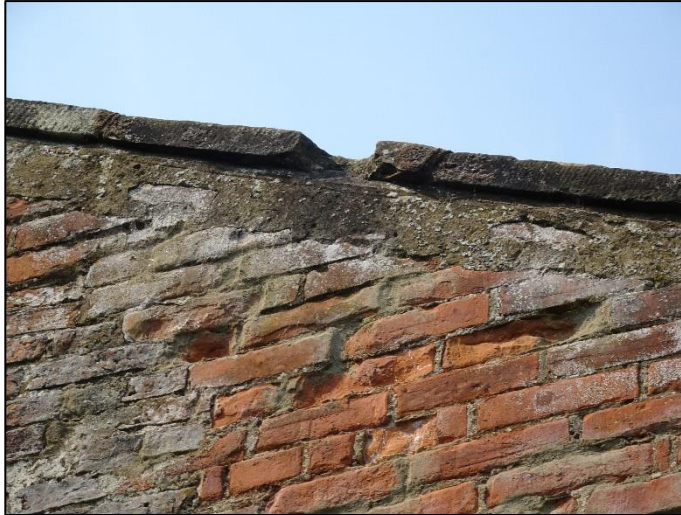
Photograph 16

- 3.1.9. The roof slopes were seen to be free from significant defects, on an even plane with no significant undulation or deflection.
- 3.1.10. There are upstands with stone water table to each of the gable apexes.
- 3.1.11. The water tables to the rear slopes of the left and right-side wings are bedded onto the pantiles.
- 3.1.12. To the left side wing, there is a damaged water table which should be replaced.

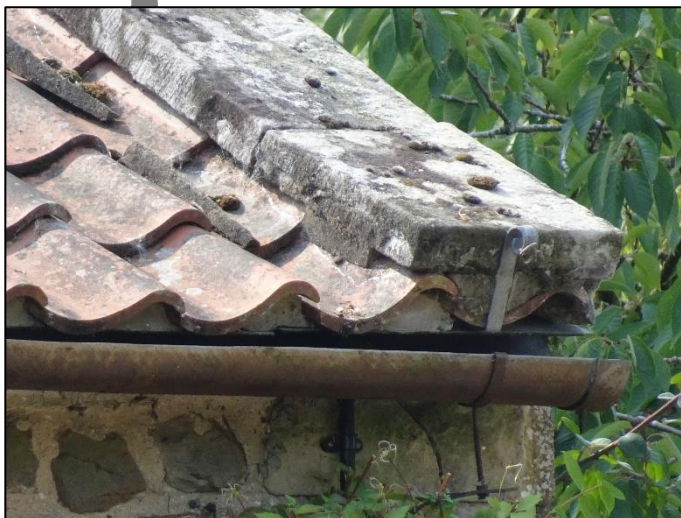
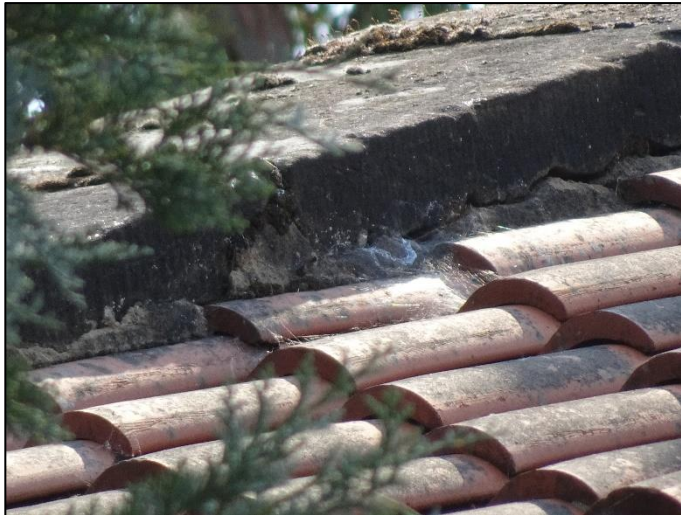
- 3.1.13. Mortar pointing between the roof tiles and stone water tables is cracked and missing to some areas and will require replacement as part of routine ongoing repairs and maintenance.

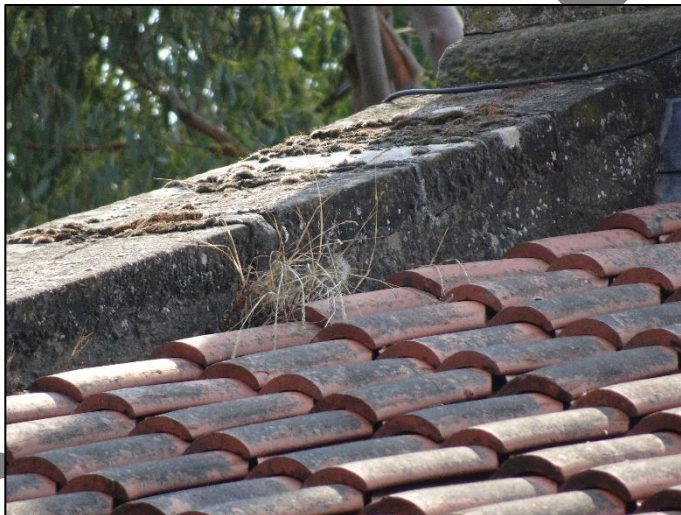
Photograph 20

- 3.1.14. There is vegetation growing to the rear of the right wing which should be removed.

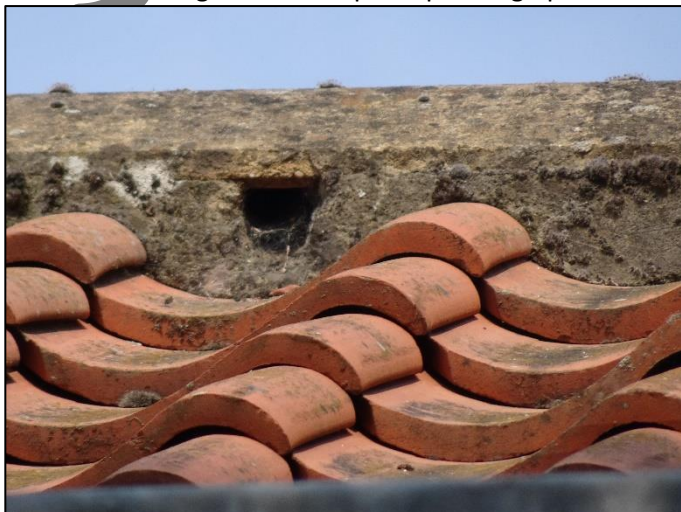
Photograph 21

- 3.1.15. To the right-side front wing, there is a small hole in the mortar bedding to one of the ridges which requires pointing up.

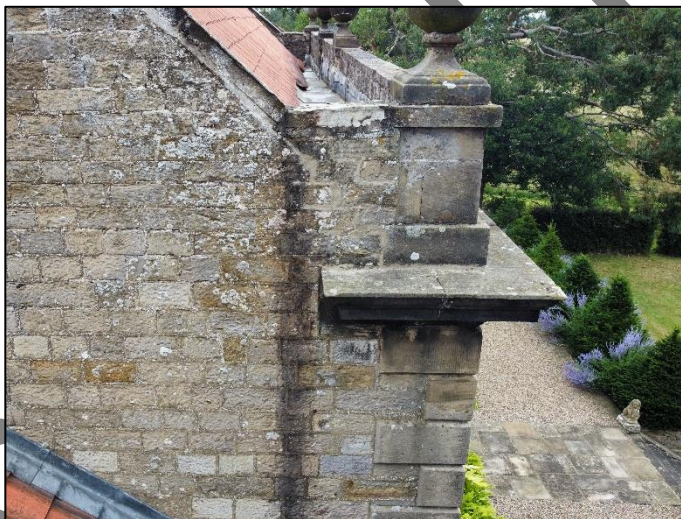
Photograph 23

- 3.1.16. To the front-right wing and left side of the central main roof, water staining is evident to the base of the water tables as a result of water running over the sides of the lower water tables.

- 3.1.17. To the main roof the water table requires adjustment when re-bedded to be in line with the outer face of the water tables above.
- 3.1.18. The water tables should slope slightly towards the roof coverings and to these areas, they slope slightly away.
- 3.1.19. Lifting, re-adjustment and re-bedding of the water tables to slope onto the roof covering should resolve the problem.
- 3.1.20. The water tables to the gable of the left-side wing do not project beyond the face of the wall which will increase the risk of water run-off to the stonework below, which will cause premature erosion of the mortar and ideally the water tables would be lifted and re-bedded with a minimum 30mm projection at some time in the future as part of ongoing maintenance.

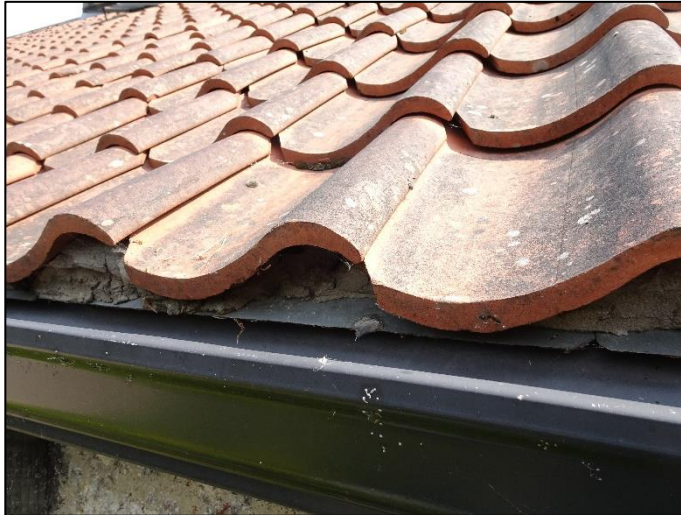
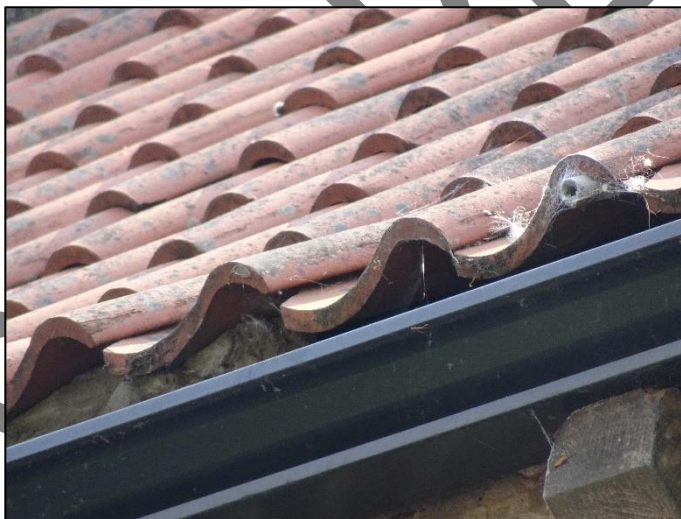
- 3.1.21. At eaves level, the underside of the pantiles is pointed with mortar onto a slate undercloak.
- 3.1.22. Some areas have eroded and missing mortar, requiring replacement and it is evident that previous repairs have been undertaken relatively recently.

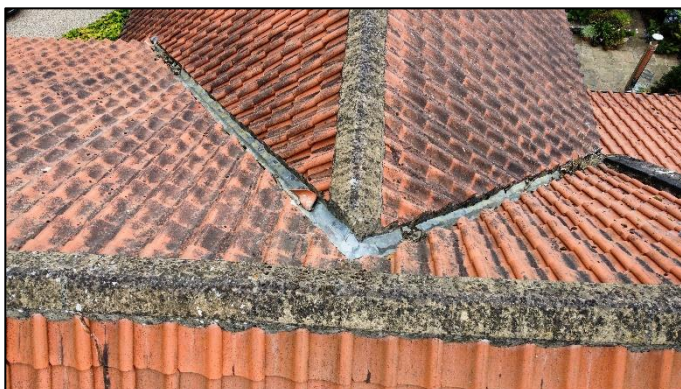
Photograph 26

- 3.1.23. At the intersection of the roof slopes there are lead lined valleys.

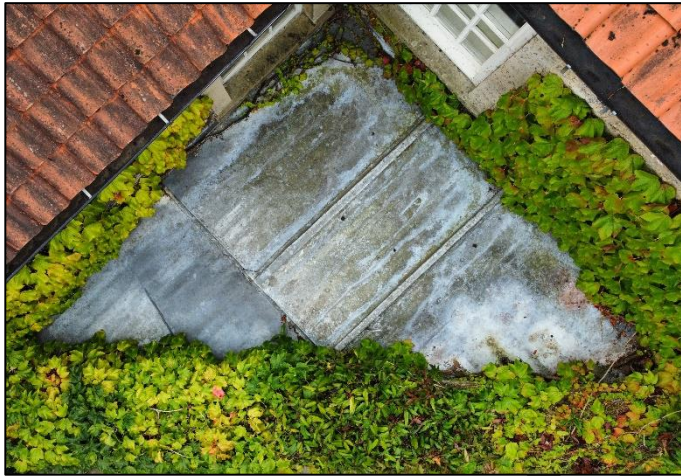
Photograph 27

- 3.1.24. There are two single-storey bay windows to the front with ashlar stone roofs which are in satisfactory condition.
- 3.1.25. The entrance vestibule has a lead covered flat roof.

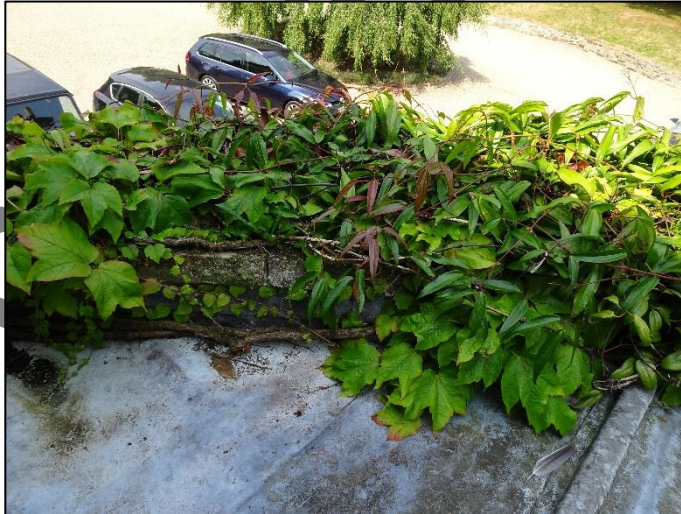
Photograph 28

- 3.1.26. There is a parapet to the front with stone copings.
- 3.1.27. The parapet is overgrown with climbing plants and could not be inspected but, where visible, there are eroded mortar joints between the copings stones, requiring re-pointing.

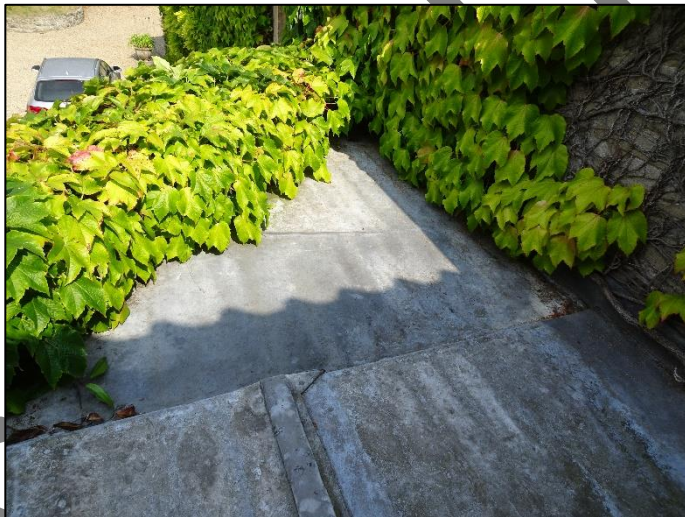
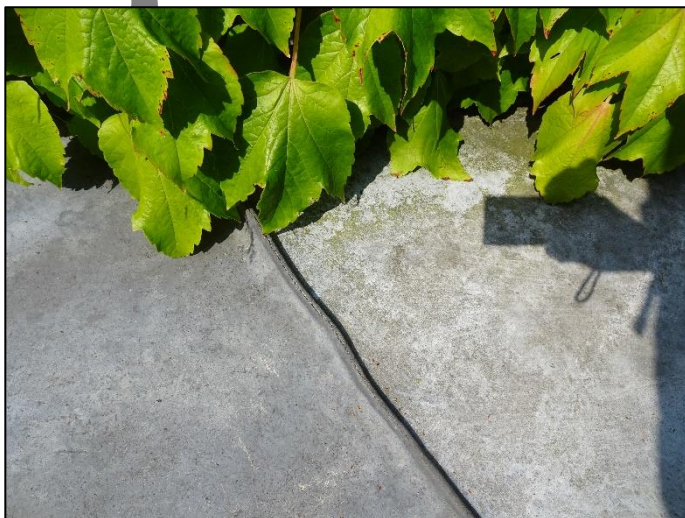
- 3.1.28. There is evidence of ponding water to the roof and the deck was noted to be soft underneath as a result of previous water penetration.

- 3.1.29. The leadwork and deck will require replacement to this area.
- 3.1.30. The leadwork is splitting to the rear right, requiring replacement.

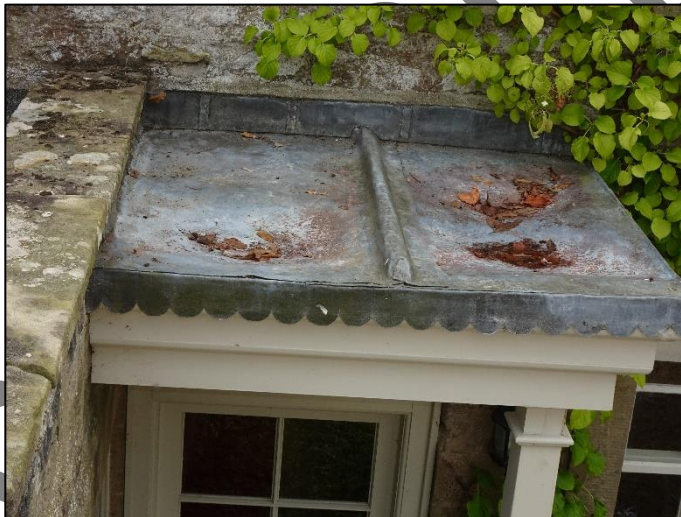
Photograph 33

- 3.1.31. To the rear of the offshoot there is a lead covered flat roof over the entrance door. The deck is distorted indicating previously defective lead however the roof has been re-covered. The deck will require replacement in the future.

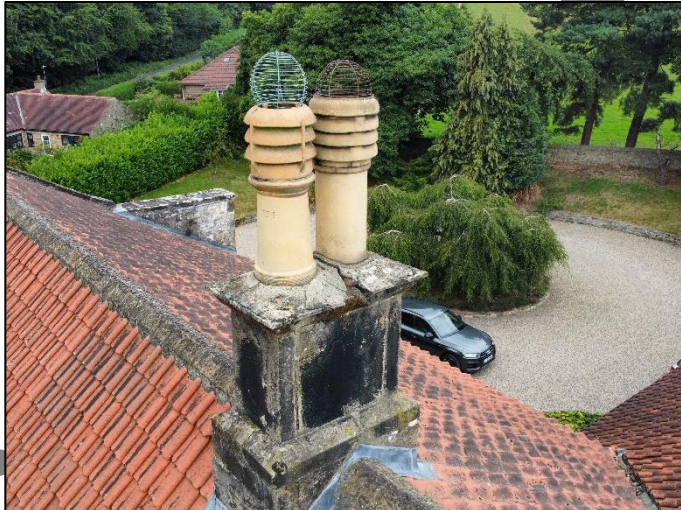
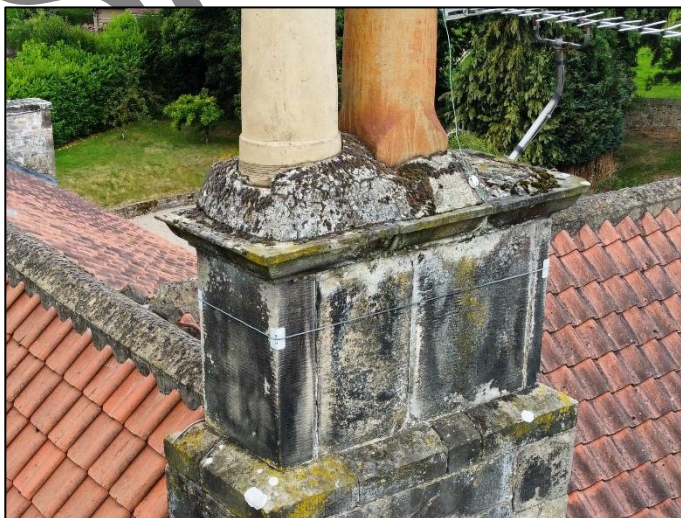
- 3.2.4. Mortar flashings to the pots on stack No. 3 and No. 4 are cracked and require replacement.

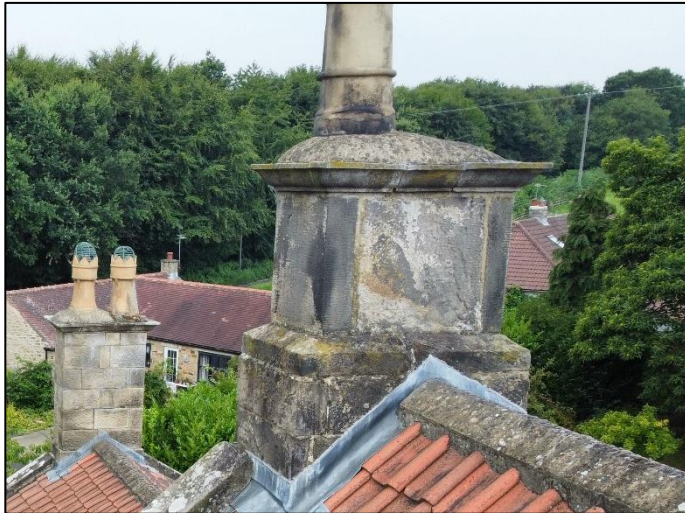
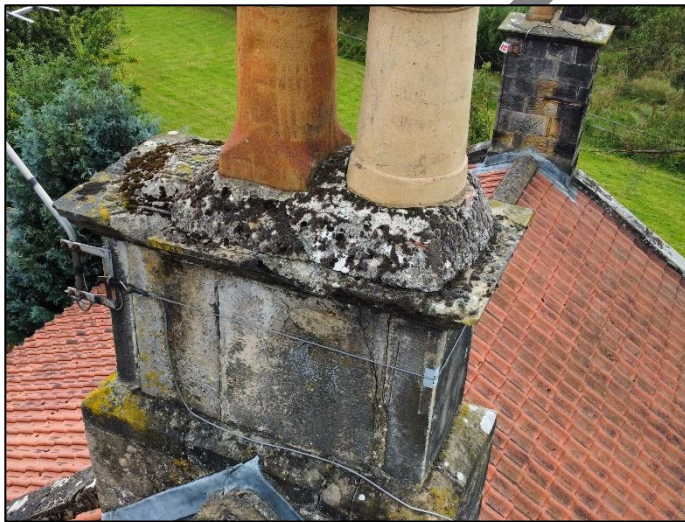
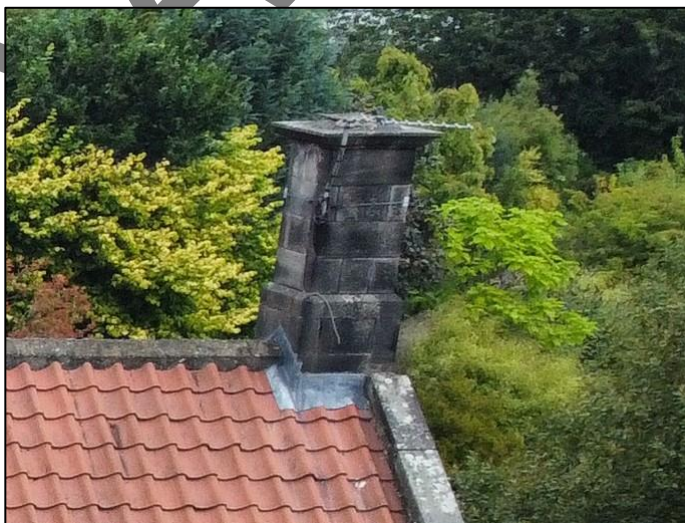
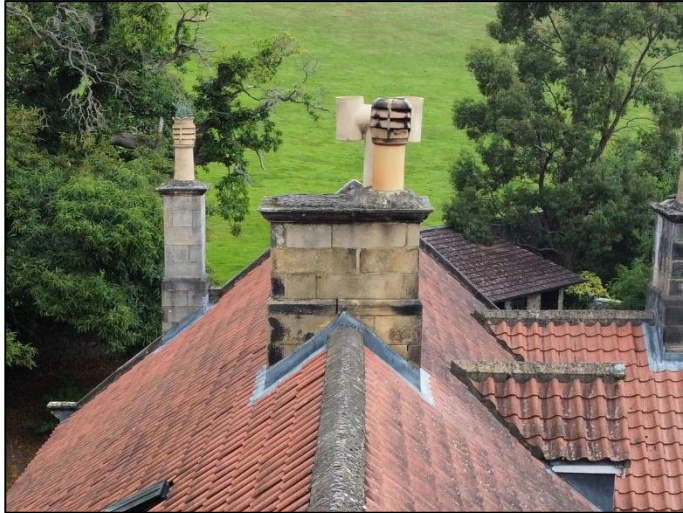
- 3.2.5. Stack No. 2, stack No. 4 and stack No. 9 have one redundant flue and No. 6, two redundant flues, all of which have been capped off.

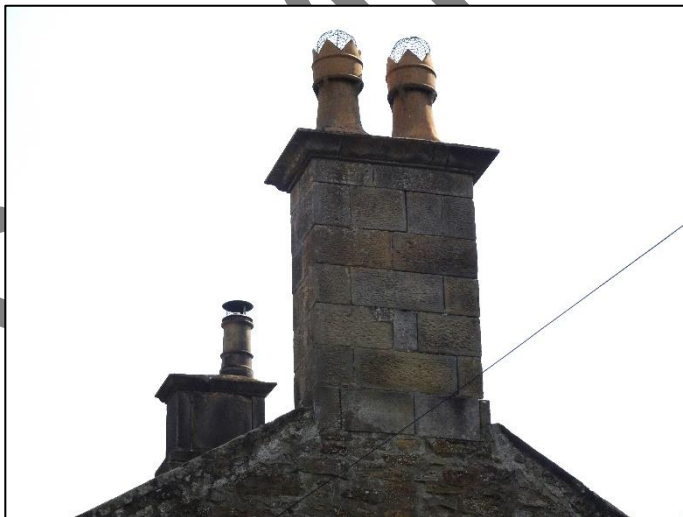
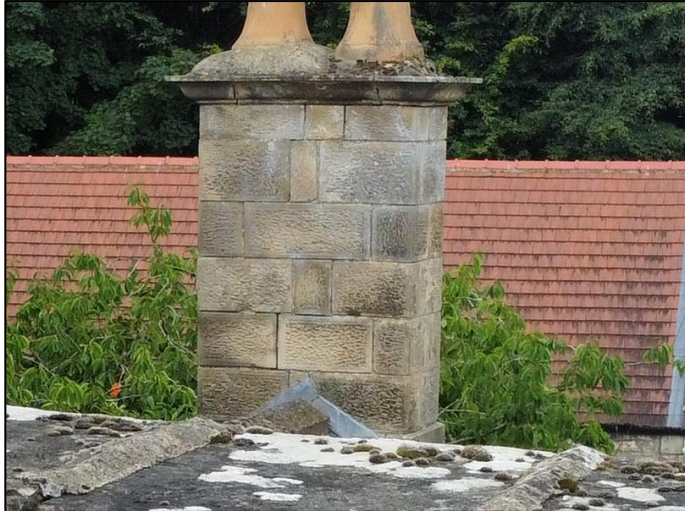
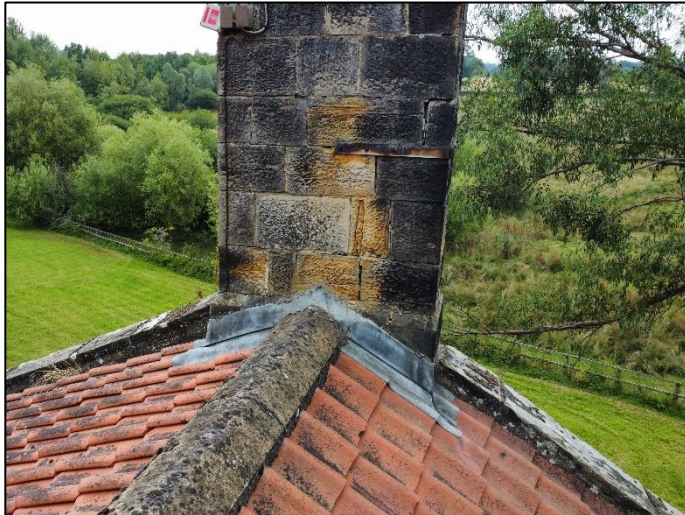
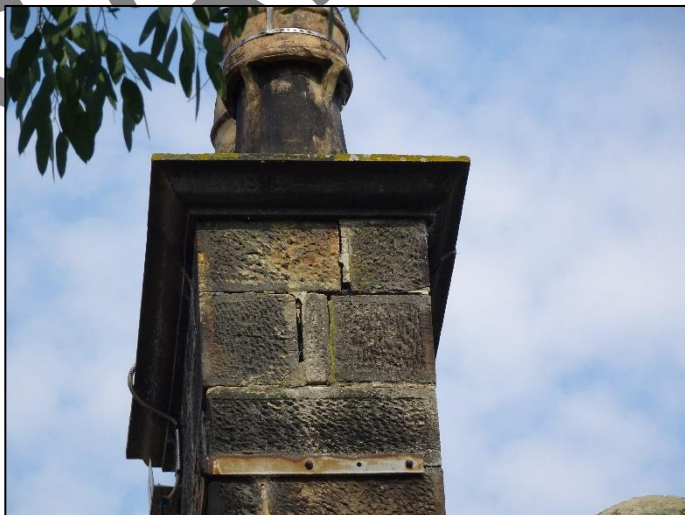
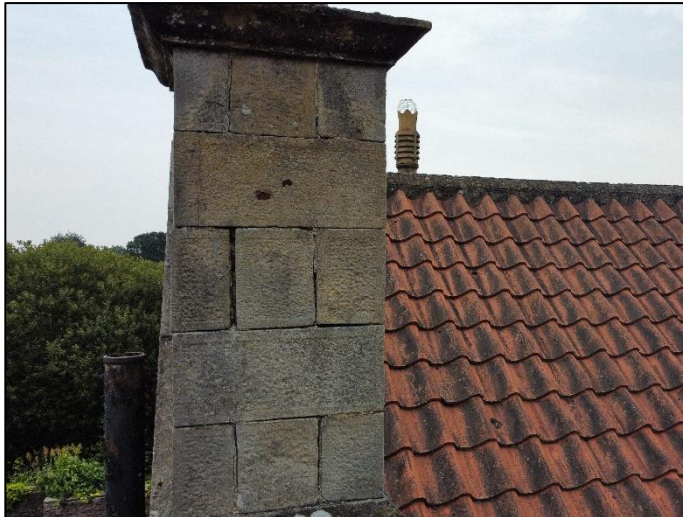
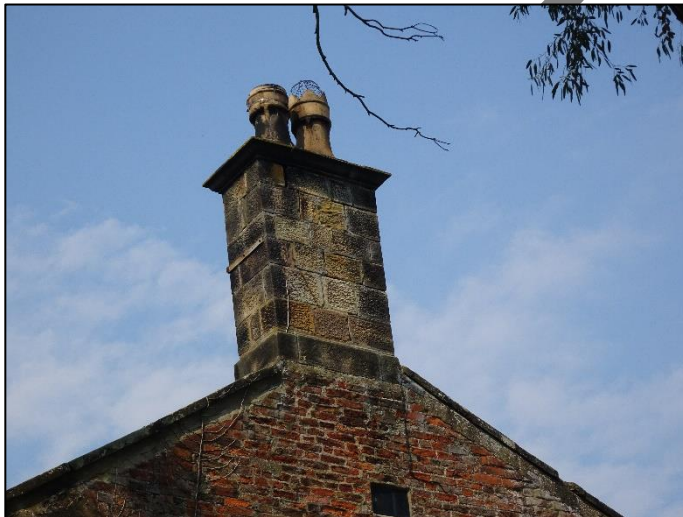
- 3.2.6. The vendor advised that the flue to the front-left bedroom has been re-utilised for the fireplace below and the dining room flue capped off when door openings were created through the original gable walls.
- 3.2.7. The stacks are of ashlar stone construction with a cornice to the top and consequently, mortar joints are very thin.
- 3.2.8. There are eroded joints of varying degrees to all of the stacks, which should be programmed for re-pointing.

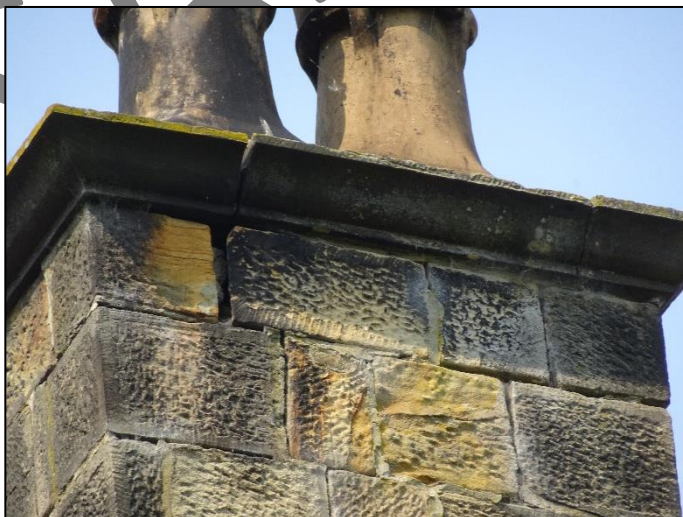
Photograph 47

- 3.2.9. There is eroded and cracked stonework and damaged/eroded cornice to the older stacks (2, 3 and 4).

- 3.2.10. Old chimney stacks can suffer extensive erosion from the flues which is not visible externally and potential re-building cannot be ruled out in the future. I anticipate that stacks 3 and 4 are likely to require re-building.

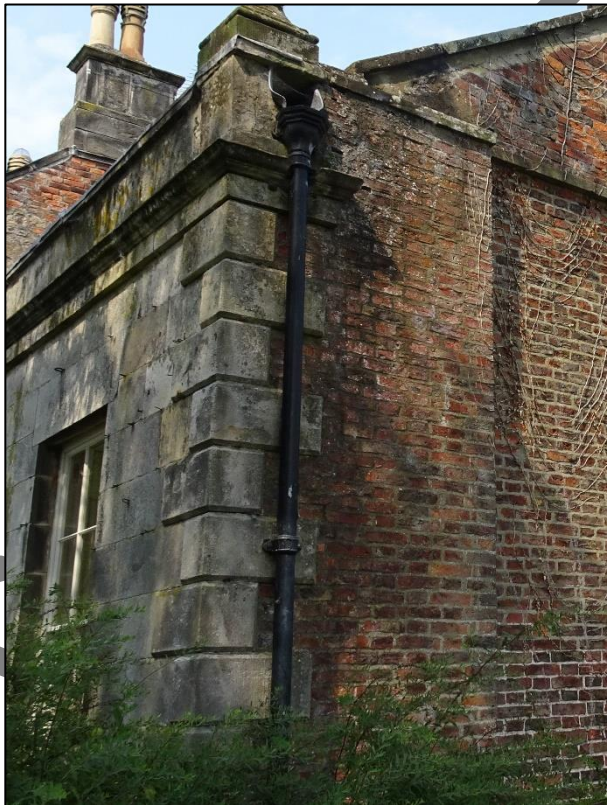
Photograph 59

- 3.3.4. To the left side the vegetation is growing into the hopper and requires cutting back.

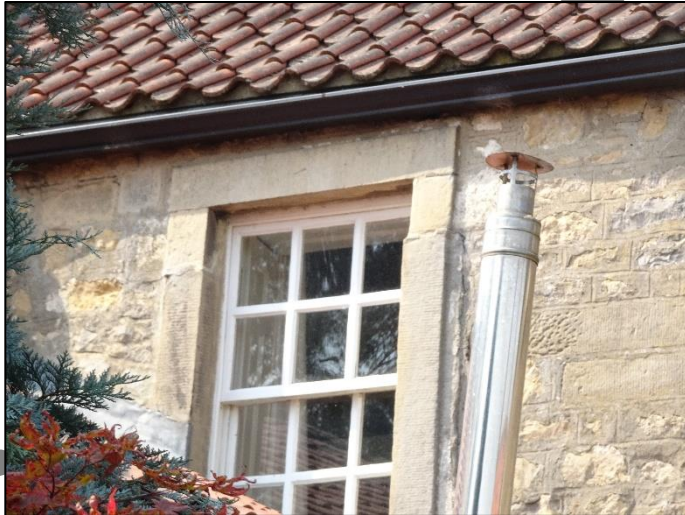
Photograph 65

- 3.4.8. To the right side, the jamb to the bathroom window is distorted and may require taking out and re-instatement in the future.

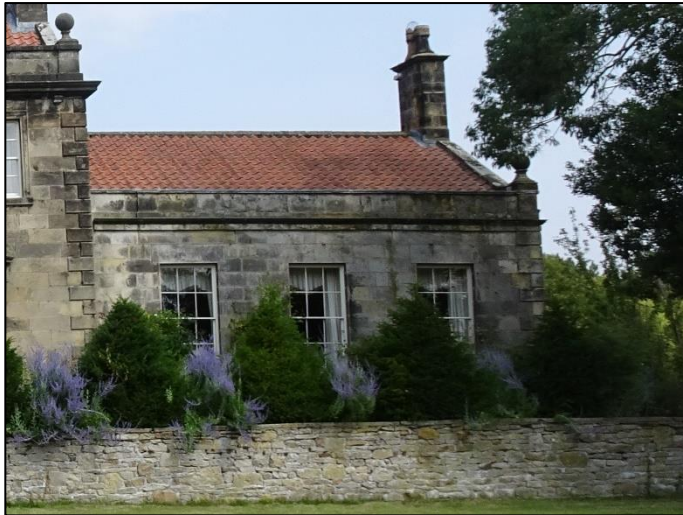
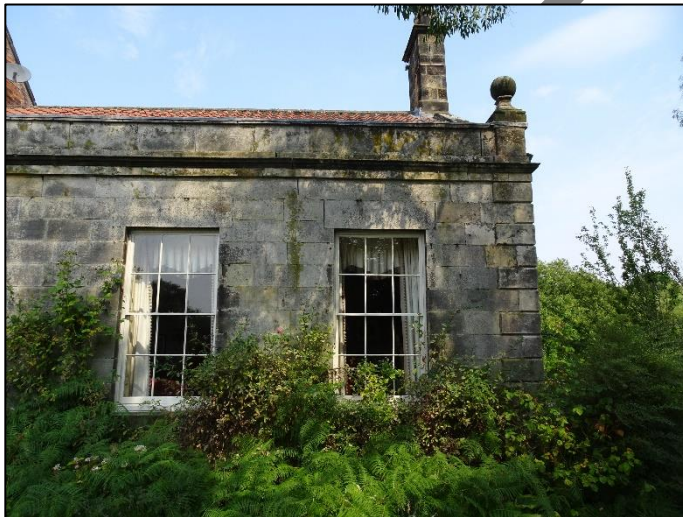
- 3.4.12. There has been structural movement to the right-side wing, evidenced by cracked and sloping masonry and distorted window openings. The movement is old standing and there is no evidence of a progressive nature to the movement.

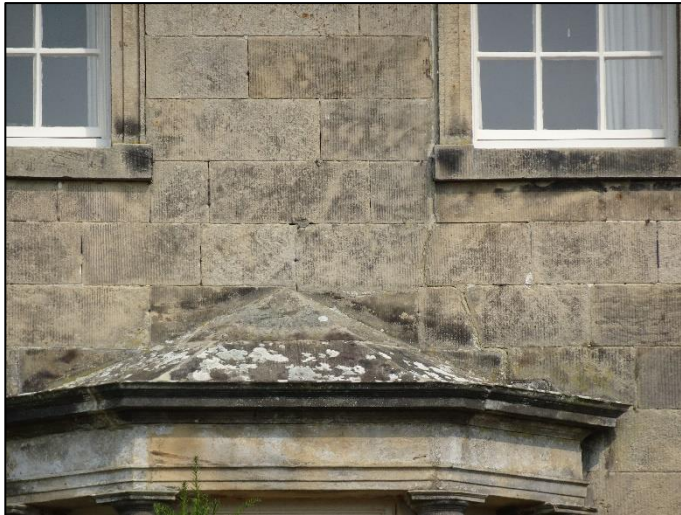
Photograph 72

- 3.4.13. Cracking is also noted above the right-side bay window, associated with the movement.

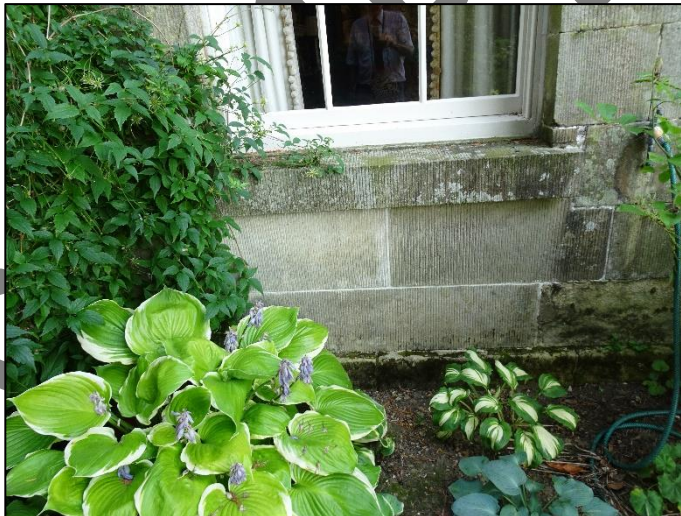
Photograph 78

- 3.4.19. To the left-side wing, the left-side window opening has previously been a door opening which has been built-in as part of alterations by the vendors.

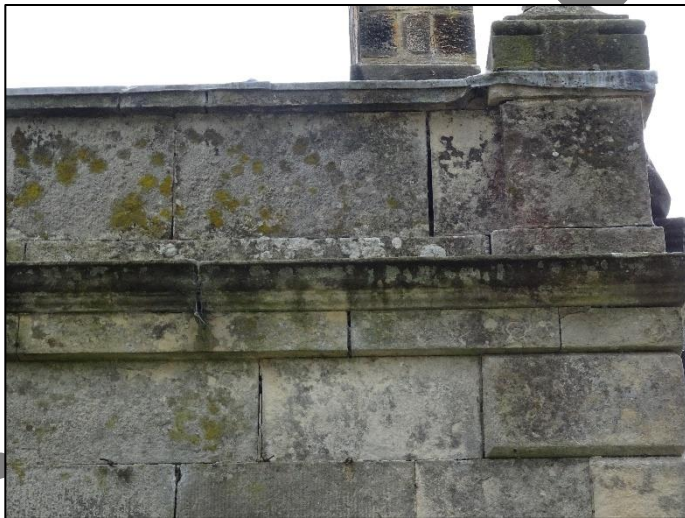
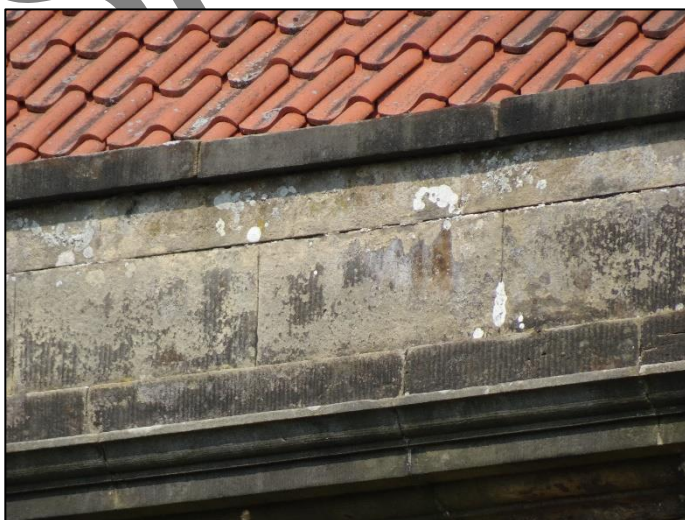
- 3.4.21. There are eroded mortar joints to the parapets which should be re-pointed.

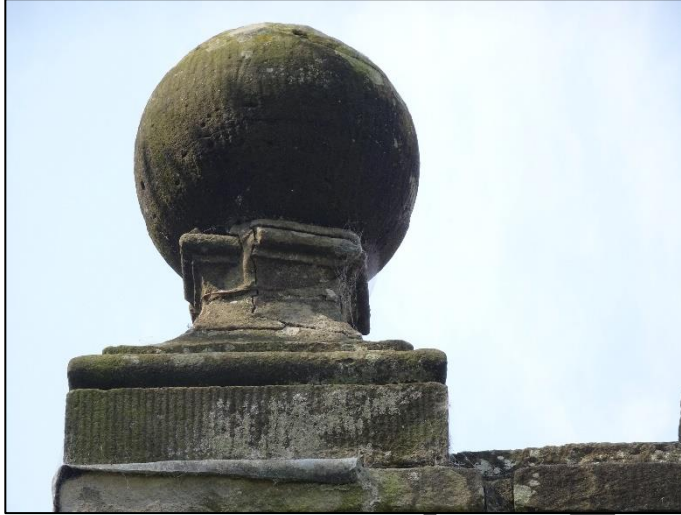
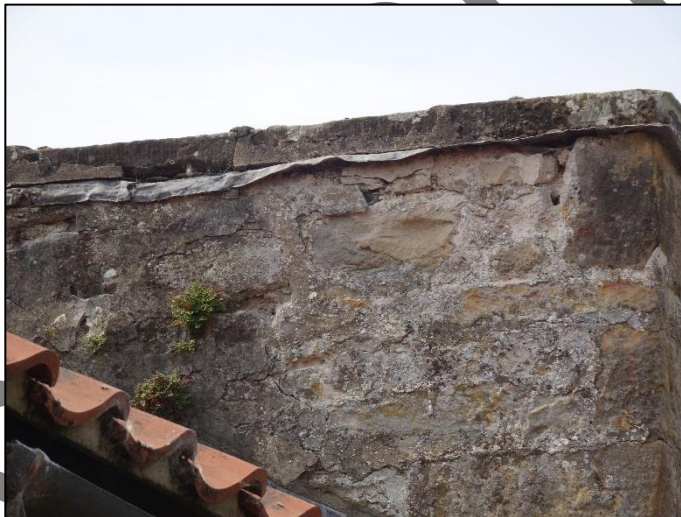
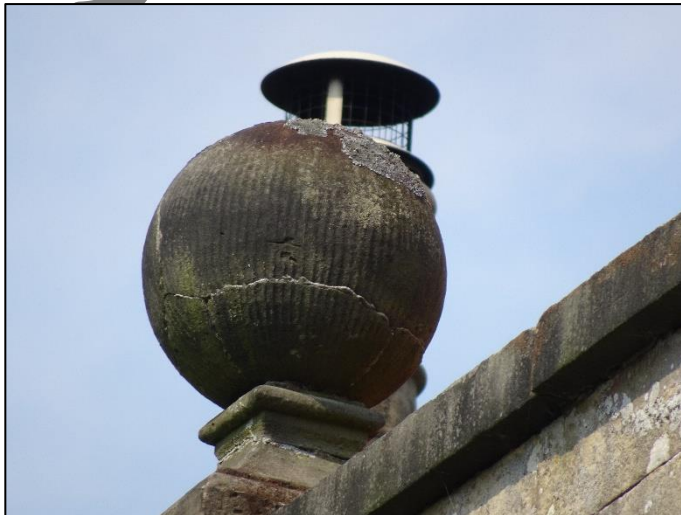
3.4.23. These have eroded mortar joints to some areas, requiring re-pointing.

3.4.24. To the top of the parapet there are stone balls. One of these is cracked and has a cracked/deteriorating mount and another has been previously repaired and will require further repair/replacement.

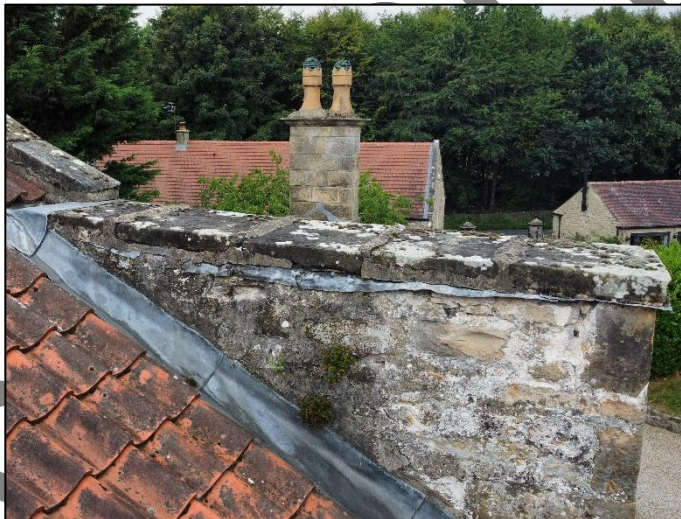
Photograph 86

- 3.4.25. There is an upstand to the rear left of the main bay with stone coping over a lead damp-proof course to the top. There is deterioration of stonework and mortar joints and splitting to the leadwork requiring re-pointing of the masonry and replacement of the defective lead.

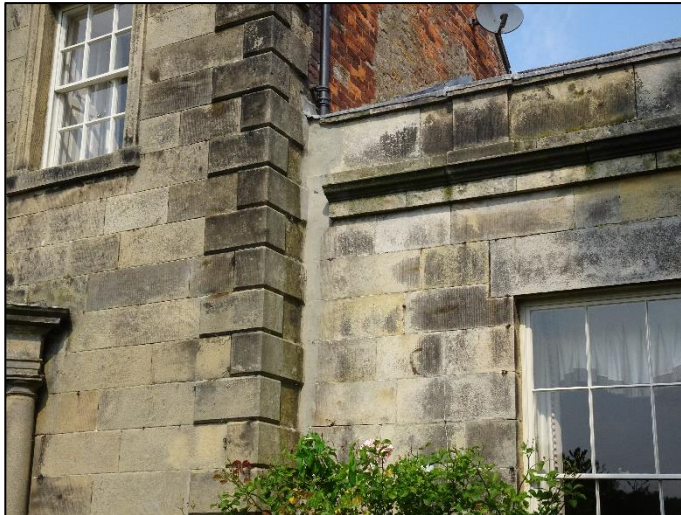
Photograph 87

- 3.4.26. To the right-side wing at the abutment with the main central bay, re-pointing has been undertaken using a cement mortar.

- 3.4.27. Cement-based mortars are hard and impervious and can lead to or exacerbate dampness problems and erosion of stonework.
- 3.4.28. I would recommend that the mortar is replaced with traditional lime mortar.
- 3.4.29. To the right side, the gables are constructed in solid brickwork, the two-storey gable and rear-right gable being laid to an English garden wall bond, the single-storey gable to the wing being a Flemish bond.
- 3.4.30. There are eroded mortar joints and brickwork to the two-storey and rear-right gables, requiring re-pointing.

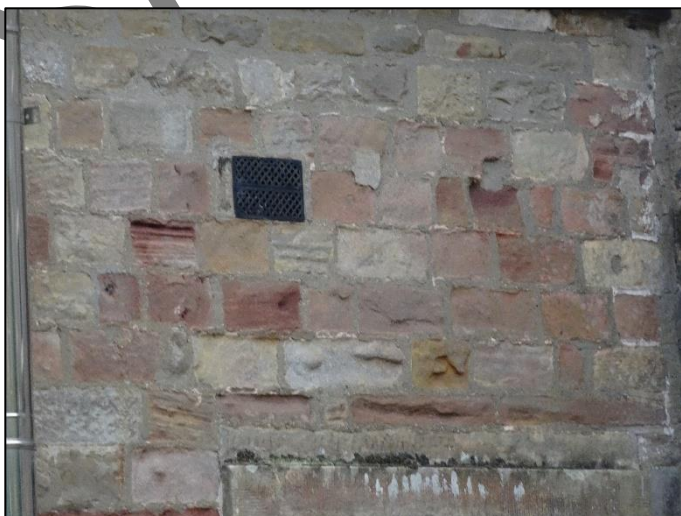
Photograph 90

- 3.4.31. Significant areas of re-pointing have been undertaken to the single-storey gable using a cement-based mortar and ideally this would be replaced with traditional lime mortar.
- 3.4.32. Re-pointing of the main rear elevation and sides of the offshoot has been undertaken using a cement mortar.
- 3.4.33. A sample panel should be commenced and if the brickwork is damaged by removal of the mortar, then the cement mortar should be left as the advantages of lime mortar will be outweighed by the damage done in removing the cement mortar.
- 3.4.34. Significant areas of re-pointing have been undertaken to the rear of the single-storey wings and left and right-side elevations of the offshoot using cement mortar.
- 3.4.35. To the rear of the left wing, this has resulted in erosion of stonework.

- 3.4.36. All cement mortar pointing would ideally be replaced with lime mortar.

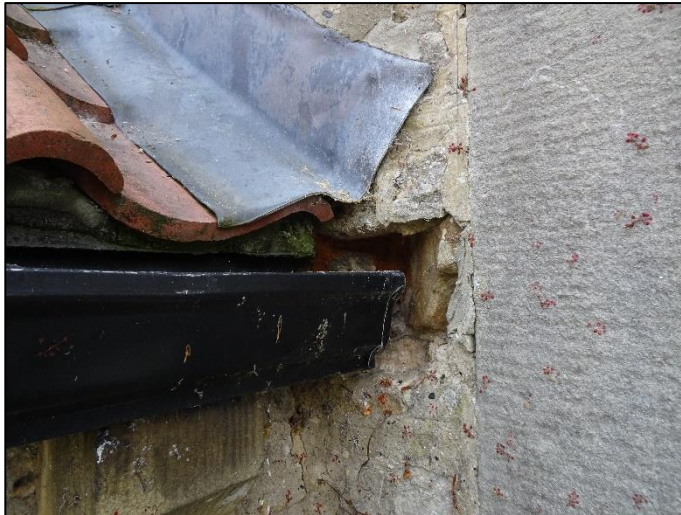
Photograph 93

- 3.4.39. To the end of the gutter, above the entrance vestibule, there is cut out masonry which should be made good.

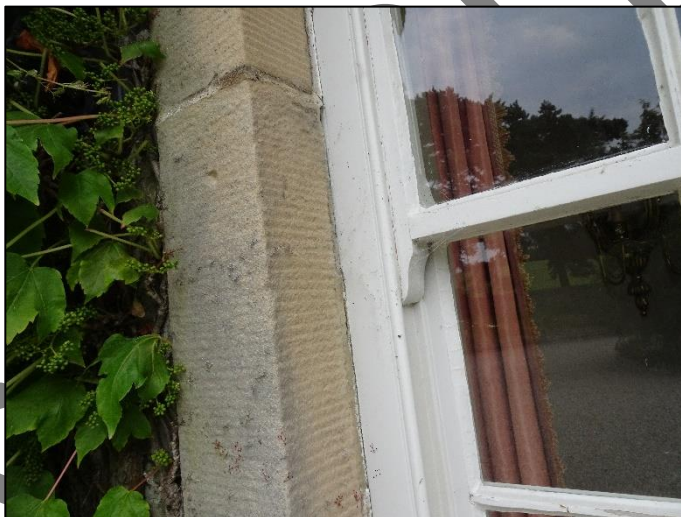
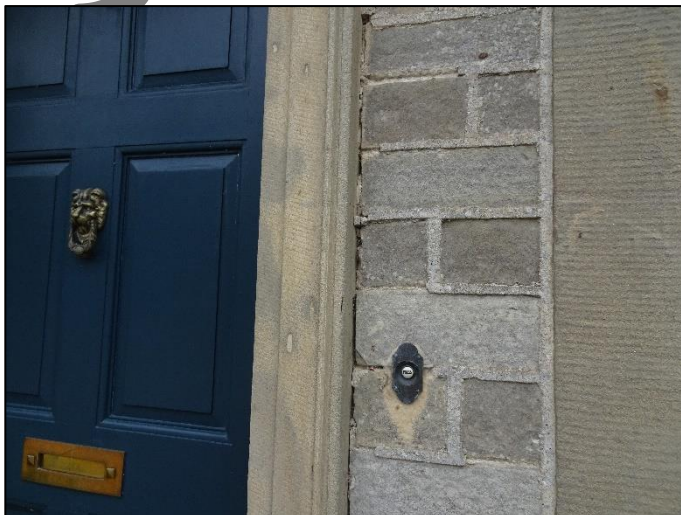
- 3.4.40. There are mortar pointed reveals to the window and door openings.
- 3.4.41. There is eroding and missing mortar to many of the windows and doors, requiring replacement.

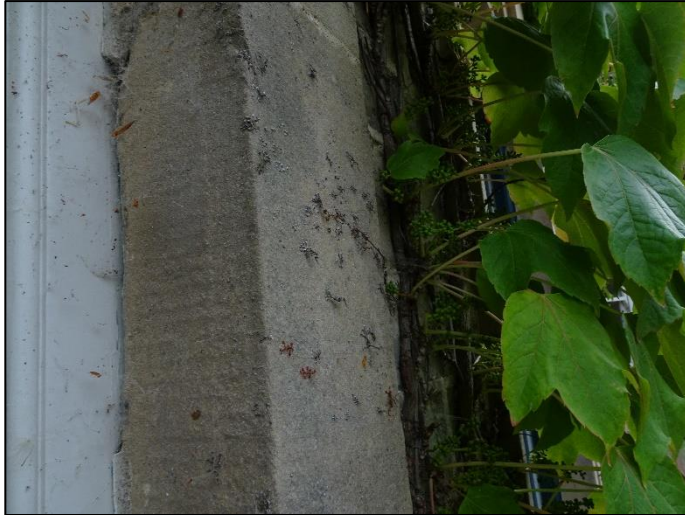
Photograph 96

- 3.4.42. At the abutment of the entrance vestibule, mortar has eroded, leaving a substantial gap which should be re-pointed.

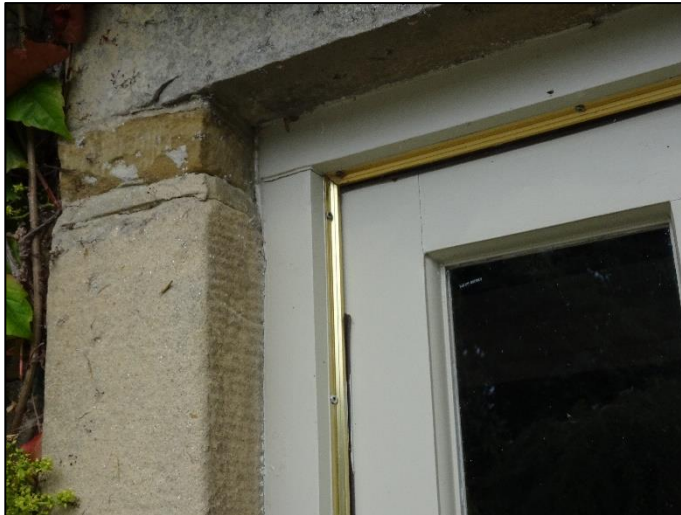
Photograph 98

- 3.4.46. There is a fracture to the top of one of the ashlar jambs to one of the rear-left first-floor windows but which is not considered to be evidence of a significant structural problem.

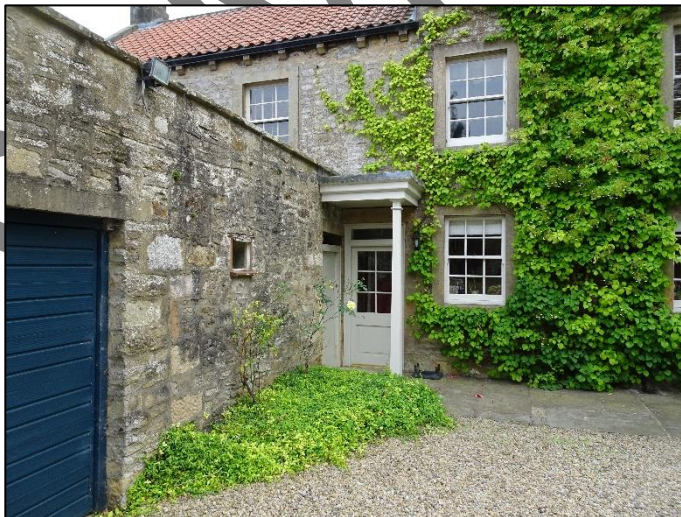
Photograph 104

- 3.5.9. Decay is beginning to set into the base of the post.

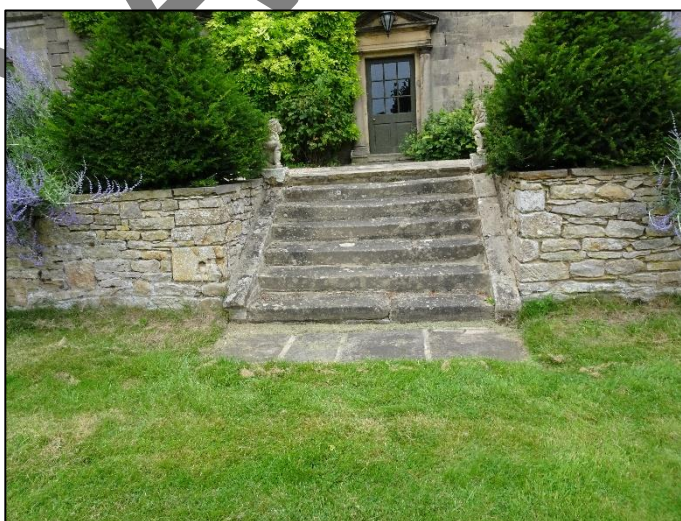
Photograph 106

- 3.6.3. Walls immediately to either side of the steps have been re-built but beyond these areas there are eroded mortar joints and broken copings.

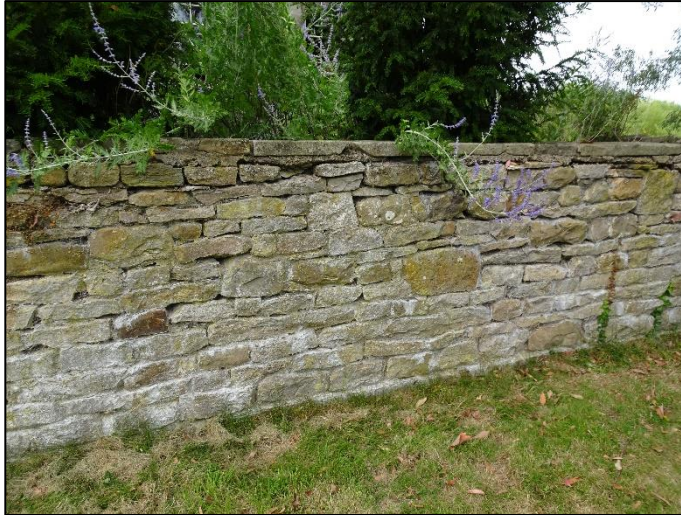
Photograph 107

- 3.6.4. There is a holly tree and large eucalyptus trees to the front-right corner which have caused the wall to lean outwards and will continue to do so until the walls collapse.

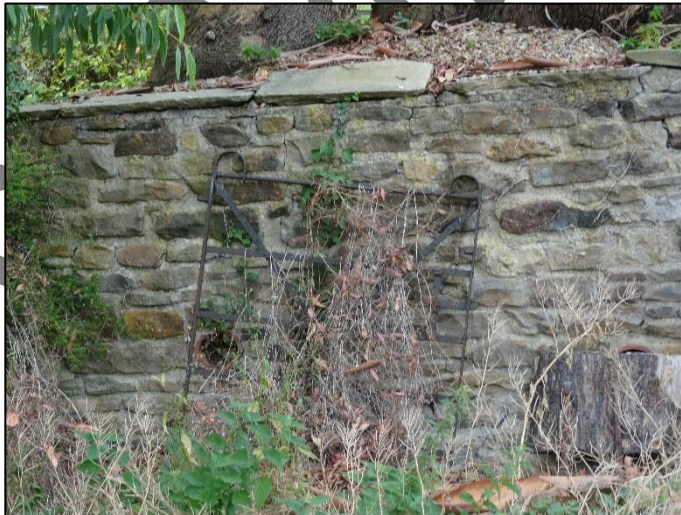
Photograph 116

- 3.6.12. The Estate railings are in quite poor condition, requiring repairs.

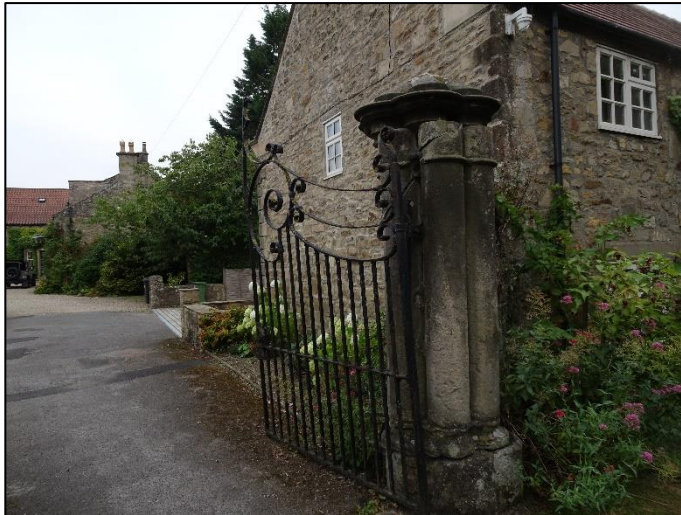
Photograph 126

- 3.6.22. The right-side post is in poor condition, having a dislodged pier cap and cracked stone due to expansion of the embedded metalwork.

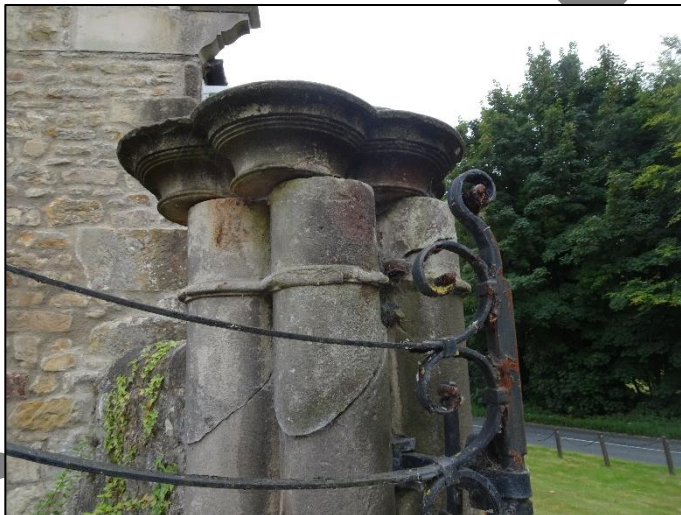
Photograph 127

- 3.6.23. The gates are suffering significant corrosion and extensive repairs are required.
