IRJ/AD/AH/EC/S1214/L3

Introduction to the Report

Instructions received are to carry out an RICS Level 3 Building Survey of the property which were accepted and confirmed in my letter of the

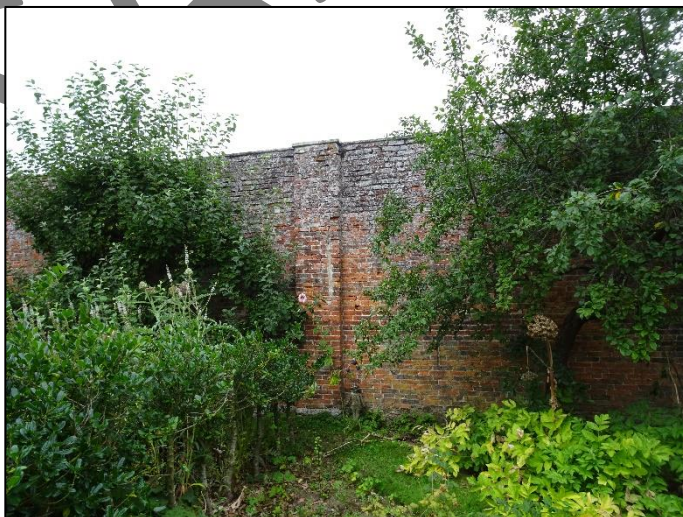
Photograph 133

- 3.6.29. To the right side of the greenhouse, the ha-ha wall has been re-built but has been pushed out of plumb by the retained earth.

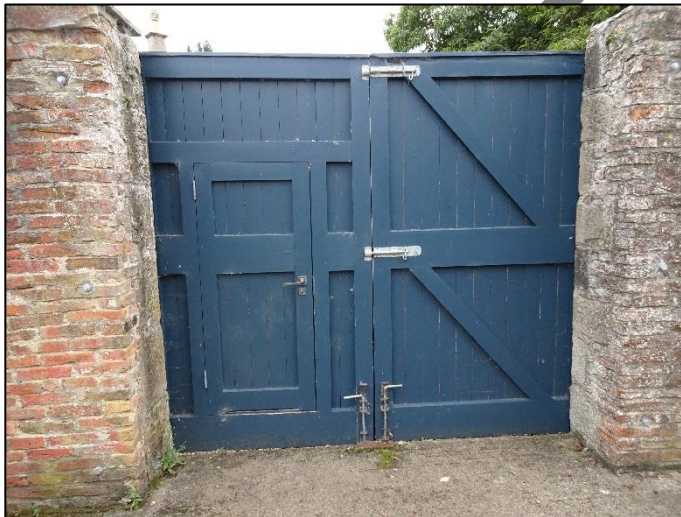
Photograph 141

3.6.32. There is decay setting into the top of the doors but otherwise the doors are in sound condition, requiring minor repairs and re-decoration.

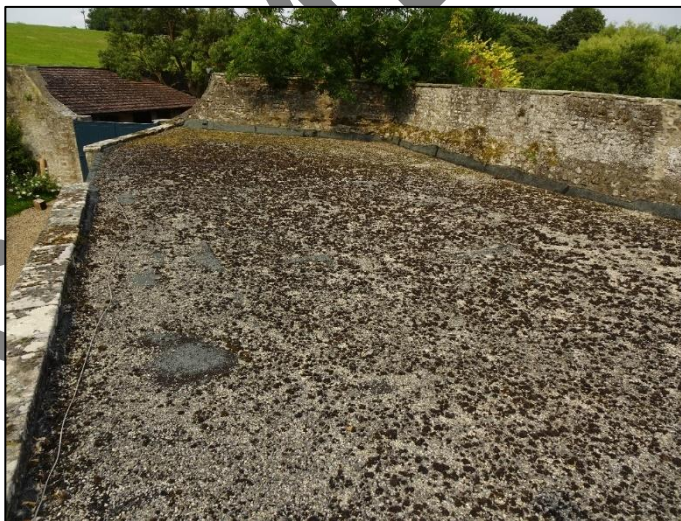
Photograph 143

- 3.7.1. The roof is flat with a bitumen felt covering and covered with chippings.

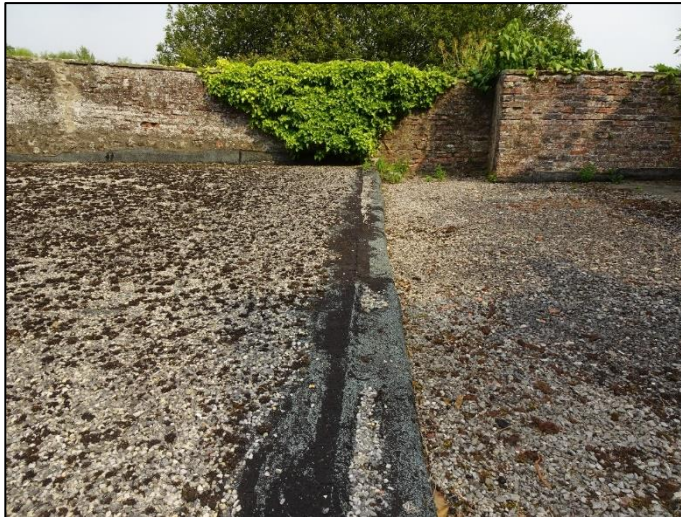
Photograph 144

- 3.7.2. There is no provision for rainwater to drain from the roof.

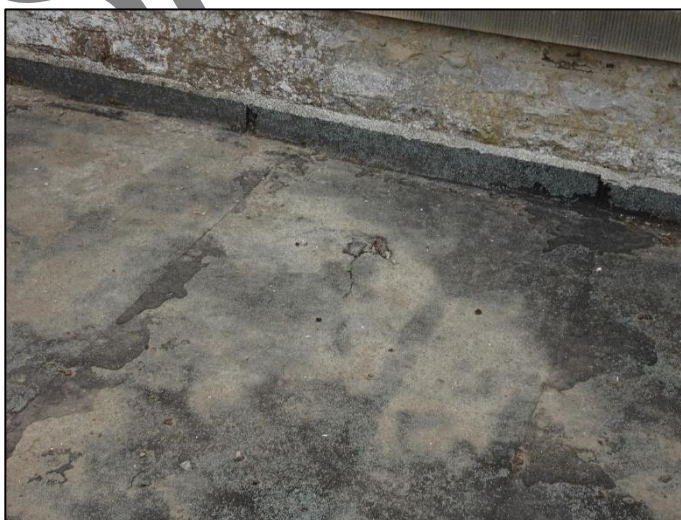
Photograph 146

- 3.7.3. The covering is in poor condition, with numerous splits noted and should be stripped and replaced.

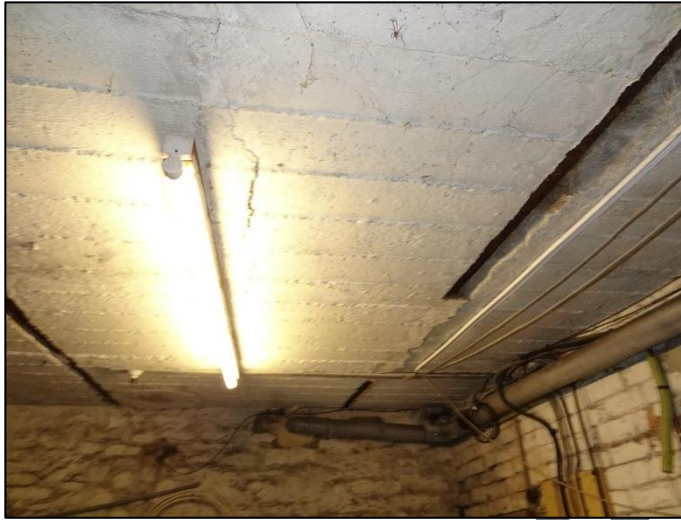
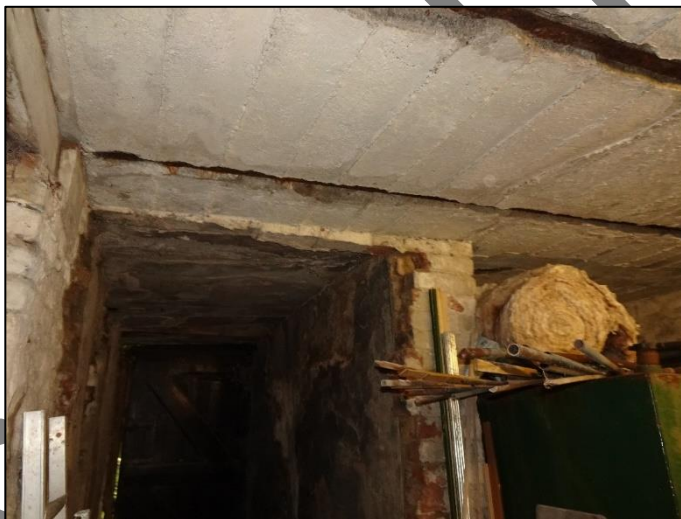
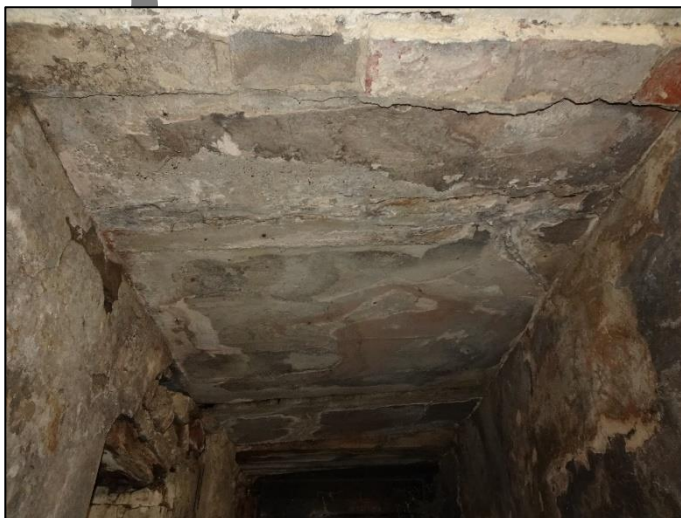
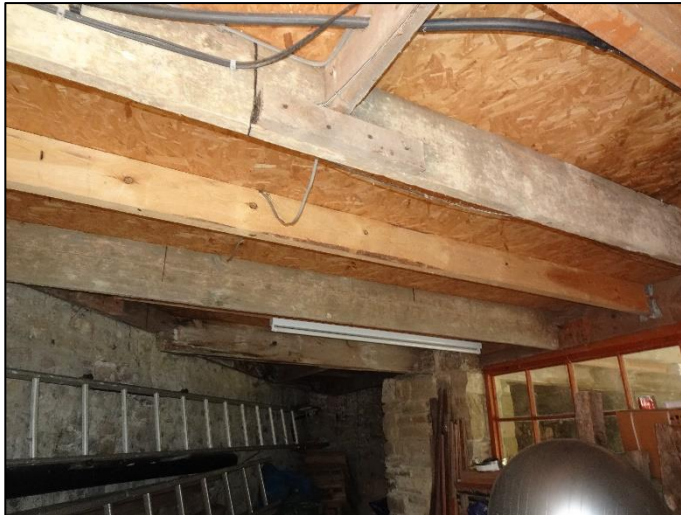
- 3.7.4. The right-side store roof structure comprises a reinforced concrete deck. The remainder of the garage, wood store and left store roof comprise timber joists supporting an OSB board deck.

- 3.7.5. To the concrete structure there is significant corrosion noted to the supporting steelwork which in turn is causing spalling to the concrete panels.
- 3.7.6. This will continue to deteriorate and compromise the structural integrity of the roof. I would recommend that the roof is programmed for full replacement and re-covering.
- 3.7.7. There are areas of water ingress and decay noted to the timber roofs particularly at the dividing wall between the garage and wood store.

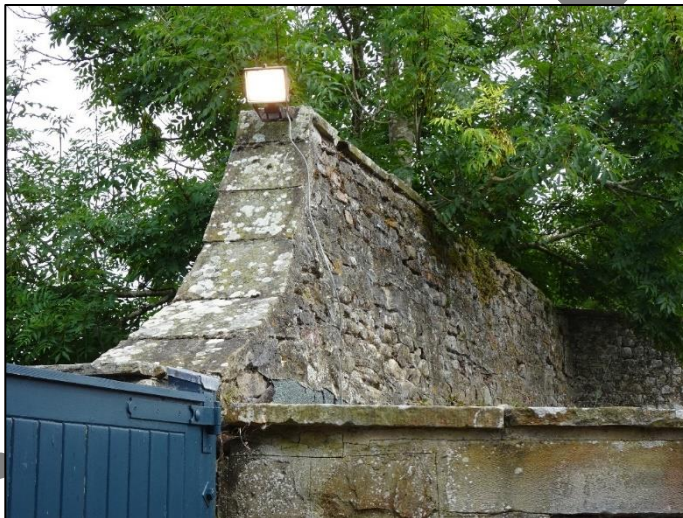
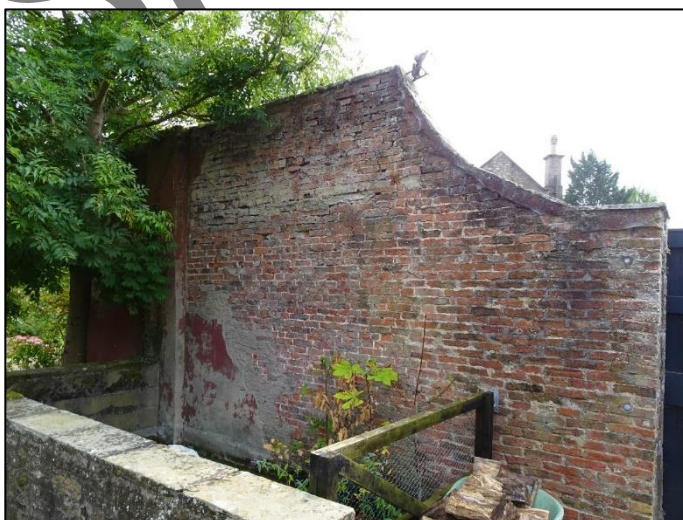
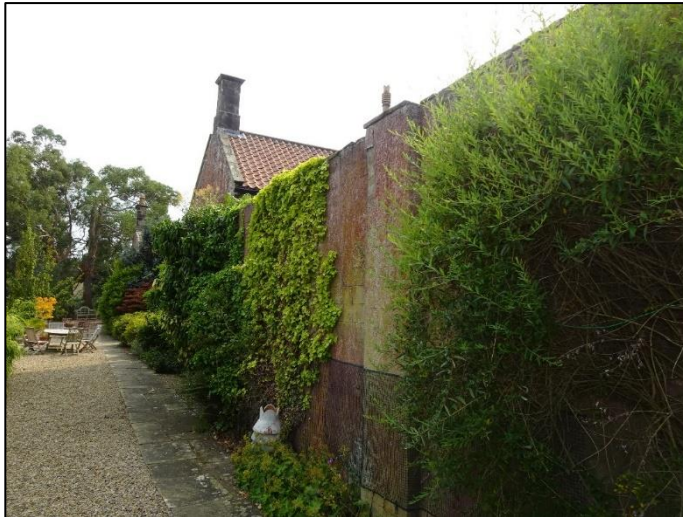
- 3.8.2. The rear walls lean out of plumb, and the render finish is in poor condition.

- 3.8.3. There is structural cracking to the internal walls within the main garage area as a result of movement to the rear walls.

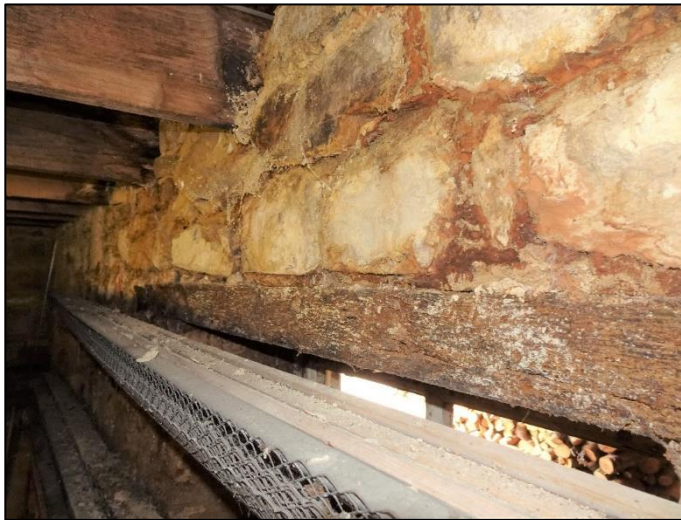
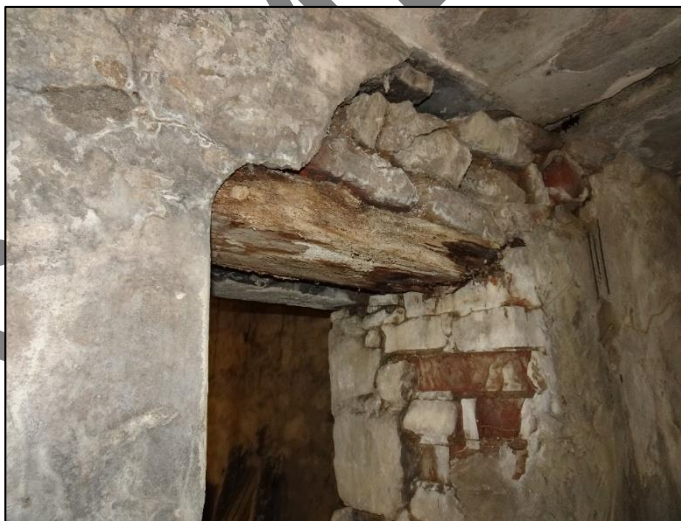
- 3.8.4. The internal finished floor level of the garage is below ground level to the rear and there is significant penetrating dampness as a result.
- 3.8.5. There are steel lintels visible over the up and over and left-side store doors. Elsewhere, lintels are stone or timber.
- 3.8.6. As a result of water ingress, timber lintels to two of the internal windows are decayed and require replacement.

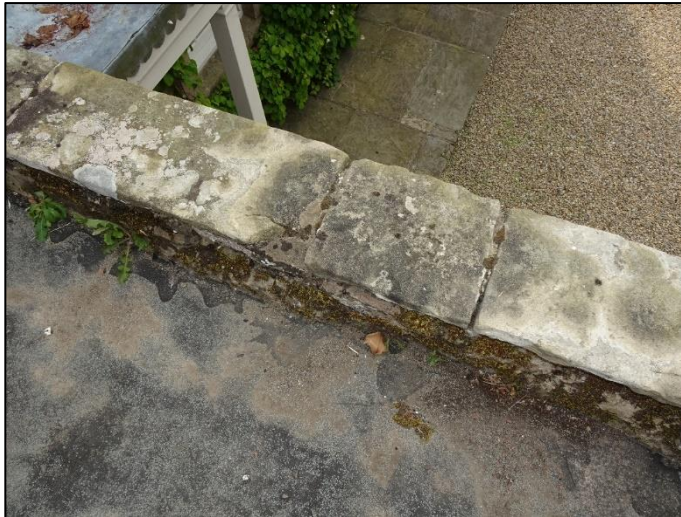
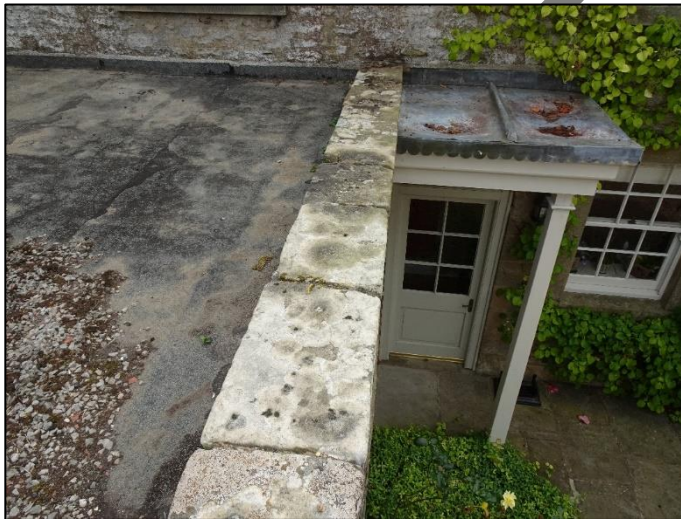
- 3.8.7. To the top of the walls there are stone copings.
- 3.8.8. There is erosion and missing mortar pointing to the joints. The coping stones should be lifted and re-laid on a damp-proof membrane.

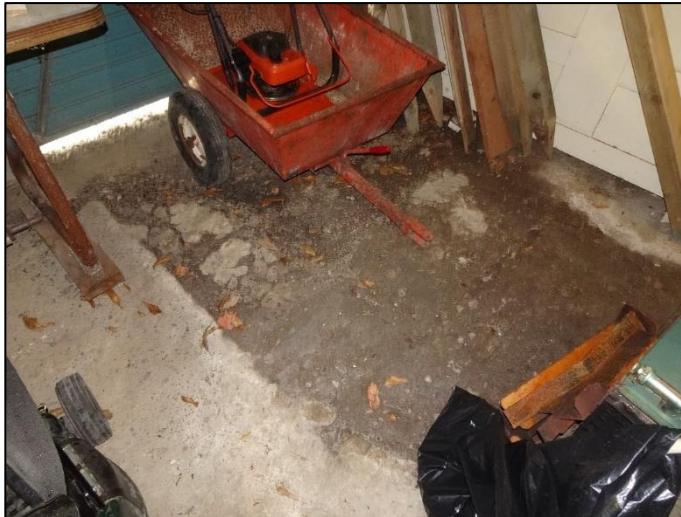
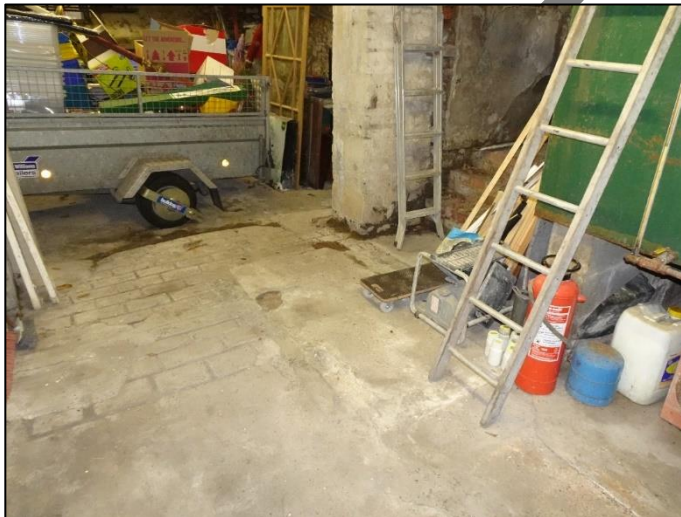
- 3.9.1. Floors to the garages and stores are of concrete construction.
- 3.9.2. The left-side store floor has been re-laid more recently and is in good condition.
- 3.9.3. The floor to the main garage and right-side store is in poor condition and ideally would be broken out and re-laid.

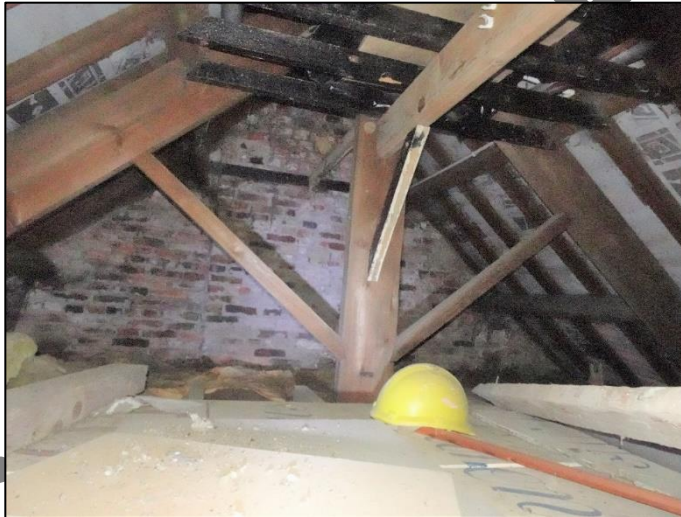
Photograph 164

- 3.10.5. Condensation issues can vary with different occupiers of a property and therefore I would recommend that the roof space is periodically inspected particularly during winter months to determine whether condensation is going to be a problem and additional ventilation added as required.
- 3.10.6. The vendor advised that the roof structures have been treated for woodworm, however there is no guarantee available for this work.
- 3.10.7. Generally, where inspected the roof structures are seen to be in satisfactory condition, free from any decay or active woodworm infestation.
- 3.10.8. Where the rafter feet are built into the wall or are not visible, although unlikely, there is the possibility of decay or woodworm infestation.
- 3.10.9. Access to the roof void over the rear-right offshoot is gained via a hatch located within the en-suite bathroom ceiling to bedroom 9.

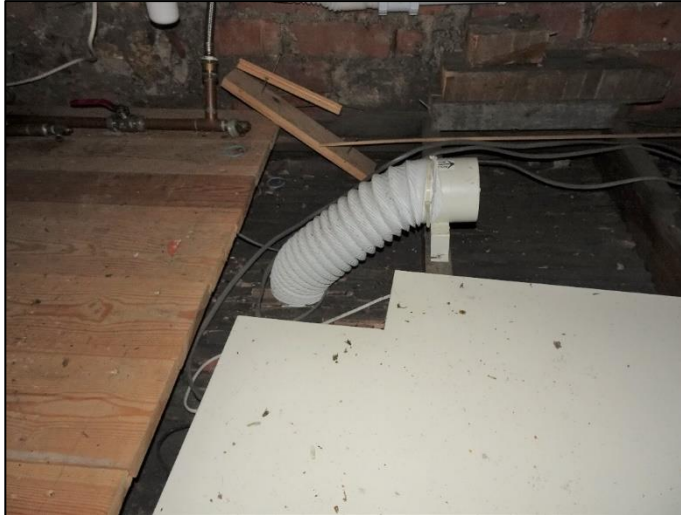
Photograph 165

- 3.10.10. The roof structure is traditional comprising a principal truss supporting two rows of purlins to each roof slope in turn supporting common rafters.
- 3.10.11. The extract fan to the en-suite bathroom discharges directly to the roof space and should be vented externally.

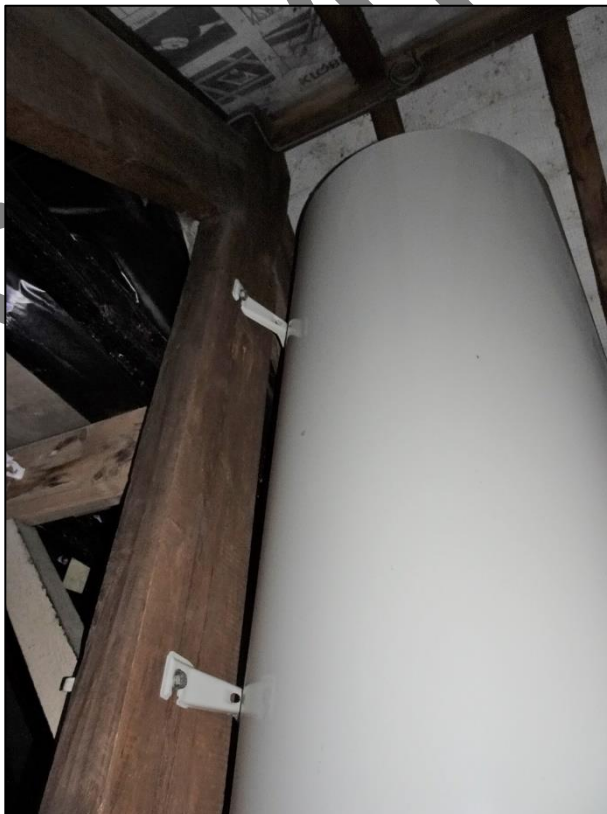
Photograph 166

- 3.10.12. Mineral wool insulation is laid within the roof space to approximately 100mm thickness between the ceiling joists and should be upgraded to a thickness of 300mm and draught seals and insulation added to the loft hatch.
- 3.10.13. There is a large redundant wasps' nest which should be removed.
- 3.10.14. There are two hot water cylinders within the roof void, which are suspended, fixed to the internal solid masonry wall and principal truss.

- 3.10.15. The principal truss appears to be pulling slightly because of the weight of the tank.

Photograph 167

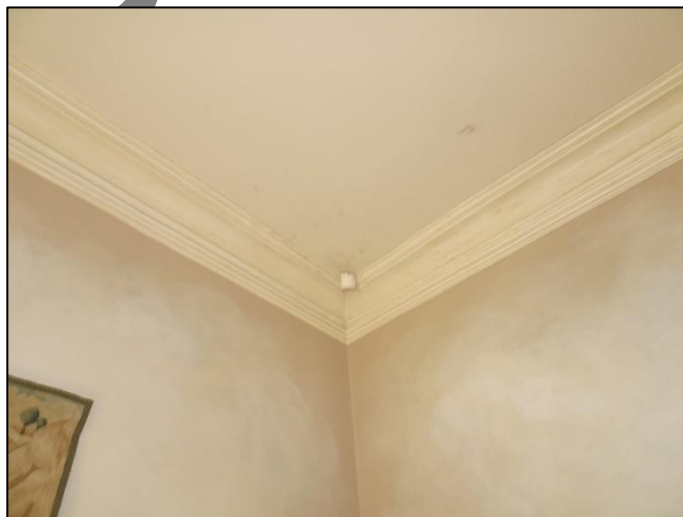
Photograph 175

- 3.11.1. Ceilings are of lath and plaster and plasterboard construction.
- 3.11.2. The majority of the lath and plaster ceilings appear to have been over boarded with plasterboard or overskimmed.
- 3.11.3. Several of the ceilings have paper finishes.
- 3.11.4. There are areas of undulation noted to several ceilings although none to an extent whereby I consider that any remedial works are necessary at present.
- 3.11.5. There is some staining to the corner of the main living room which when tested with an electronic moisture meter, recorded satisfactory readings.

3.11.6. Lath and plaster ceilings deteriorate over time due to corrosion of the nail fixings holding the laths to the joists and plaster becoming de-bonded from the laths. It is almost inevitable that replacement or overboarding of the ceilings will be necessary in the future.

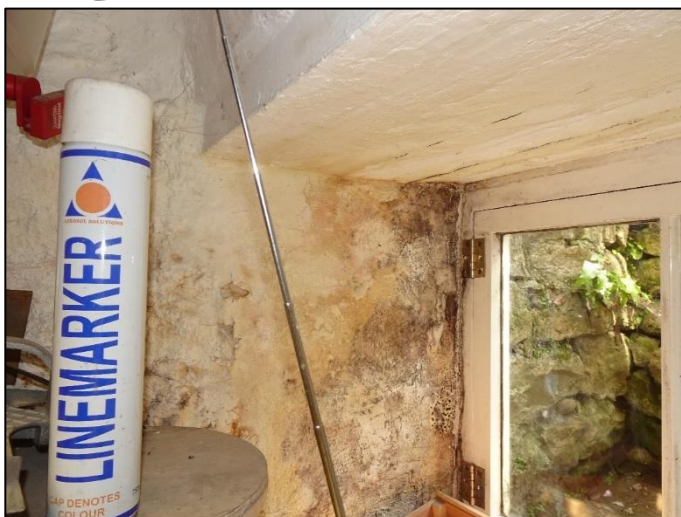
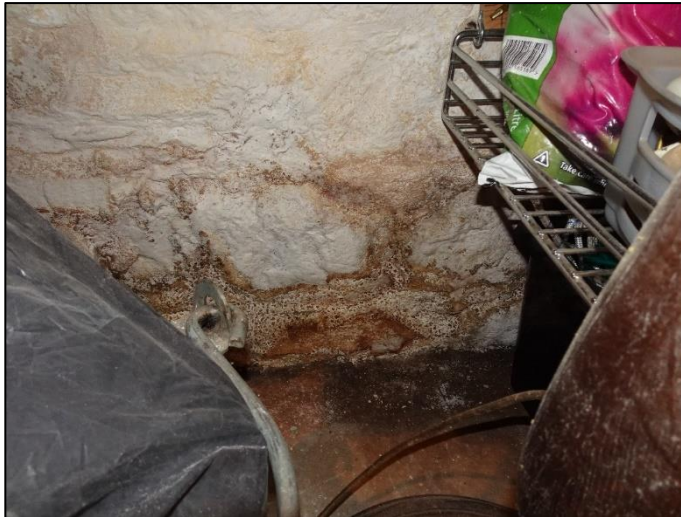
- 3.12.18. I do not anticipate that paint to the walls within the workshop is a vapour permeable type.
- 3.12.19. There is visible dampness throughout the basement, most significantly to the workshop area.

- 3.12.20. The dampness noted is not unexpected to a below ground level situation such as this.
- 3.12.21. There is an old chute to the basement, which has been built-in and fitted with air bricks.

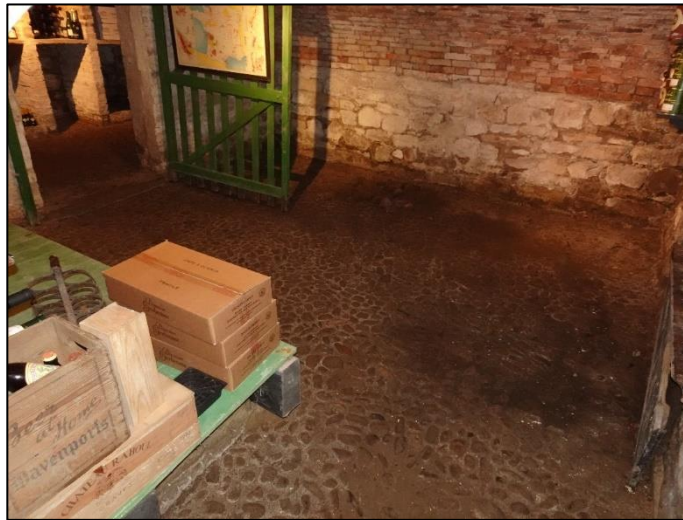
Photograph 181

- 3.13.15. I understand from the vendor that the flags to the scullery were lifted and the floor replaced, incorporating a damp-proof membrane.
- 3.13.16. The stone flags to lobby area to the foot of the stairs have not been re-laid and are visibly damp.
- 3.13.17. I am advised by the vendor that occasionally there is standing water to the wine cellar floors, which naturally drains away.

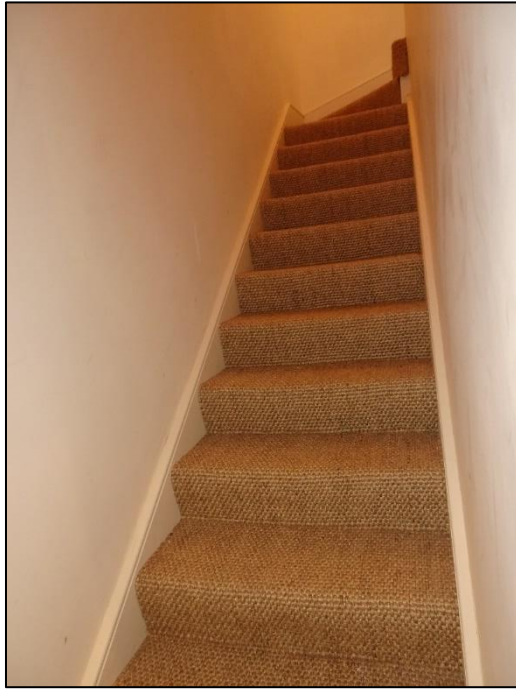
Photograph 184

- 3.14.8. The annexe staircase is modern and constructed from MDF. The staircase creaks slightly, a defect which is not unusual for replacement modern staircases such as this, but is otherwise in satisfactory condition.

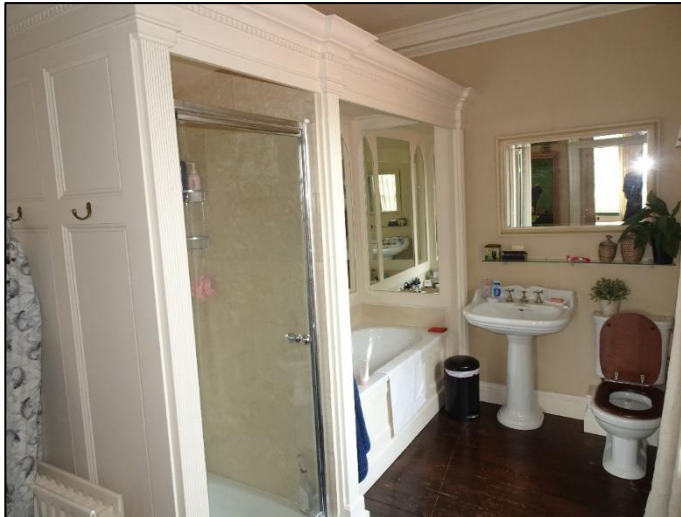
Photograph 188

- 3.15.5. There is part tiling to the shower enclosure and around the bath, which is in satisfactory condition.
- 3.15.6. The appliances were all in satisfactory condition and operating at the time of inspection.
- 3.15.7. There is no extractor fan to the bathroom.

- 3.18.13. There is an electrical supply to the ground-floor WC for the addition of an extractor fan, which should be installed.
- 3.18.14. There are no extract fans fitted to the billiard room WC or bedroom 2 en-suite. I would recommend fans are installed.
- 3.18.15. There are recirculation hoods fitted to the utility/second kitchen and cottage kitchens, which ideally would be replaced with externally vented fans.
- 3.18.16. An extract fan should not be fitted to the main kitchen as gases from the Aga can be drawn back into the room.

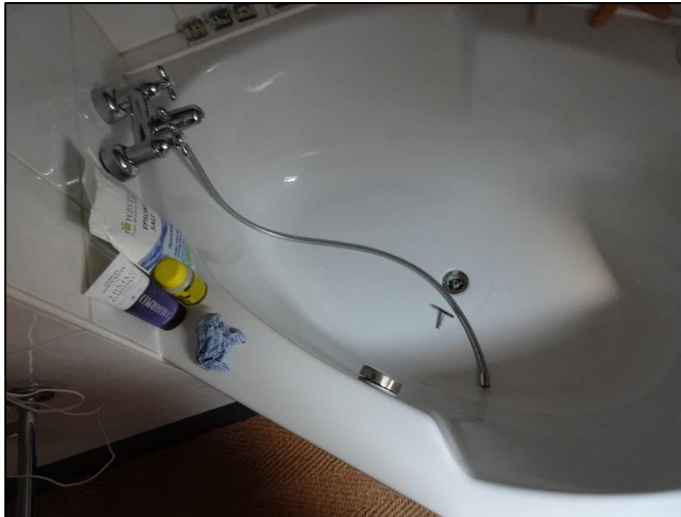
Photograph 190

- 3.15.9. There is part tiling to the walls which is in satisfactory condition.
- 3.15.10. One of the fittings to the bath taps and the shower head from the handheld shower attachment is missing.

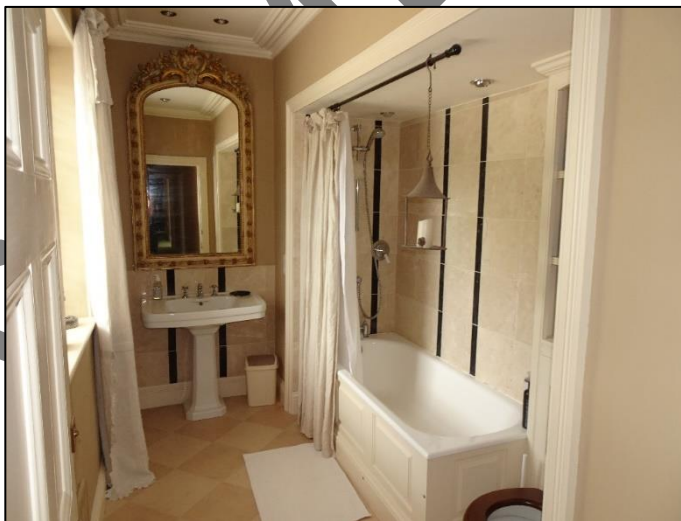
Photograph 191

- 3.15.13. There is part tiling to the walls, all of which is in satisfactory condition.
- 3.15.14. The appliances were in satisfactory condition and operating at the time of inspection.
- 3.15.15. Sealant to the bath is deteriorating and should be replaced.

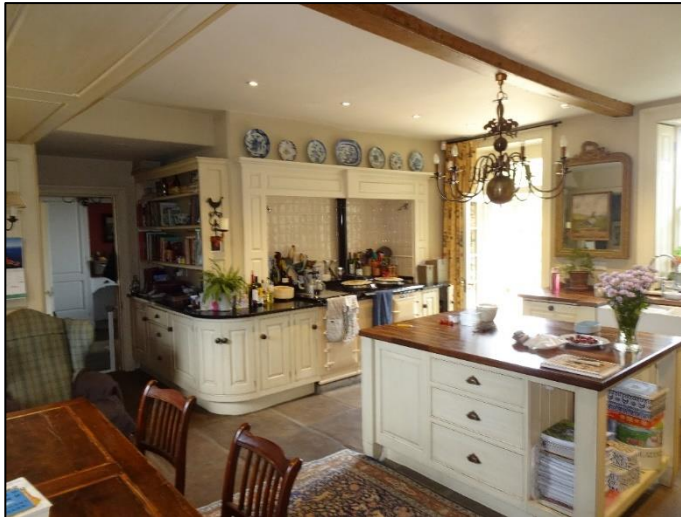
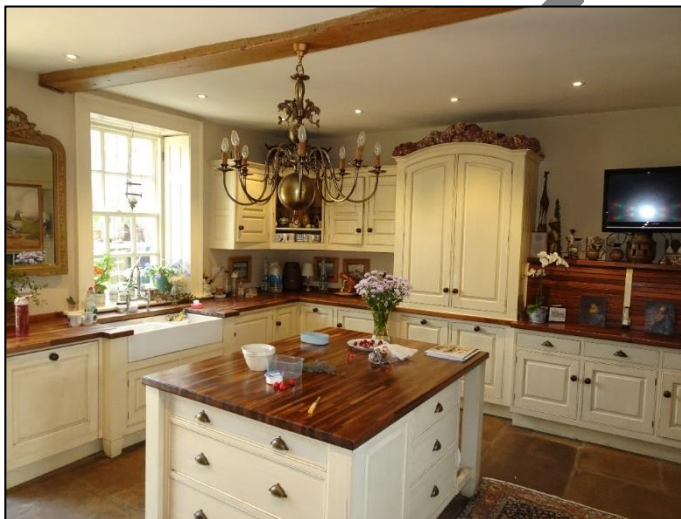
- 3.15.30. There is a double ceramic Belfast sink with mono-block mixer tap, built-in fridge and dishwasher.
- 3.15.31. There is an oil-fired Aga.
- 3.15.32. The kitchen fittings are of a high quality and generally in satisfactory condition. There is deterioration of the finish to the worksurface around the sink.

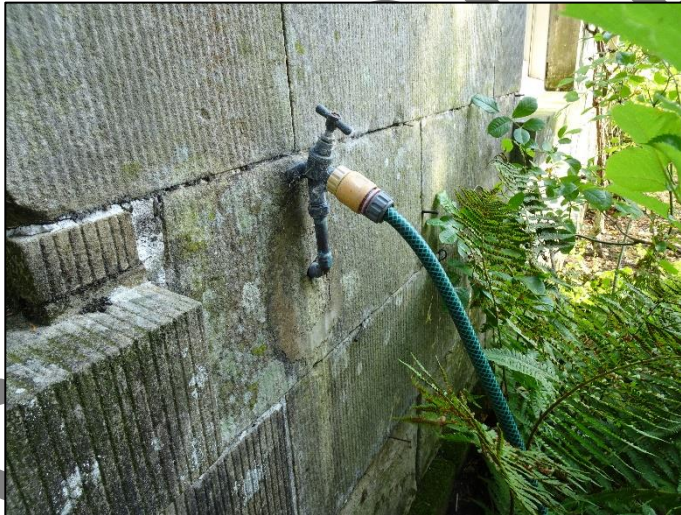
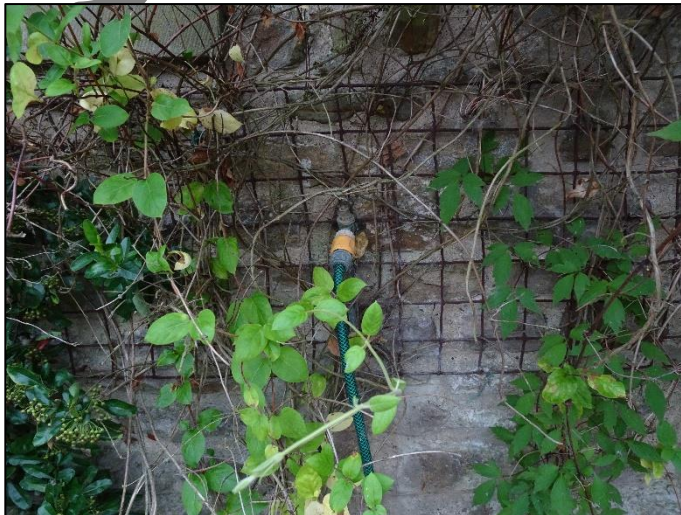
- 3.16.6. The incoming supply pipe is noted to be alkathene and was replaced by the vendors.
- 3.16.7. There are external water taps provided at several points to the external grounds including the front and rear of the left-side wing.

- 3.16.8. The external supply pipework should be fitted with insulation.
- 3.16.9. Hot water is provided by factory insulated pressurised hot water cylinders, one located to the main house ground-floor WC, one located to main house and two within the roof space to the rear right offshoot.
- 3.16.10. There is a factory insulated copper cylinder to the second kitchen/utility room.

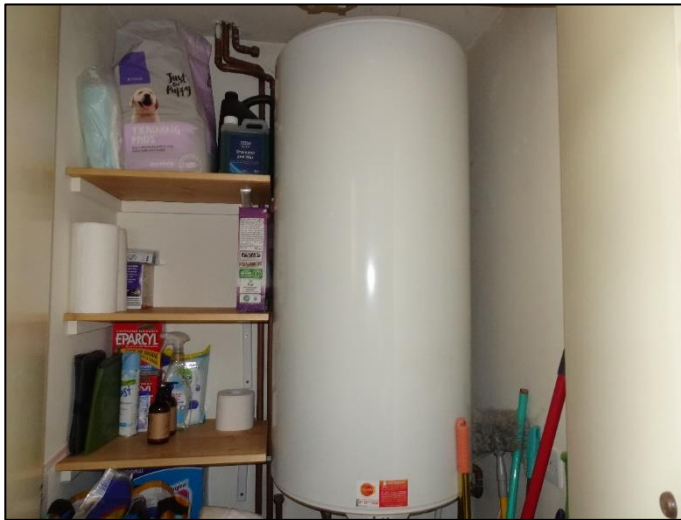
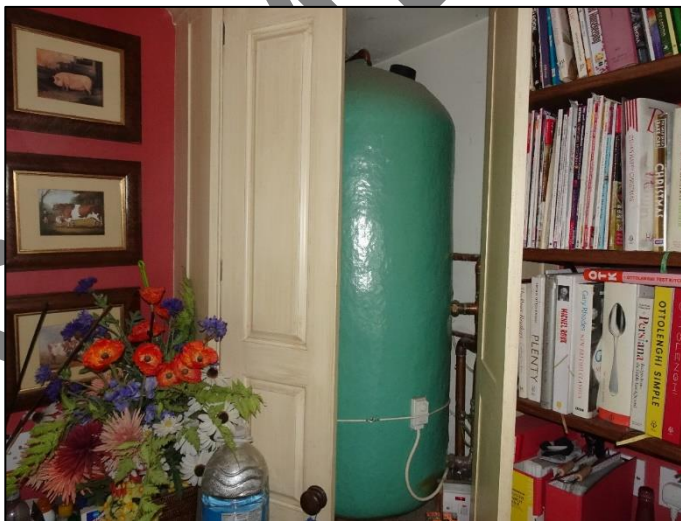
- 4.24. There are two hot water cylinders fitted within the roof void to the rear right roof void, one of which is hung off the principal truss.
- 4.25. The principal rafter to the truss appears to be pulling slightly and I would recommend the tank is relocated, not fixed to the truss.

- 4.26. The supporting brackets to the tanks appear to be bending, which may be a design fault. The tank to the main house W.C. is also wall mounted, although the brackets could not be inspected. The tanks may not be supposed to be mounted vertically and I would recommend the tanks are inspected.

- 3.16.11. As noted earlier within the report, the bracket fixings to the cylinders within the roof void appear to be bending and should be inspected and the cylinder fixed to the truss should be relocated.
- 3.16.12. Water is heated by electric immersion heaters and the utility/second kitchen tank is also heated by the Aga cooker.
- 3.16.13. Service pipework is a combination of copper and plastic.
- 3.16.14. Plastic fittings do not have the same life span as copper.
- 3.16.15. There was no evidence of any ongoing leaks at the time of inspection.

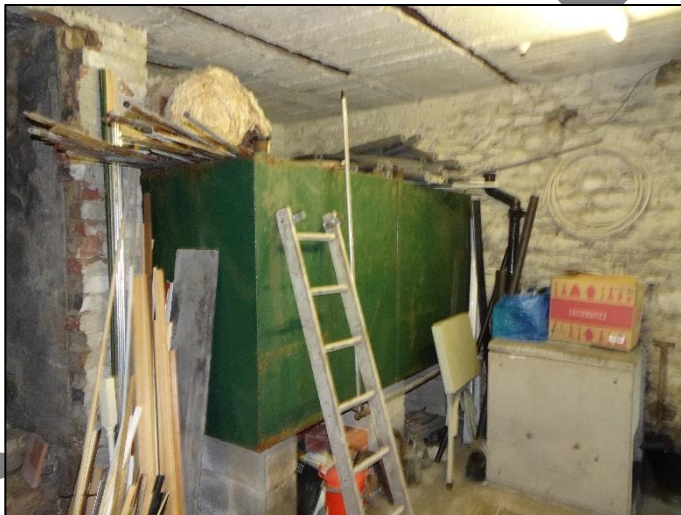
Photograph 207

- 3.17.6. The oil tanks supplying the boilers are located to the right-side store adjacent to the garage and are old metal tanks.

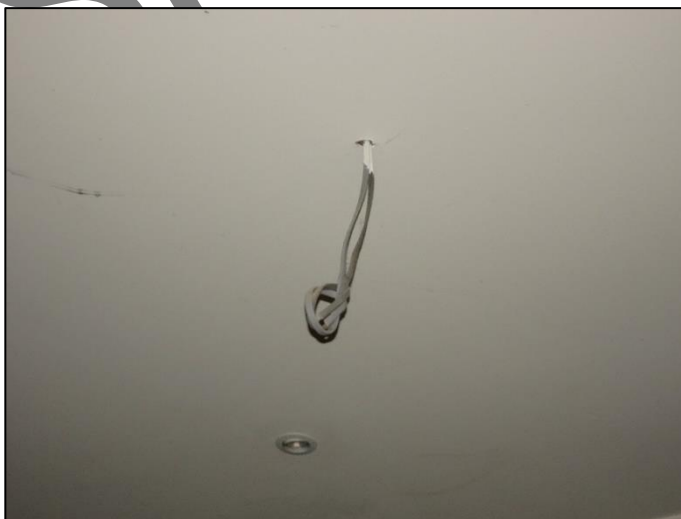
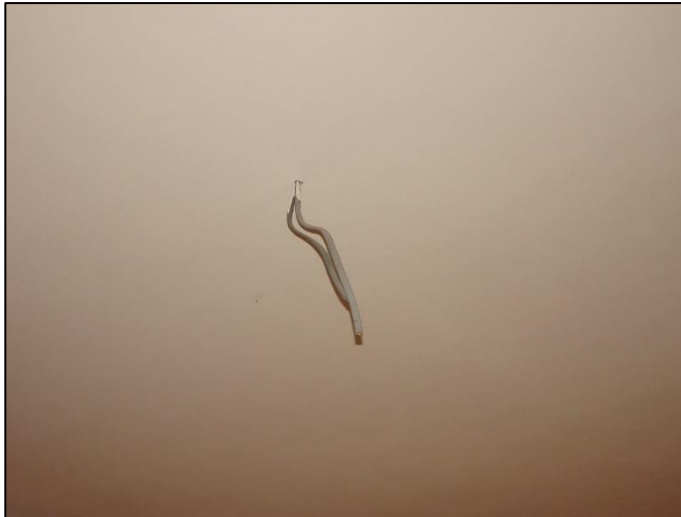
- 3.18.7. The consumer units are modern units with mini circuit breakers fitted.
- 3.18.8. The units are plastic and would not meet regulations for a new installation however there is no obligation to replace them.
- 3.18.9. Power outlet sockets and switch covers are plastic throughout and the provision of sockets is plentiful by current expectations.
- 3.18.10. Wiring, sockets and switches to the basement rooms are surface mounted.
- 3.18.11. There are docks installed for mains-wired, interlinked smoke/heat detectors throughout the property, however the majority of the alarms have been removed, I would recommend that the alarms are re-instated.
- 3.18.12. There are exposed electrical lighting supplies to the billiard room and drawing room.

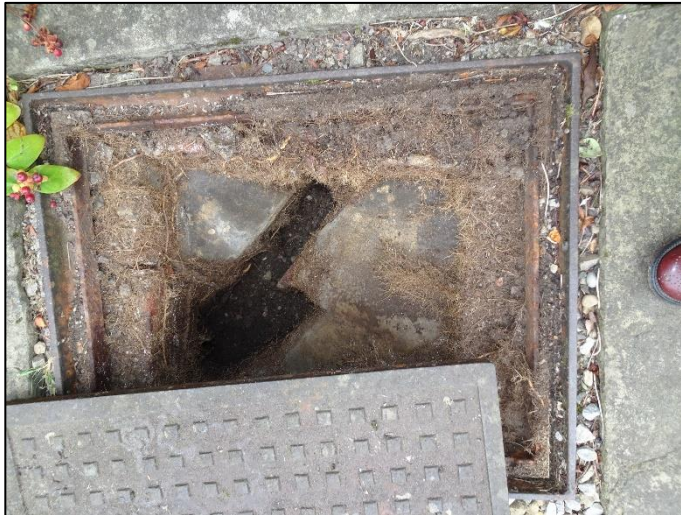
Photograph 222

- 3.20.10. There is a cast iron cover and frame to the rear left of the property.
- 3.20.11. The cast iron cover was lifted to reveal a shallow brick-built chamber with mortar benching.
- 3.20.12. There is significant root growth within the chamber which is currently redundant since drainage was altered in 2019.
