I R Johnson MRICS, Chartered Building Surveyor

IRJ/AH/S1596/L2

Introduction to the Report

Instructions received are to carry out an RICS Level 2 Building Survey of the property which were accepted and confirmed in my letter of the

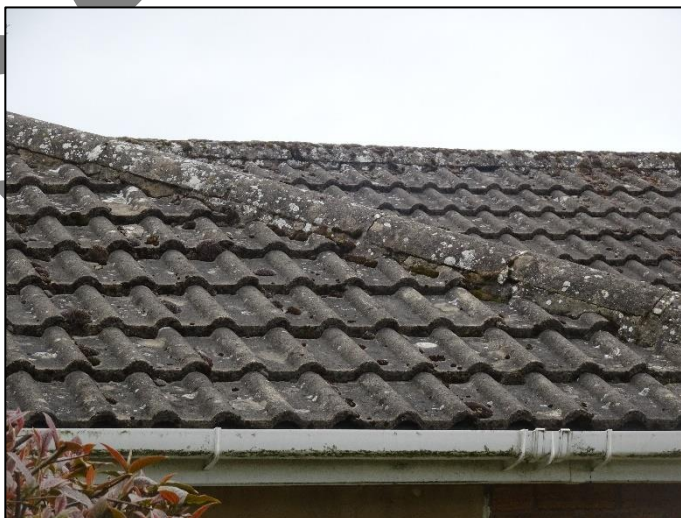
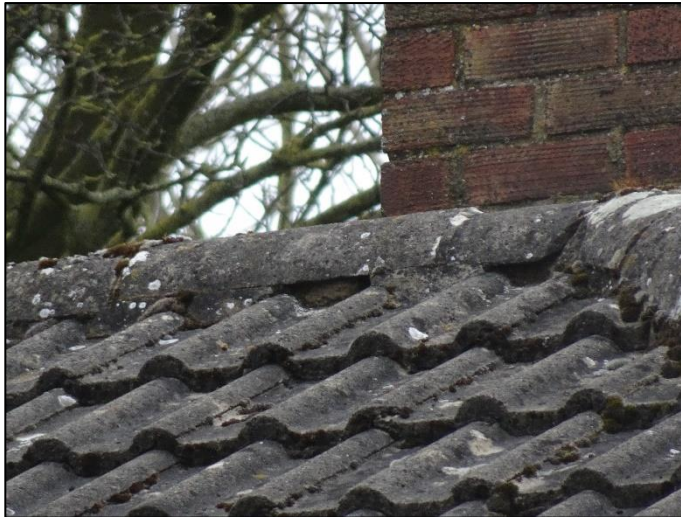
Photograph 5

- 3.1.8. Mortar to the ridges is eroding, cracked and partially missing to some areas and should be replaced.

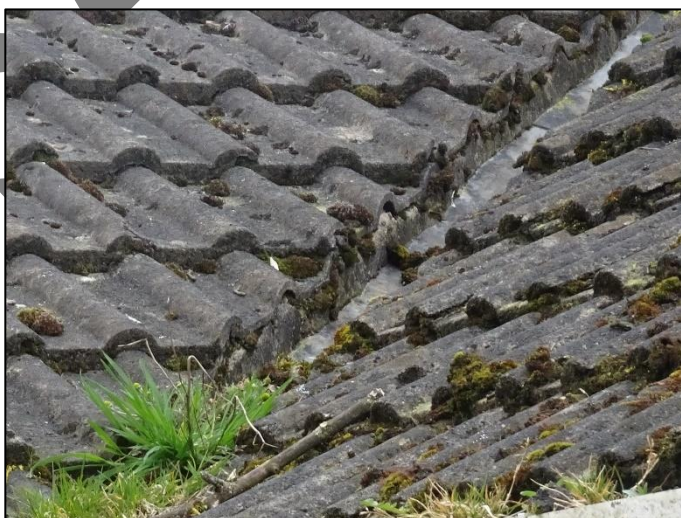
Photograph 10

- 3.1.13. There is some defective/loose mortar pointing to the underside of tiles bedded into the valleys which requires replacement.

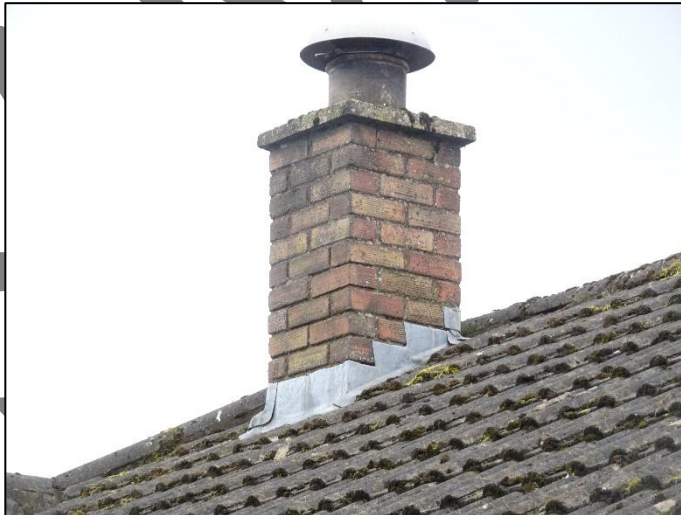
Photograph 12

- 3.2.2. Mortar joints to the brickwork are eroding and should be programmed for re-pointing.

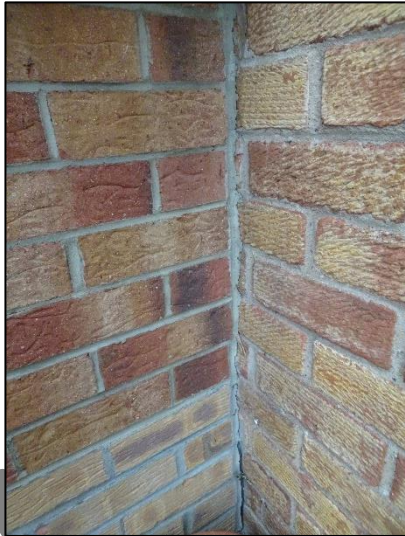
Photograph 18

- 3.4.10. Injected cavity wall insulation can cause problems of dampness internally however there were no such problems evident.
- 3.4.11. At the abutment of the conservatory dwarf walls and original walls there is hairline cracking which is not considered to be of structural significance and should be pointed up.

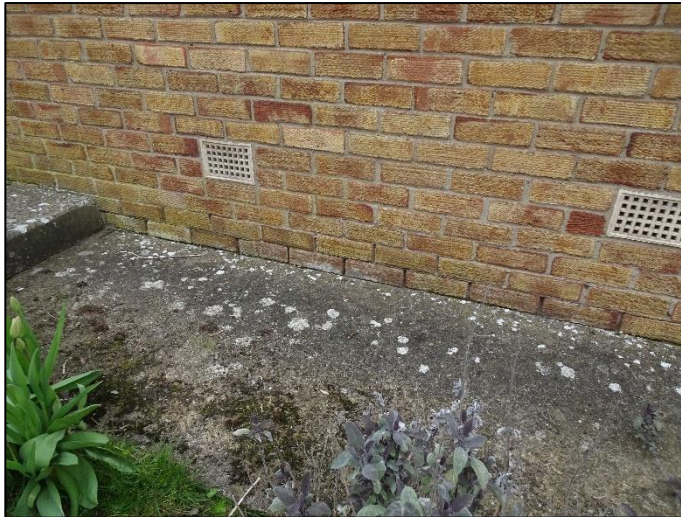
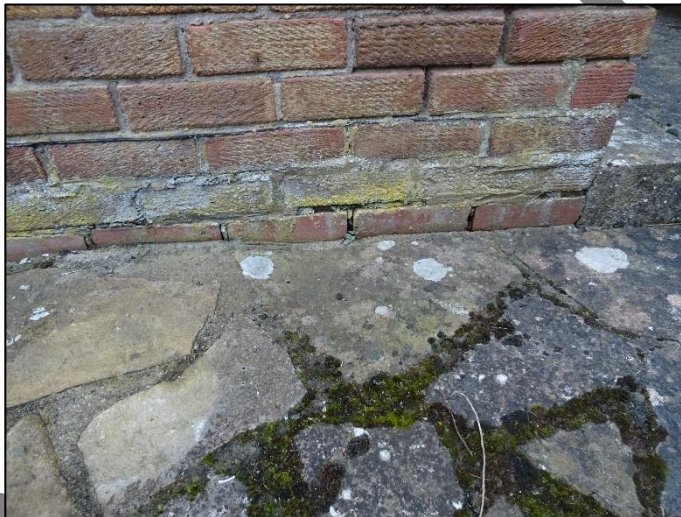
Photograph 20

3.4.12. Mortar joints are eroding at lower level to the original walls, requiring re-pointing.

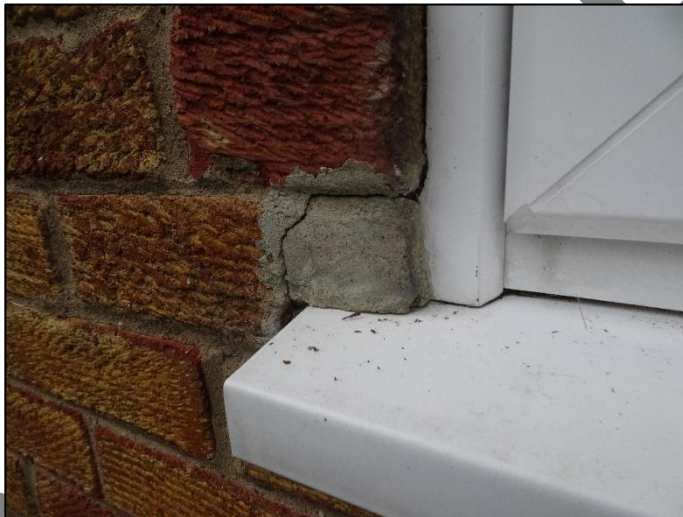
Photograph 25

3.5.9. Brick slips or mortar pointing has been provided to each side of the window cills, many areas of which are now loose, requiring replacement.

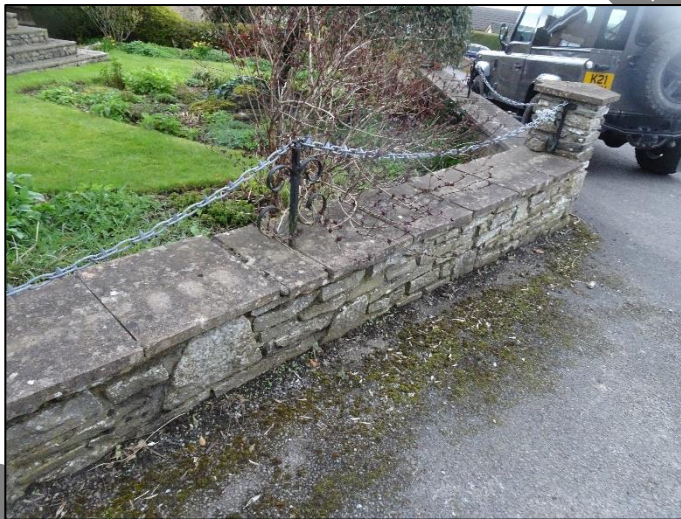
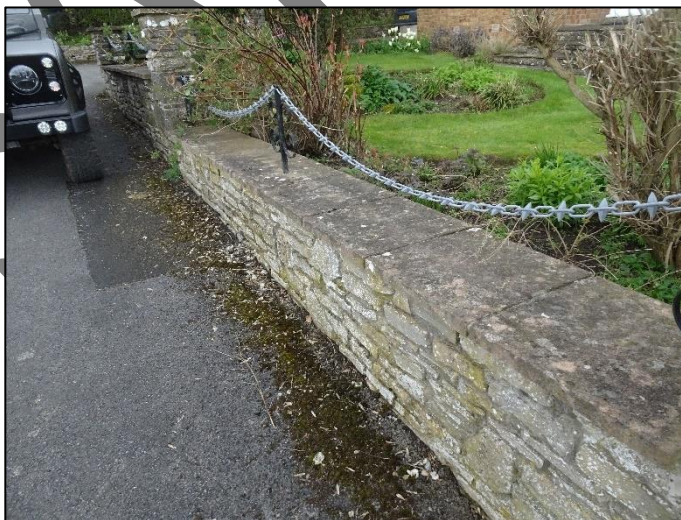
Photograph 27

3.6.3. There are concrete copings to the top of the wall which are loose and have eroded mortar joints requiring lifting and re-bedding.

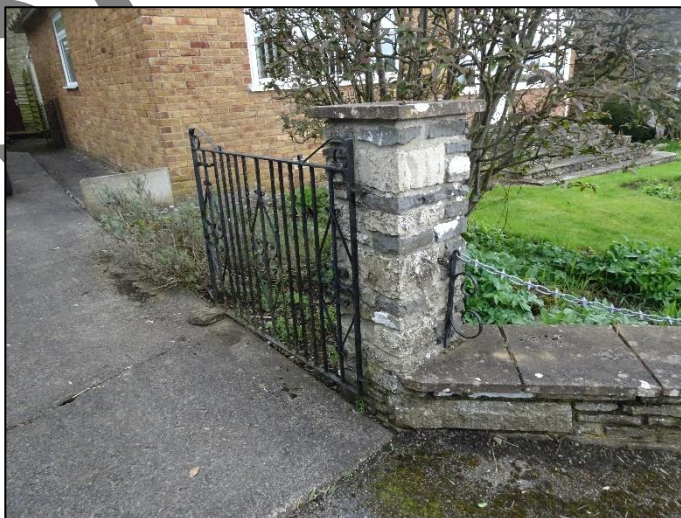
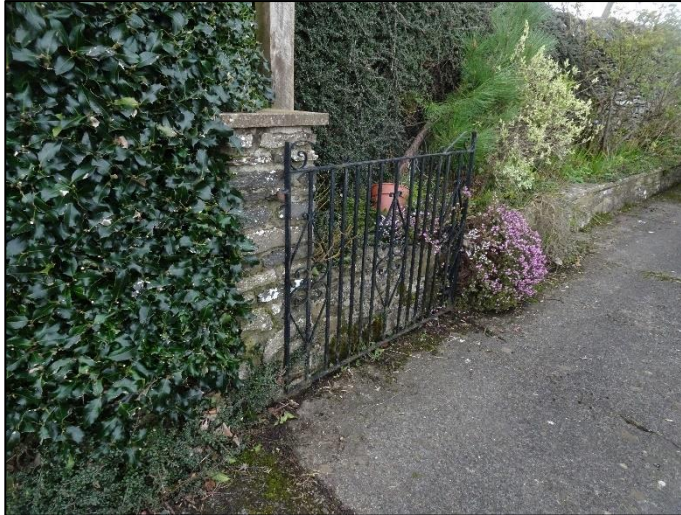
Photograph 31

- 3.6.4. There is an ornamental metal personnel gate and pair of vehicular entrance gates which are corroding, requiring fully cleaning down and re-decorating.

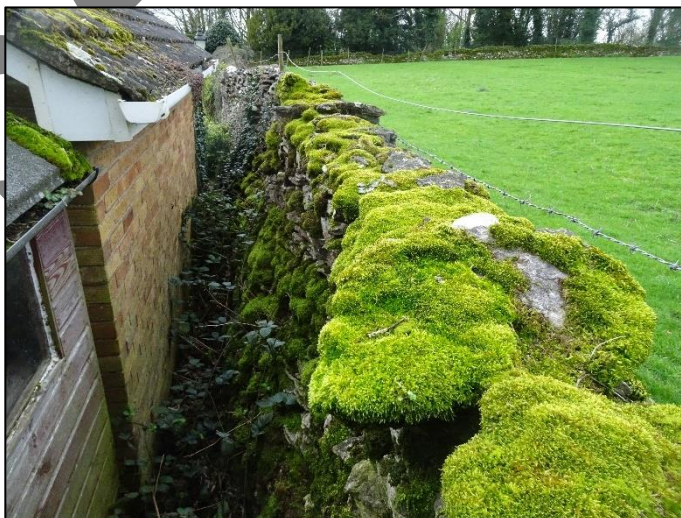
Photograph 34

- 3.6.5. The left-side boundary is a dry stone wall which leans, bows and bulges and will inevitably require repairs as part of ongoing maintenance.

- 3.6.6. The wall has been undermined to some areas which will reduce its stability and should be made good.

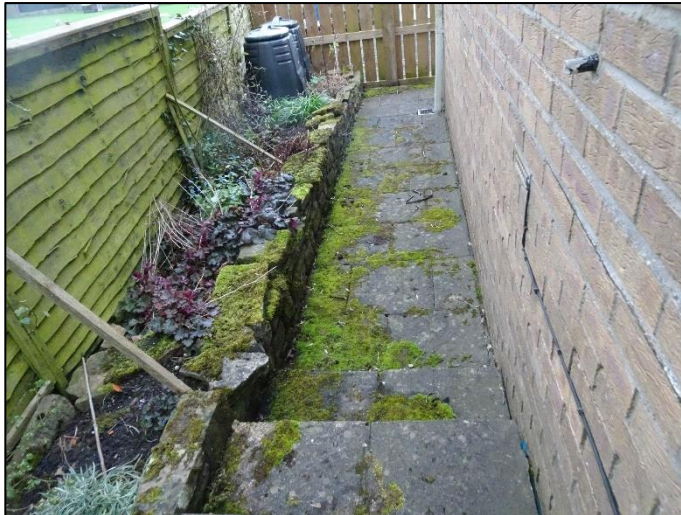
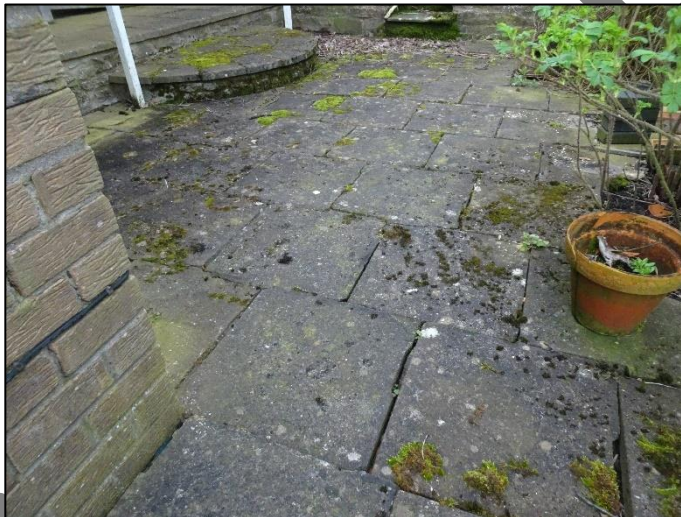
Photograph 37

- 3.6.12. There are cracks to the cast insitu concrete and defective joints to the majority of the concrete flagged areas.

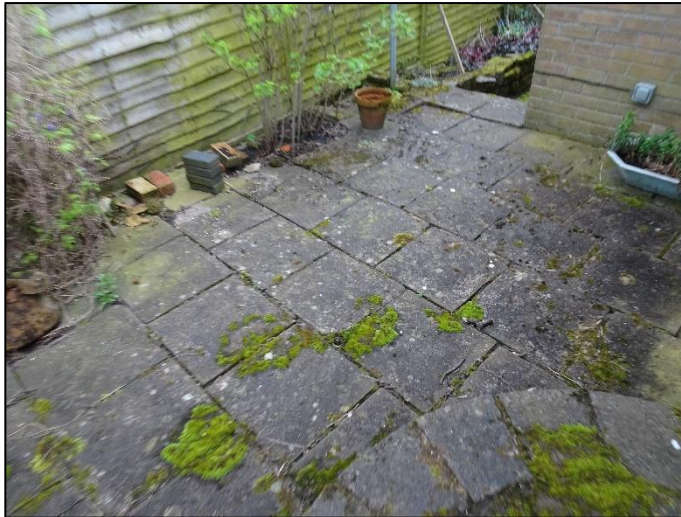
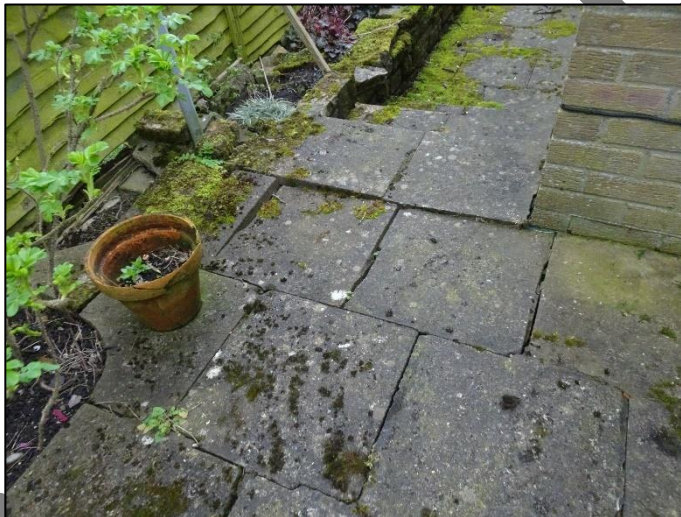
Photograph 40

- 3.6.13. Some of the flags are uneven, requiring re-laying.

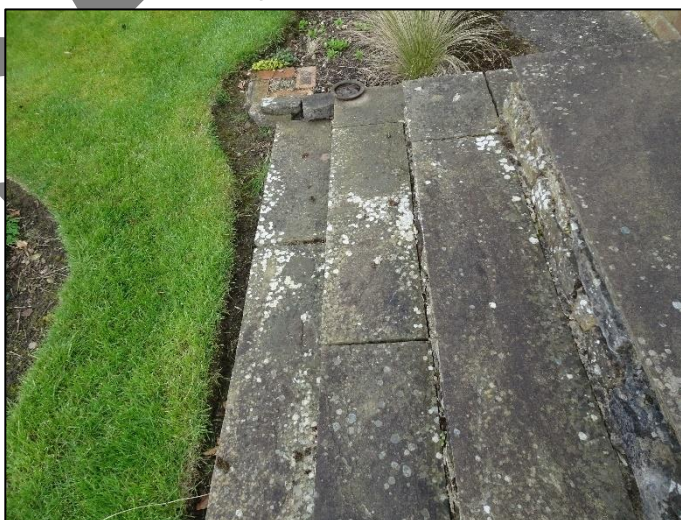
Photograph 42

- 3.6.15. Mortar pointing to the joints is eroding, requiring replacement.

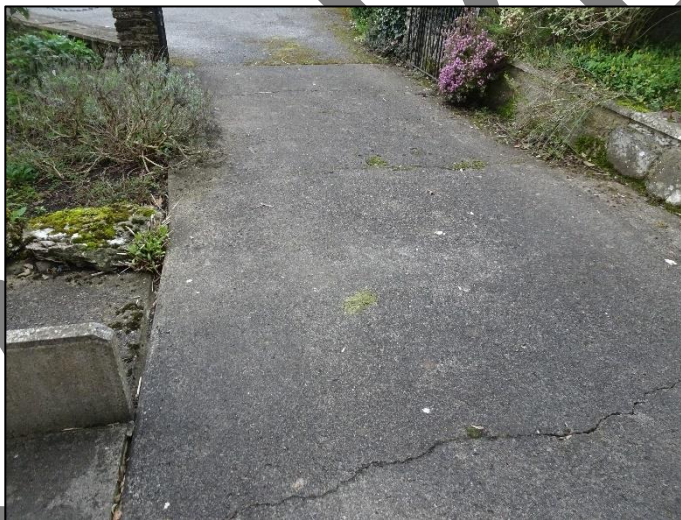
Photograph 44

- 3.6.18. The concrete is beginning to deteriorate and has isolated cracks, requiring repairs.

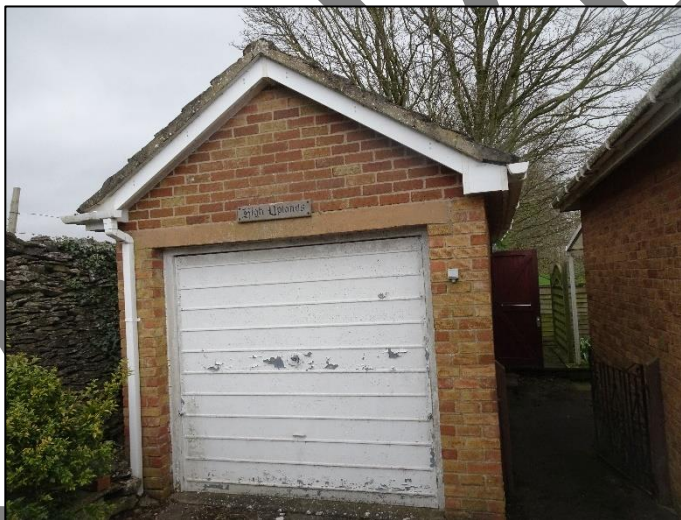
Photograph 49

- 3.7.1. The roof is of duo-pitched construction with ridge running perpendicular to the front elevation.
- 3.7.2. The roof is covered with the same tiles as the dwelling.
- 3.7.3. There is significant moss growth to the roof which has restricted examination and should be cleaned off.
- 3.7.4. There is eroded/cracked mortar to the ridges which requires replacement as necessary.
- 3.7.5. There are mortar pointed verges to the roof which are cracked and eroding, particularly to the rear requiring replacement.

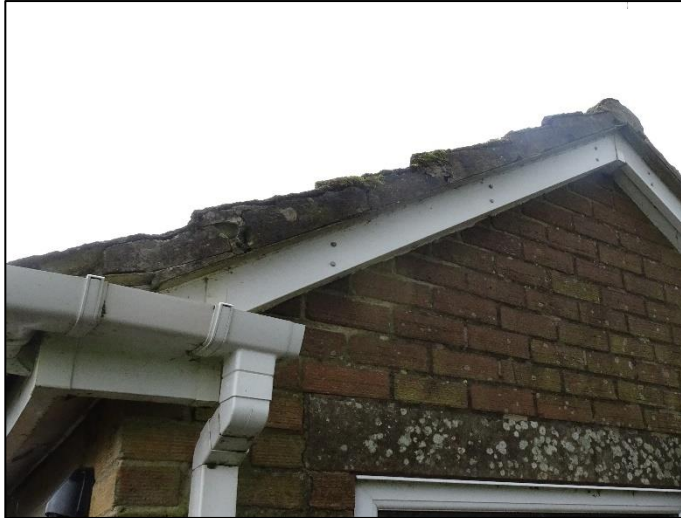
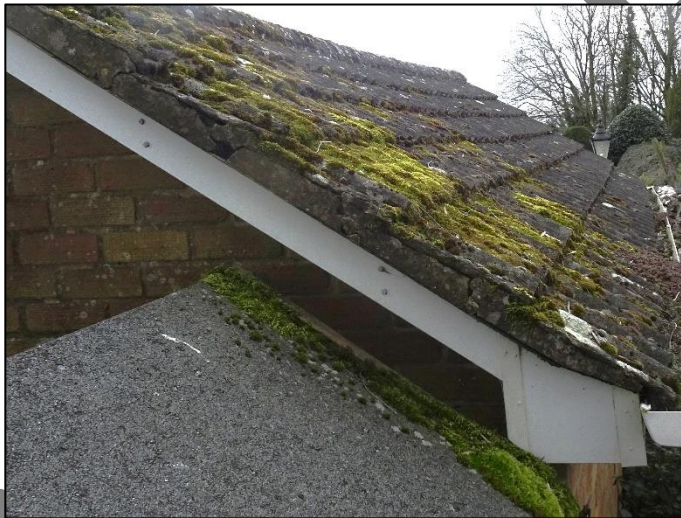
Photograph 50

- 3.7.6. There is slight deflection of the roof slopes.
- 3.7.7. The roof structure is a traditional rafter roof with raised ties to every other pair of rafters.

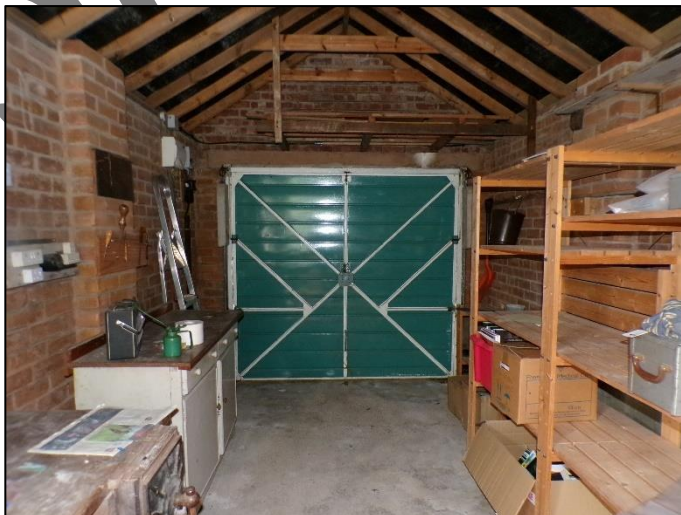
Photograph 52

- 3.7.8. The rafters are undersized, which has resulted in the deflection but which is unlikely to become any worse.
- 3.7.9. There was no evidence of any active woodworm infestation to roof timbers where these could be inspected.
- 3.7.10. There is a bitumen-based roofing underfelt beneath the tiled covering.
- 3.7.11. Underfelts provide a secondary barrier to water penetration.
- 3.7.12. Bitumen underfelts used in construction prior to the early 1990s are likely to contain asbestos fibres although these are bound up in bitumen and risk to health is minimal but I would recommend not to access the roof space unnecessarily and a particle mask should be worn.
- 3.7.13. Repairs have been undertaken at eaves level with polyethylene damp course and plywood evident.

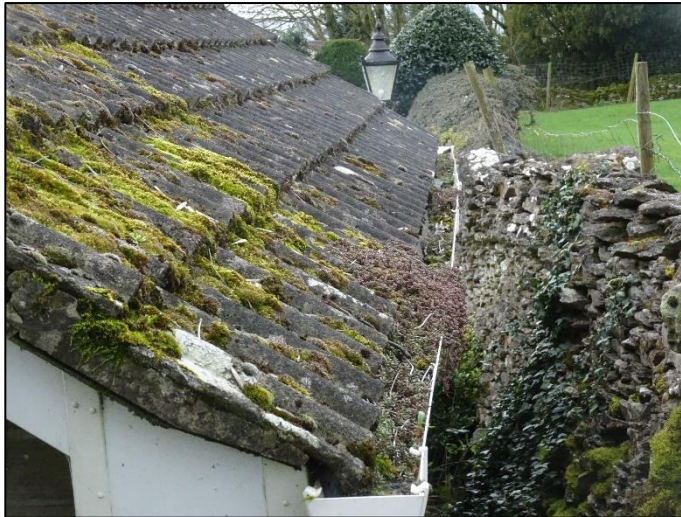
Photograph 54

- 3.8.1. The roof slopes discharge to square section, white plastic gutters and downpipes.
- 3.8.2. The gutters are blocked requiring cleaning out.

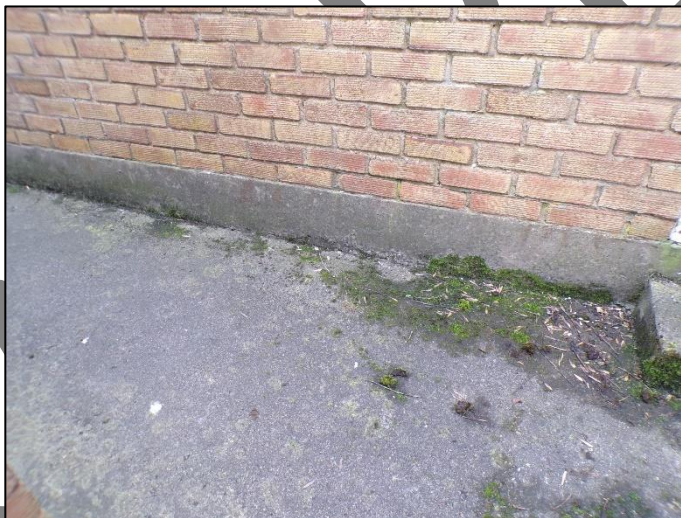
Photograph 55

- 3.9.3. To the left side, ground levels are higher, which is resulting in lateral damp penetration and a cementitious tanking solution has been applied to the walls to reduce the damp penetration.
- 3.9.4. The dampness cannot easily be resolved other than by reducing ground levels externally and constructing a retaining wall to hold back the higher ground.
- 3.9.5. There are eroded mortar joints to the base of the front-left corner requiring re-pointing.

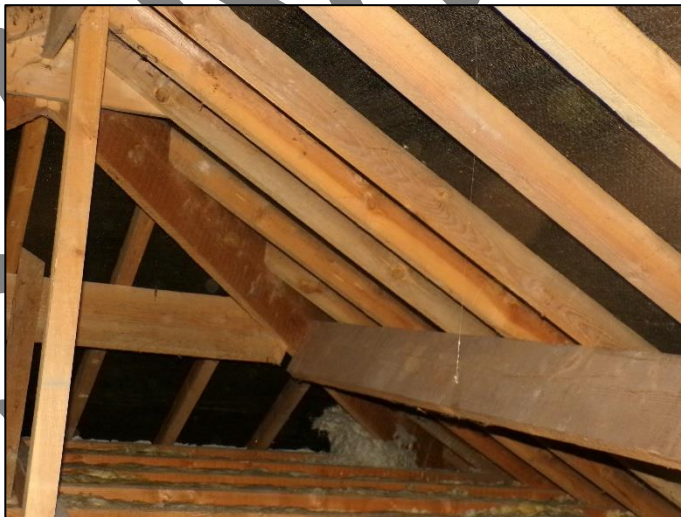
Photograph 65

- 3.12.3. Underfelts provide a secondary barrier to water penetration.
- 3.12.4. Bitumen underfelts used in construction prior to the early 1990s are likely to contain asbestos fibres although these are bound up in bitumen and risk to health is minimal but I would recommend not to access the roof space unnecessarily and a particle mask should be worn.
- 3.12.5. The underfelt has decayed where it is draped into the gutters and consideration should be given to the fitting of plastic eaves trays.
- 3.12.6. There is an old wasps' nest to the rear-right corner.

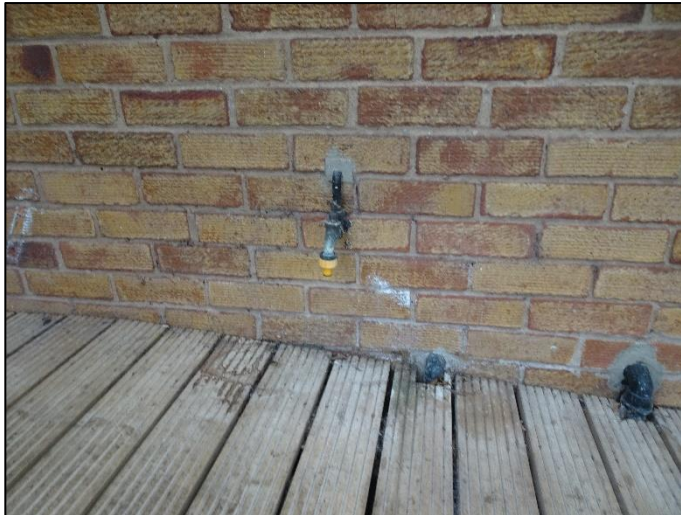
Photograph 79

- 3.18.3. I could not locate the external stop tap and the vendor did not know its location.
- 3.18.4. Hot water is provided from a combination boiler.
- 3.18.5. Water service pipework, where visible, is noted to be copper.
- 3.18.6. There is an external water tap beneath the kitchen window.

3.18.7. There was no evidence of any leaks at the time of the survey.

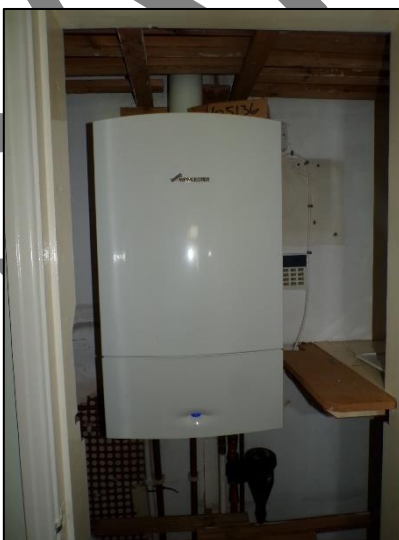
Photograph 80

3.19.2. The property has central heating which comprises a Worcester wall-mounted, gas-fired boiler with high level discharge flue which penetrates the roof via a proprietary sleeve and collar.

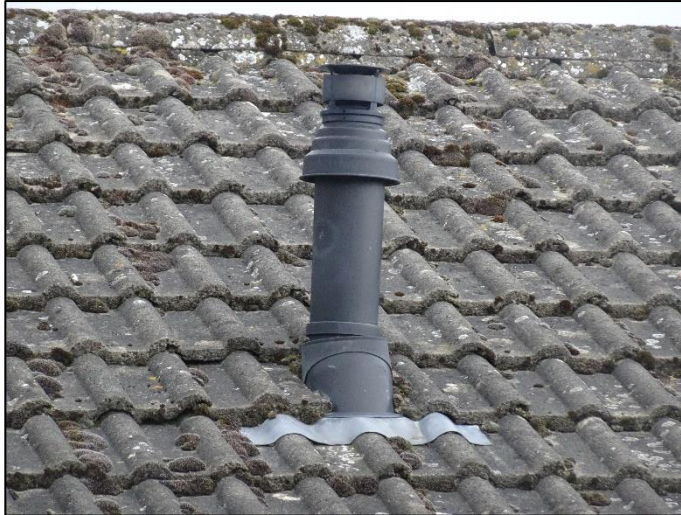
Photograph 81

- 3.19.3. I understand that the boiler is approximately 5 years old and has been serviced annually, being last serviced in September 2023.
- 3.19.4. Gas boilers have an anticipated life of 10-15 years.

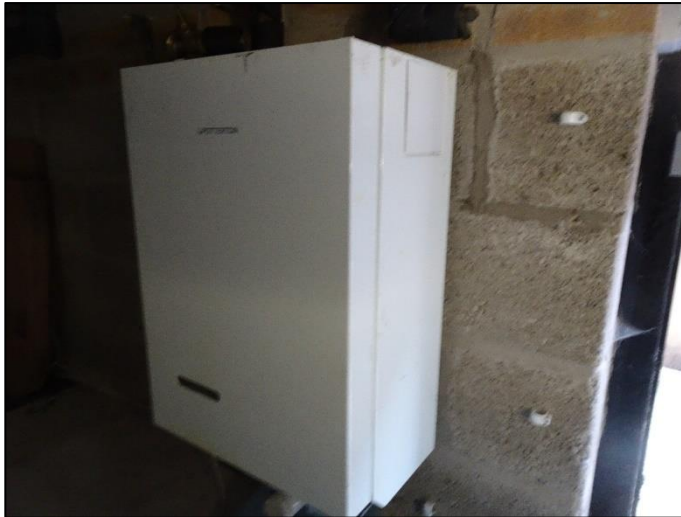
Photograph 82

- 3.19.11. There is a redundant boiler in the undercroft and associated thermostat in the hall which have not been removed but are disconnected.

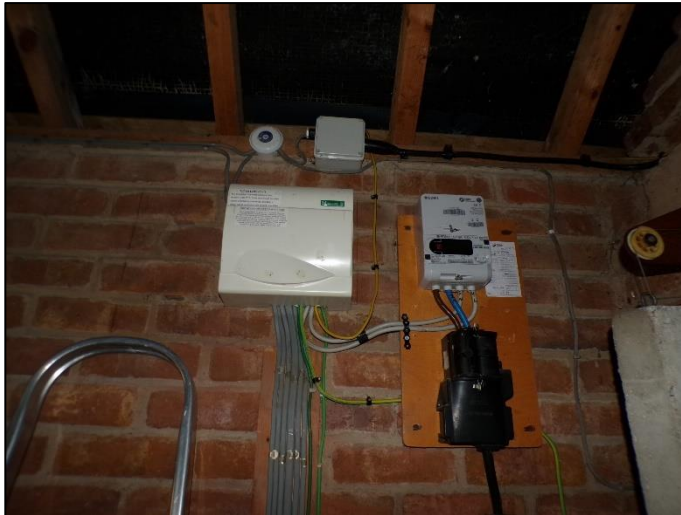
Photograph 84

- 3.20.1. The Electrical Safety Council recommends that you should get a registered electrician to check the property and its electrical fittings at least every ten years, or on change of occupancy. All electrical installation work undertaken after 01 January 2005 should have appropriate certification. For more advice contact the Electrical Safety Council.
- 3.20.2. The property is connected to mains electricity.
- 3.20.3. There is a digital meter located within the garage adjacent to which there is a consumer unit with RCD protected circuits and mini circuit breakers.

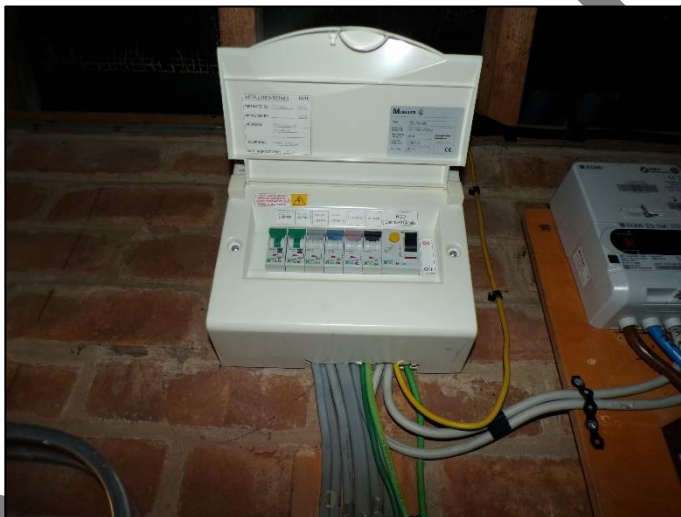
Photograph 85

- 3.20.4. The consumer unit has a plastic casing which would not comply with regulations for a new installation however there is no legal requirement to upgrade the unit.

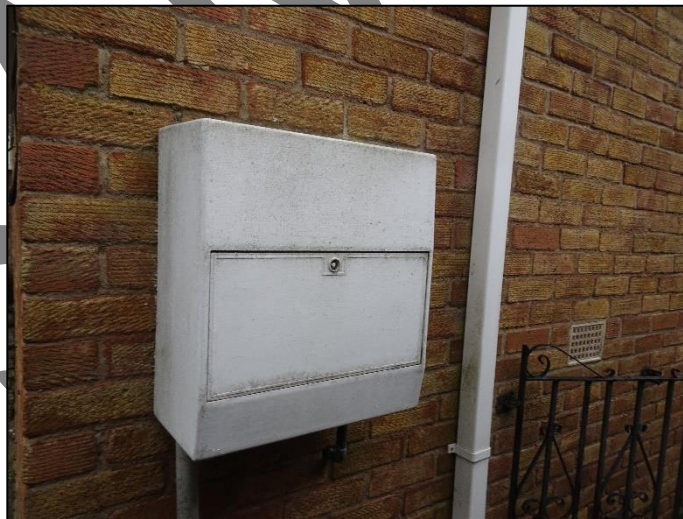
Photograph 86

- 3.20.18. There is power and lighting in the garage.
- 3.21. **Gas Installation**
- 3.21.1. The property is connected to mains gas.
- 3.21.2. The meter is located within a proprietary cabinet fixed to the right side wall of the property.

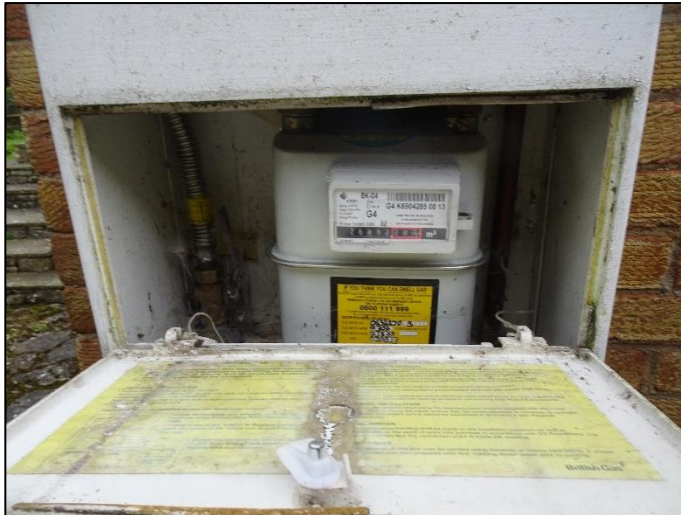
Photograph 87

3.21.3. Gas service pipework is copper and connected to the central heating boiler and fire.

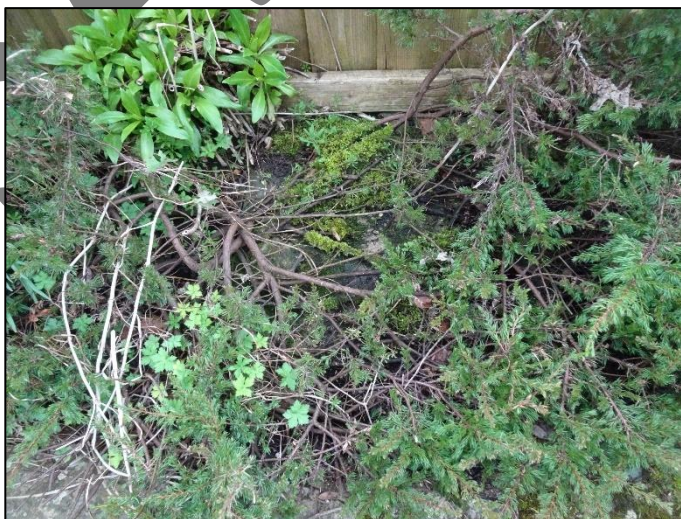
Photograph 88

3.22.5. There is an inspection chamber to the front right of the site beneath plants, the cover of which could not be lifted.

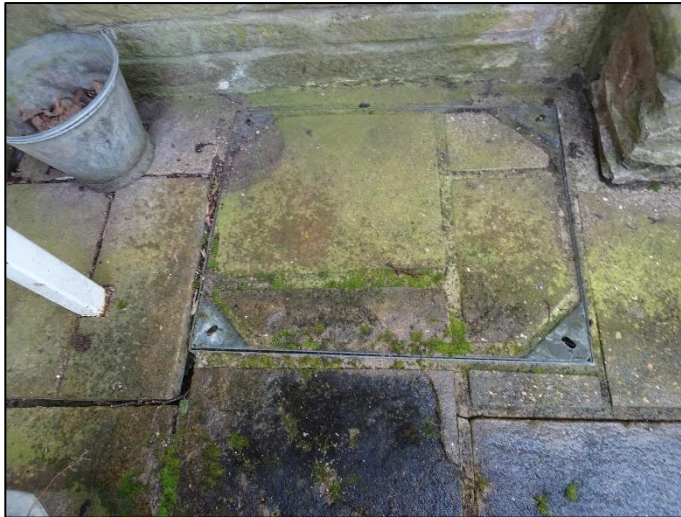
Photograph 91

- 3.22.10. To the rear left of the extension, there is a chamber which has a cover inset with concrete flags and which could not be lifted.

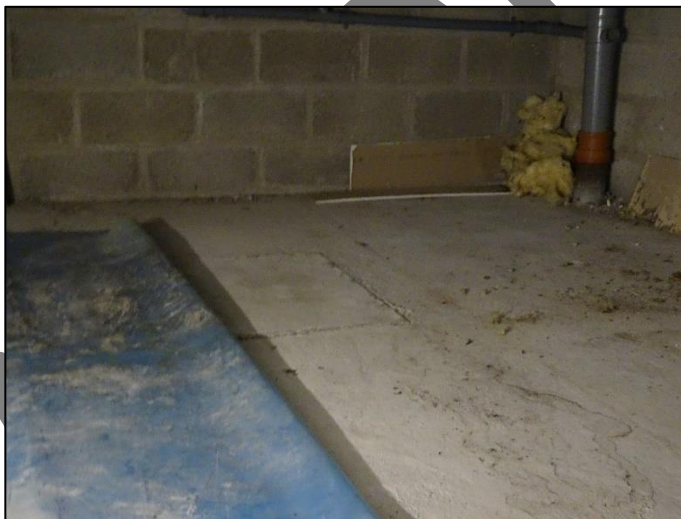
Photograph 92

- 3.22.11. There appears to have been an inspection chamber within the undercroft floor which, given the very low headroom, will be extremely difficult to lift the cover.
