I R Johnson MRICS, Chartered Building Surveyor

IRJ/AH/S1597/SA

Instructions received are to carry out a Structural Appraisal of the property which were accepted and confirmed in my letter of the

- 2.1. The property is a Grade II listed corn water mill, believed to date to 1817.

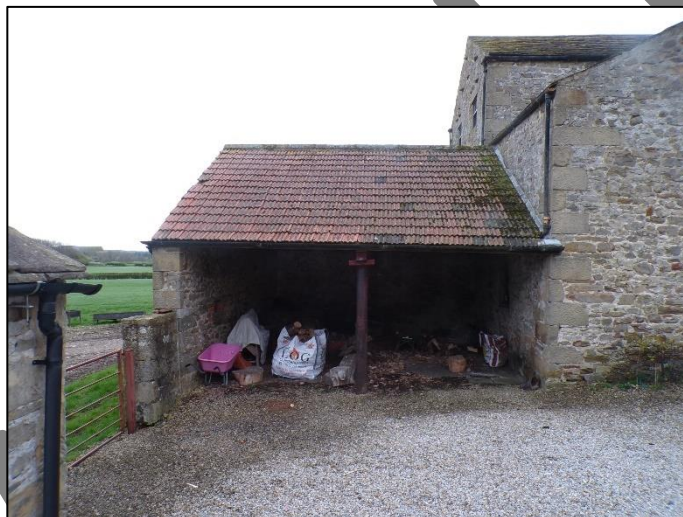
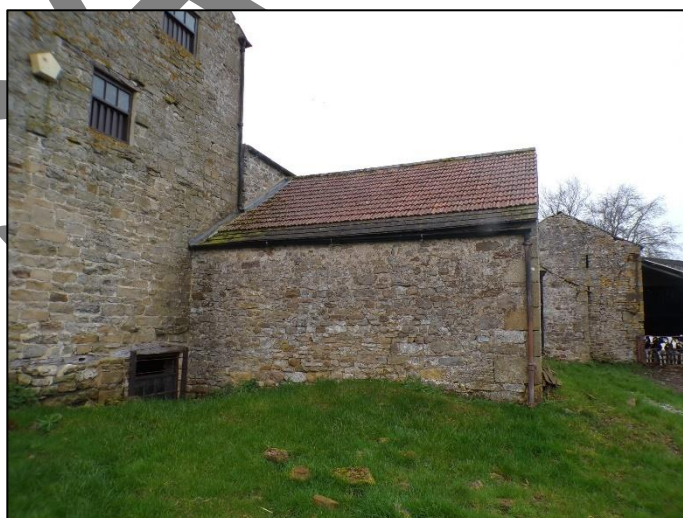
- 3.1.5. The roofs have mortar bedded and pointed, angular stone ridges.

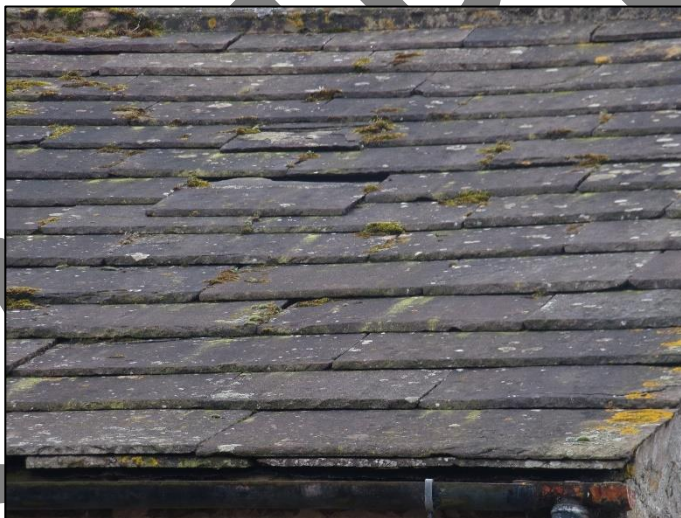
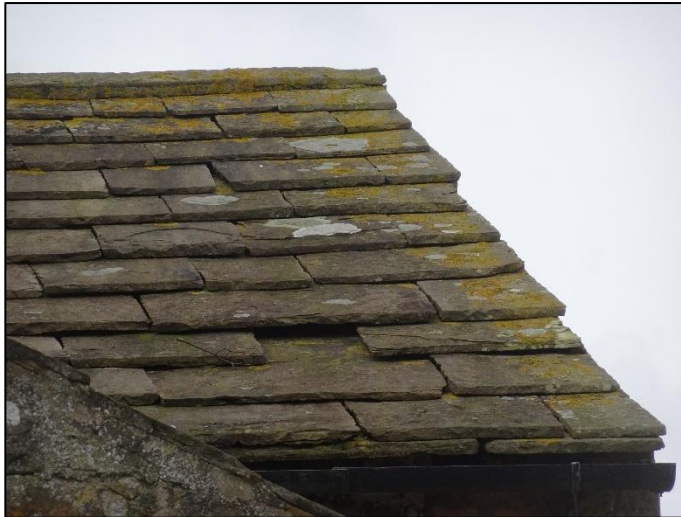
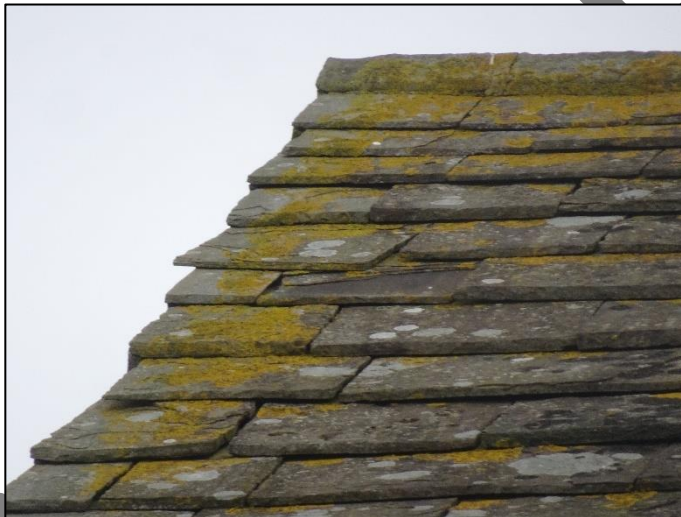
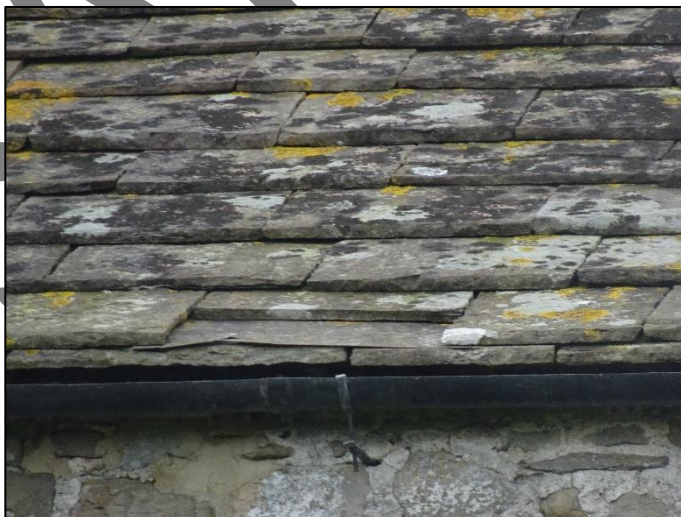
3.1.6. There are missing/broken slates to the following areas:

- 3.1.7. There are large gaps between some of the slates on the right-side slope which is due to poor workmanship, but has not resulted in water penetration.

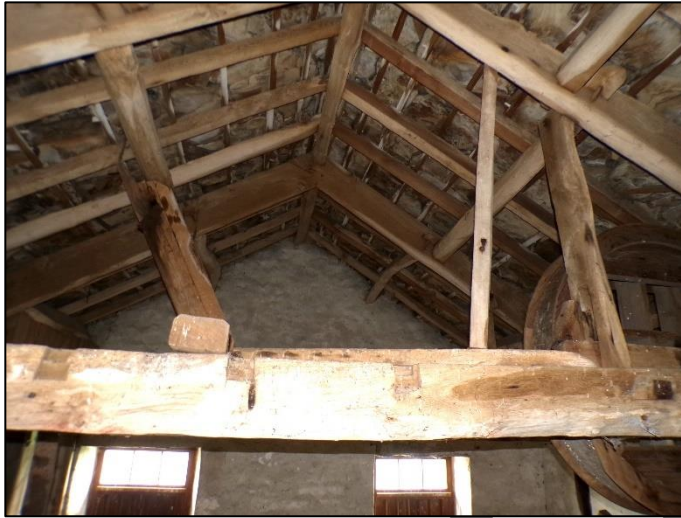
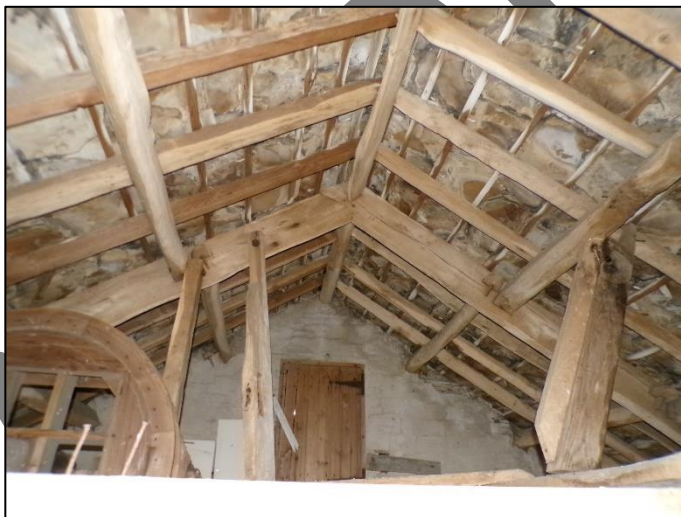
- 3.1.13. There is no underfelt beneath the slate covering.
- 3.1.14. The slates are held in place with oak pegs, many of which are snapped or missing and the roof will require stripping and re-covering in the medium term, prior to which isolated slate replacements are to be expected.
- 3.1.15. The roof timbers are primarily oak, although some replacement softwood rafters have been installed when the roof was last repaired or re-covered.
- 3.1.16. There is significant woodworm infestation to many of the timbers, however this does not appear to extend into the solid heartwood and the roof structure is considered to be in good condition for its age.

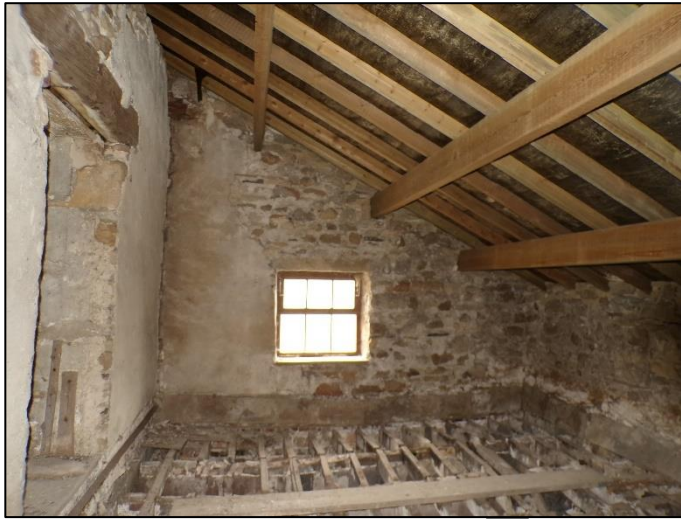
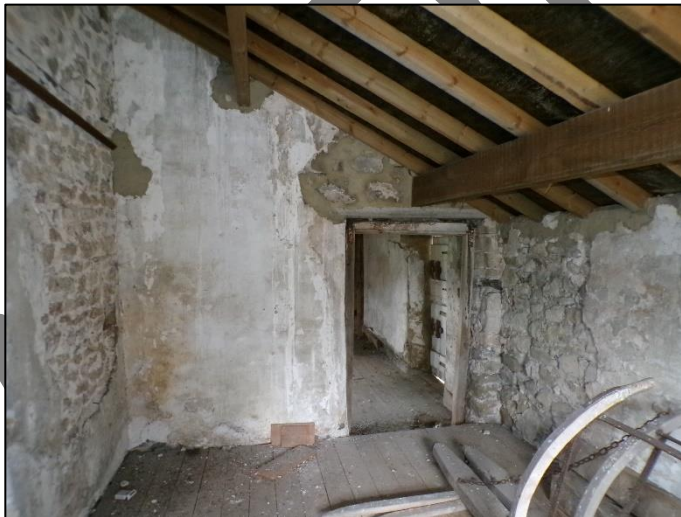
- 3.1.17. The structure over the left side of the building has been replaced approximately 50 years ago and comprises purlins supported between load bearing walls, in turn supporting common rafters over which there is a bitumen-based roofing underfelt.

- 3.1.18. Underfelts provide a secondary barrier to water penetration.
- 3.1.19. Bitumen underfelts used in construction prior to the early 1990s are likely to contain asbestos fibres although these are bound up in bitumen and risk to health is minimal.
- 3.1.20. There is an isolated hole in the underfelt.

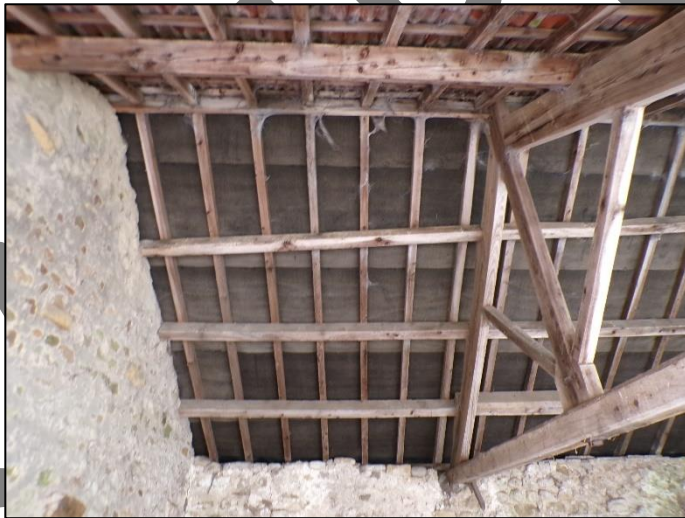
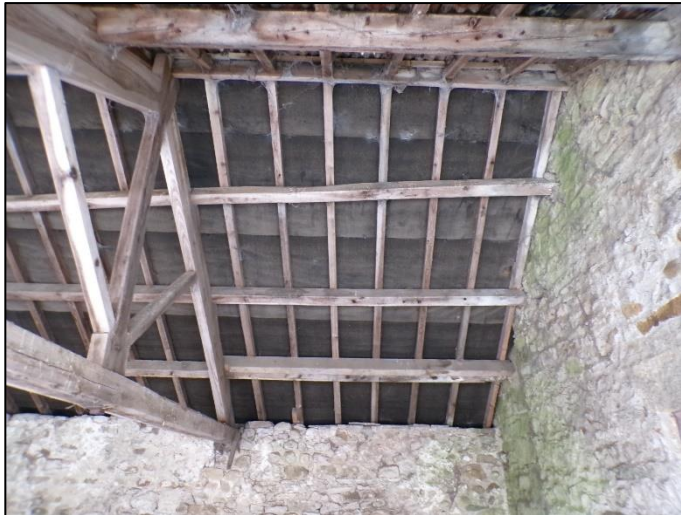
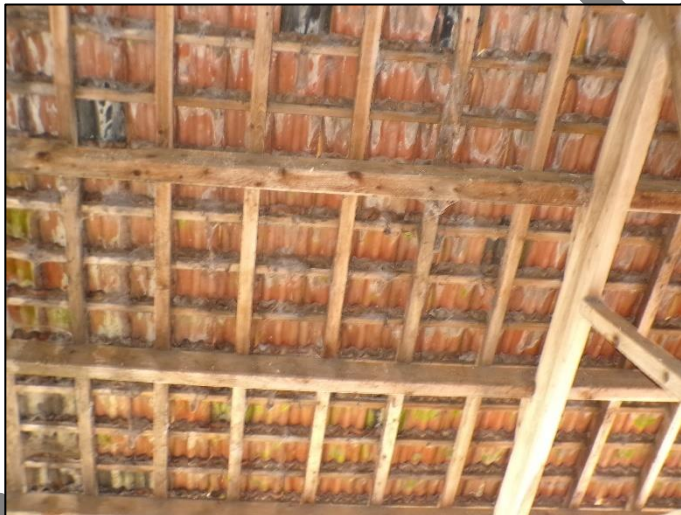
3.1.23. To the right-side slope, there is a bitumen-based roofing underfelt but to the left-side slope there is no underfelt.

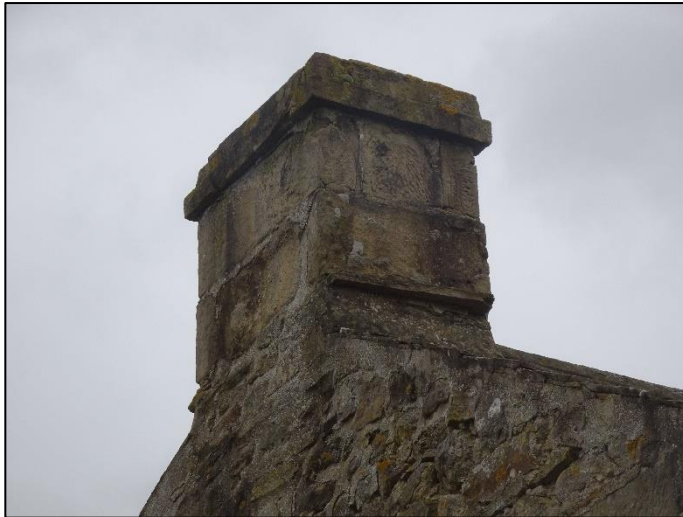
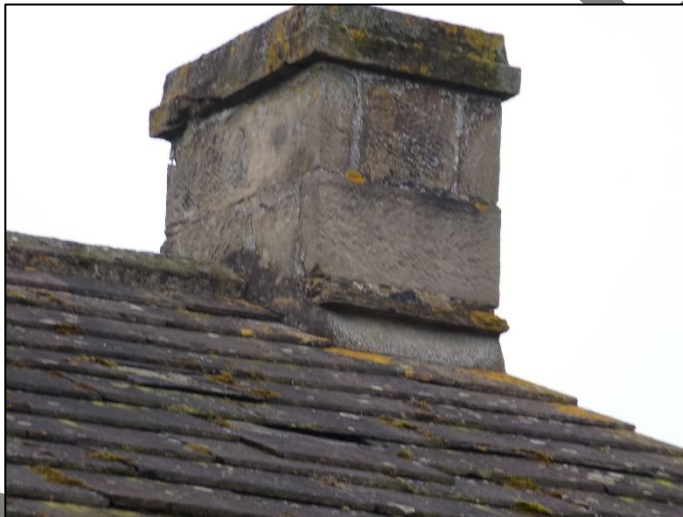
3.2.2. The stonework has visible deterioration and will require replacement in the medium-long term.

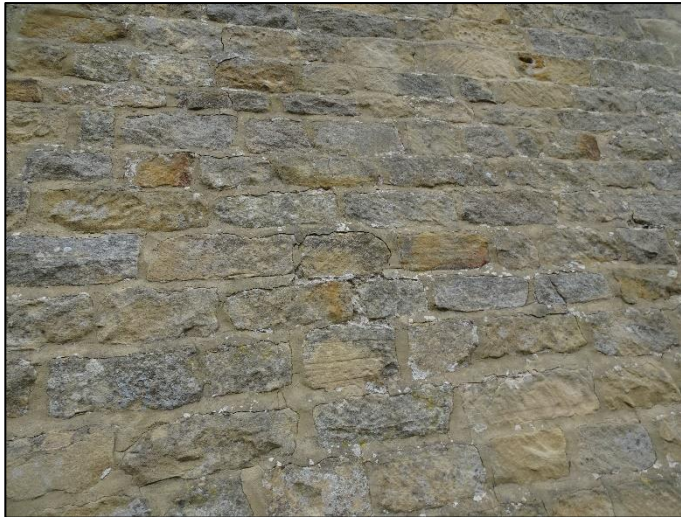
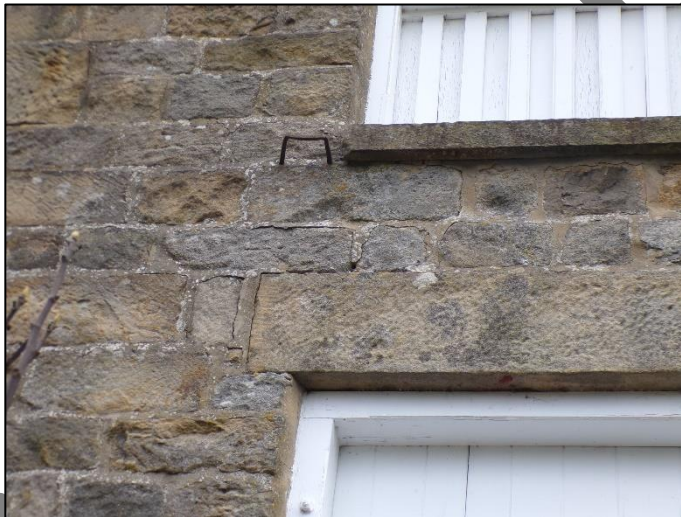
- 3.4.5. There are stone heads and cills to the window and door openings.
- 3.4.6. The front elevation has been re-pointed with a cement-based mortar although the old lime joints have not been raked out prior to re-pointing, resulting in significant areas of cracked and loose mortar.

3.4.7. Cement-based mortars are hard and impervious and can lead to or exacerbate dampness problems and erosion of stonework.

3.4.8. The cement mortar should be removed and replaced with traditional lime mortar.

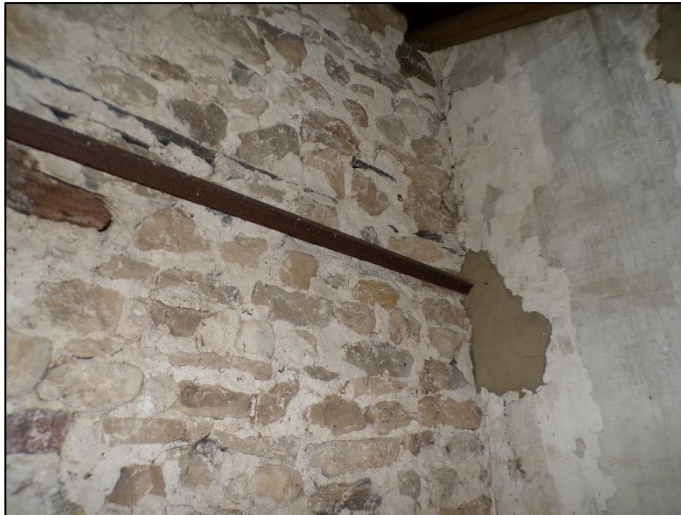
Photograph 57

- 3.4.22. Internally, there is a stone hopper which, especially when it was full of corn, will have exerted significant outward thrust on the walls resulting in the bulging, which has occurred over a long period of time.

- 3.4.23. Cracks are evident to the rear elevation which have been previously re-pointed with a cement-based mortar but since re-opened.
- 3.4.24. A structural engineer will be required to design a suitable method of support for the stone hopper to prevent further outward movement.

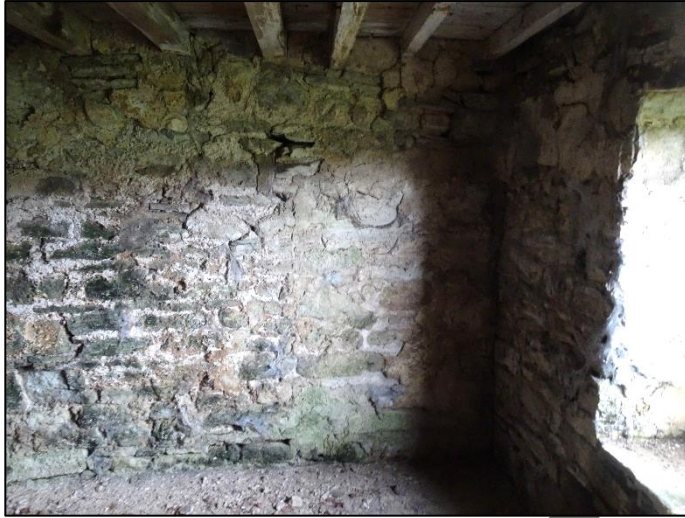
Photograph 61

- 3.4.32. Water penetration is a problem to the front and a channel has been cut to discharge water into the water wheel area.

- 3.4.33. It will be necessary to intercept and divert the water externally.
- 3.4.34. Ground levels to much of the perimeter of the building appear to have been raised over time and this is resulting in damp ingress. Ideally the ground levels would be lowered.
- 3.4.35. The walls have originally had a lime plaster finish internally, although much of this is missing and remaining areas are cracked, loose and friable.

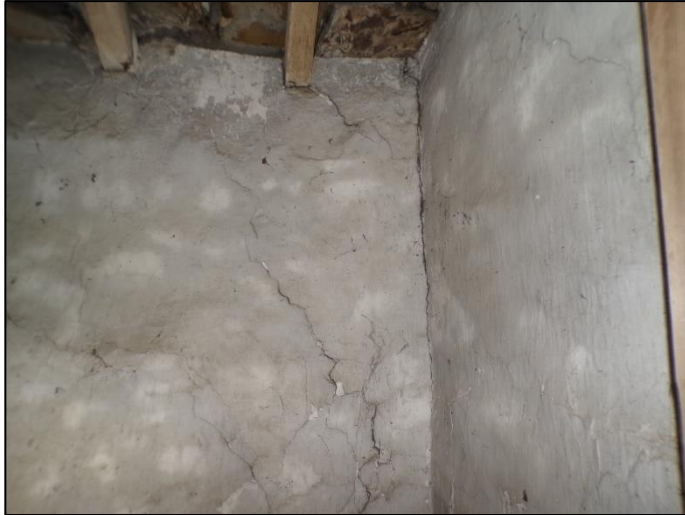
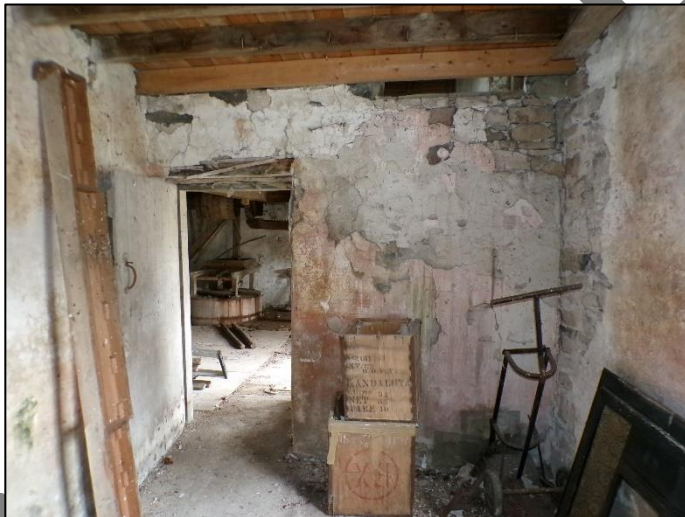
- 3.4.36. There is a substantial gap between the internal cross wall and left-side elevation as a result of outward movement of the external wall although there does not appear to have been any progression since the tie bars were installed and the roof structure replaced.

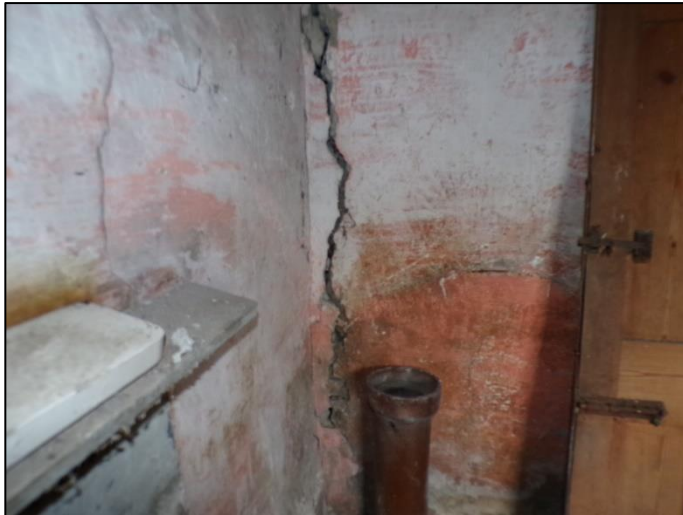
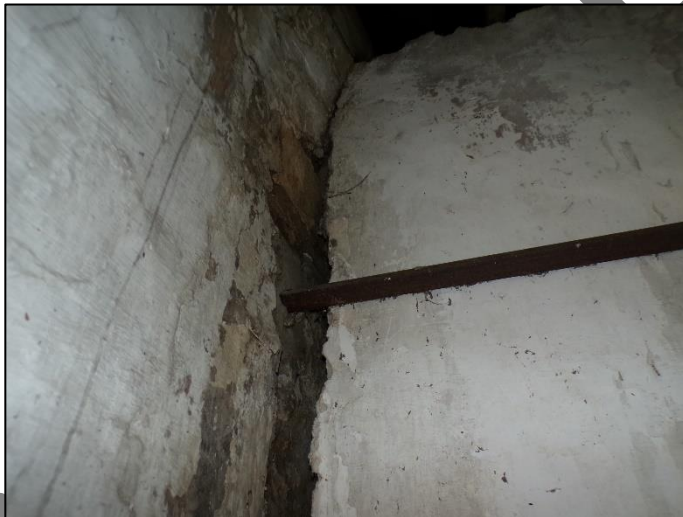
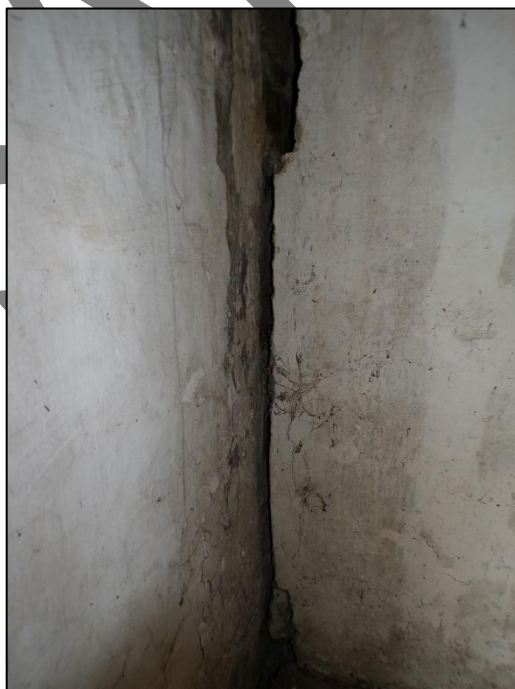
- 3.4.37. To the internal side of the external door and window openings and to the internal door openings, there are timber lintels which have woodworm infestation but when probed with a pen knife, appeared to be reasonably sound.

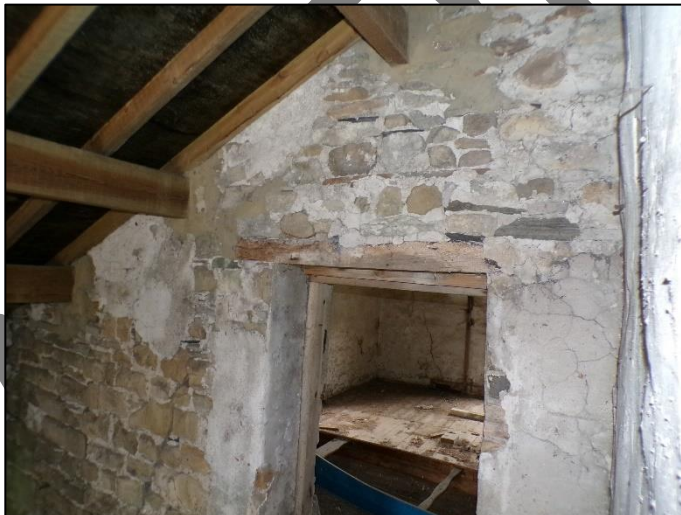
Photograph 70

- 3.4.38. The masonry should be tied into the external wall, particularly if the building is to be converted.
- 3.4.39. Some of the lintels have deflected but are unlikely to deflect any further.

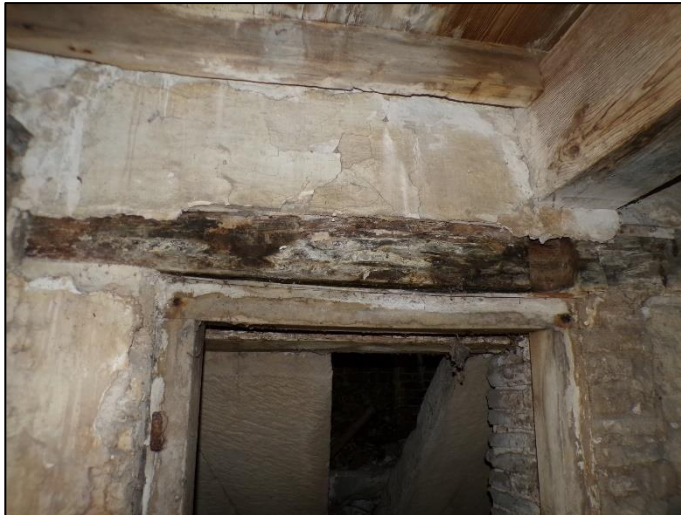
Photograph 71

- 3.4.40. To the front-left, first-floor room, concrete lintels have been installed at the time of re-roofing, the lower purlin being supported above the door.

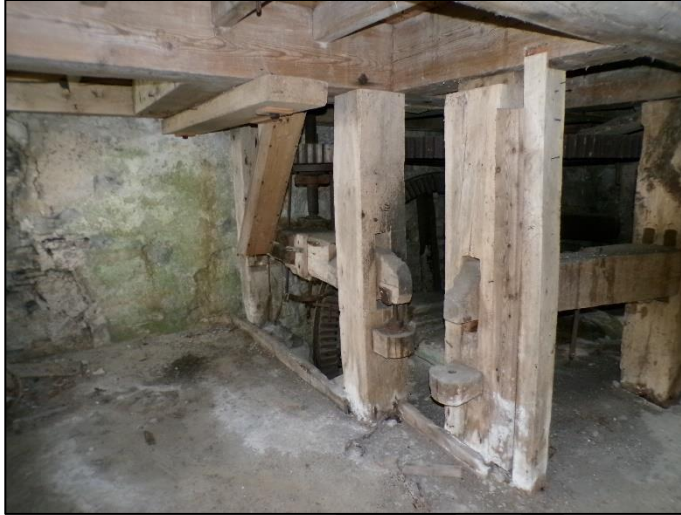
Photograph 73

- 3.5.8. The base to the posts supporting the floor is significantly decayed and will require repair involving replacement of the lower sections.

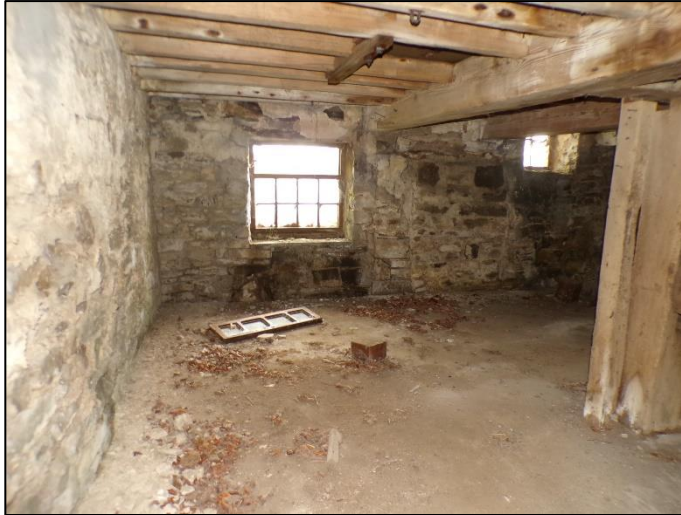
Photograph 85

- 3.5.16. The floor is uneven and I anticipate to have been laid over an earlier floor.
- 3.5.17. Ideally, the floor would be reinstated at its original level if this can be identified/confirmed.
- 3.5.18. The hopper/drying room floor could not be inspected.
- 3.5.19. There are brick columns and arches supporting stone joists and the hopper is formed with ashlar stone slabs.

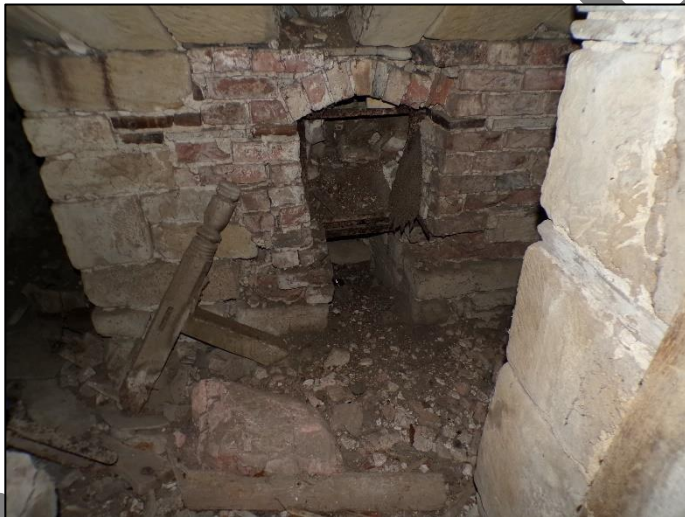
Photograph 88

3.5.20. Some of the stone slabs and stone joists have collapsed or been removed.

- 3.5.21. There is debris in the hopper which requires cleaning out.
- 3.5.22. Brickwork is deteriorating and some of the columns lean out of plumb.
- 3.5.23. Some of the stone joists are broken and missing and extensive repairs are required.

- 4.17. The hopper requires repairs/re-building to the supporting brickwork columns and I would recommend that a suspended timber floor is installed above the existing stone joists.
