IRJ/AH/S1603/L2

**Introduction to the Report**

Instructions received are to carry out an RICS Level 2 Building Survey of the property which were accepted and confirmed in my letter of the

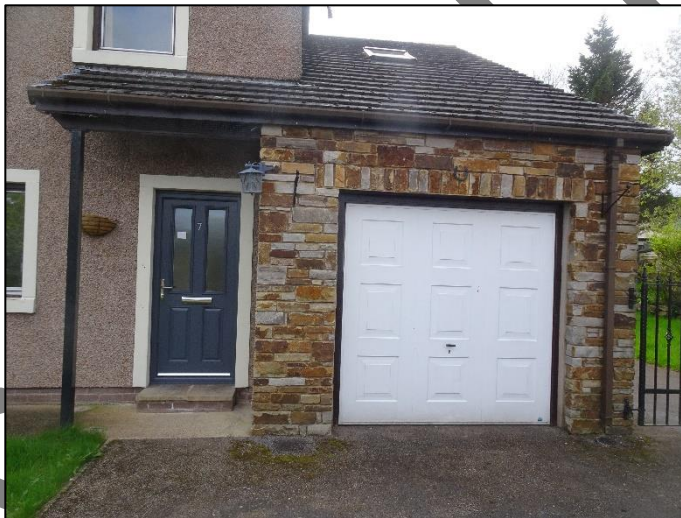
**Photograph 2**

- 3.1.1. The roofs have been viewed from ground level with the aid of a pair of binoculars where appropriate.
- 3.1.2. The roof is on two levels, to the right side, the roof over the garage is at lower level than the main roof and extends over the front entrance door.

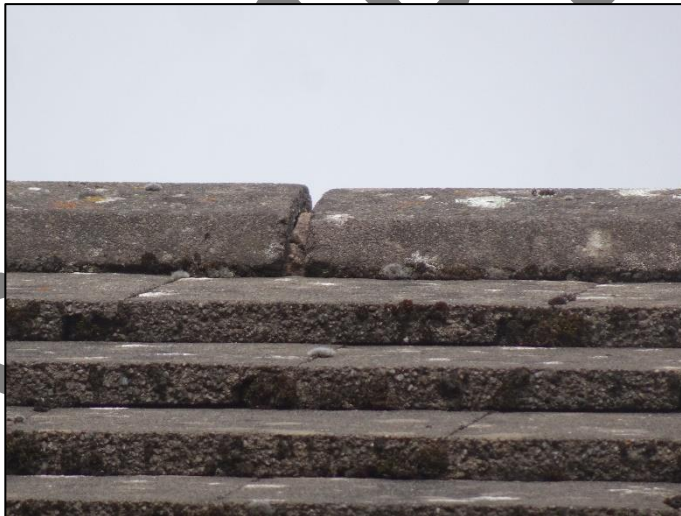
**Photograph 4**

- 3.1.6. There is light moss growth to the roof slopes which should be periodically cleaned off and has prevented inspection of the pointing to the ridges.
- 3.1.7. There is some erosion and cracking of mortar to the ridges which should be replaced as necessary as part of ongoing maintenance and repairs.

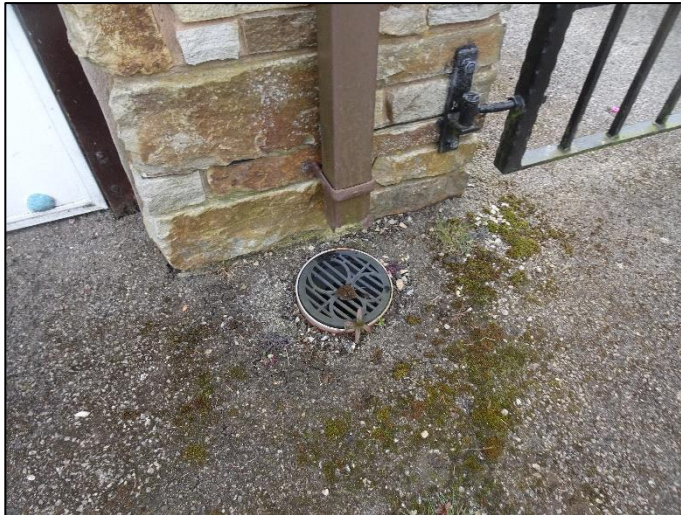
**Photograph 8**

- 3.3.1. The roof slopes discharge to eaves gutters which are square section, brown plastic, supported with fascia brackets and in turn discharging to square section, brown plastic rainwater downpipes.
- 3.3.2. To the front right, the downpipe is damaged at its base and does not discharge over the gulley. The shoe is defective, having been taken off and laid beneath the meter cabinets to the right side of the property.

- 3.3.3. I would recommend that a bend or shoe is fitted to ensure that rainwater discharges properly into the gulley.
- 3.3.4. The shoe to the rear-right rainwater downpipe is damaged and held in place by a piece of wire.

- 4.6. The rainwater goods were not seen under operational conditions and I anticipate that there may be leaking joints.
- 4.7. At this stage, allowance should be made for replacement of the seals and replacement shoes to the front and rear-right side downpipes.

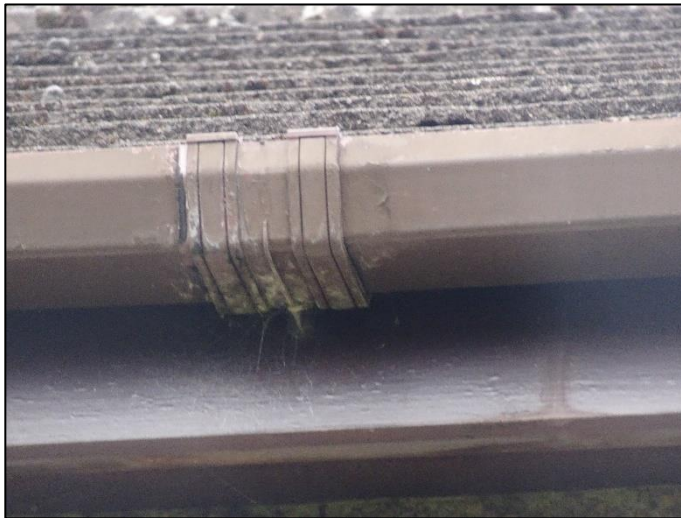
**Photograph 11**

- 3.3.5. There is some discolouration evident to the rainwater goods due to sunlight but which will not affect performance.
- 3.3.6. The weather remained essentially dry during the survey and therefore the rainwater goods were not seen under operational conditions.
- 3.3.7. There is staining around gutter and pipe joints, potentially indicative of leakage.

- 3.3.8. The rainwater goods should be observed during periods of rainfall to determine whether or not replacement seals are required.
- 3.3.9. Inadequate disposal of rainwater can cause serious defects within a building, including damp, timber decay and structural movement. It is therefore important that rainwater goods are kept in a well-maintained condition. In particular, it is recommended that gutters are kept clear and cleaned of any leaves, silt and rubbish on a regular basis. In addition, joints and brackets should be checked periodically.

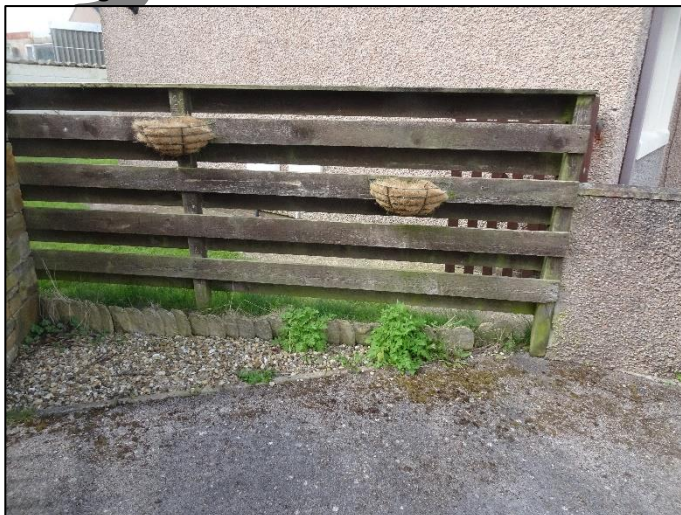
**Photograph 21**

- 3.6.6. The fence is wobbly, indicative of decay to the posts below ground.
- 3.6.7. To the front left, there is a timber post and horizontal rail fence which is within a hedge, the only visible bit being close to the house, where it is seen to be in reasonable condition.

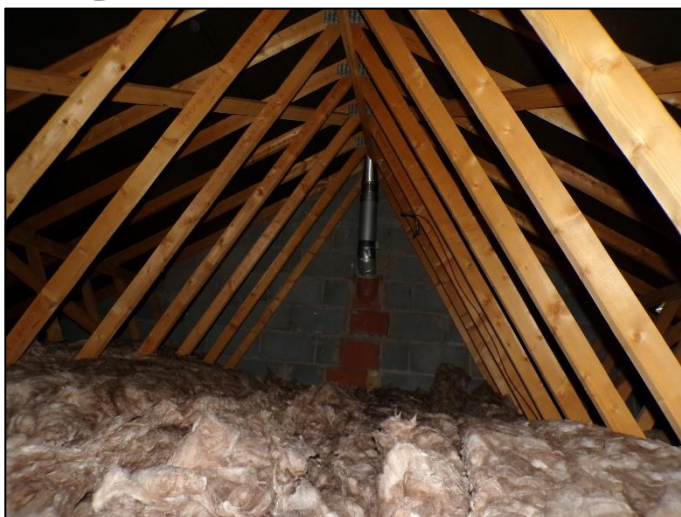
**Photograph 33**

- 3.7.1. Access to the main roof void is via a hatch within the landing ceiling.
- 3.7.2. The hatch is very small.
- 3.7.3. The inspection was limited to a head and shoulders examination due to the amount of insulation laid between and over the ceiling joists and small access hatch.
- 3.7.4. The roof structure comprises pre-fabricated trussed rafters, over which there is bitumen-based roofing underfelt.

- 3.7.5. Underfelts provide a secondary barrier to water penetration.
- 3.7.6. Where inspected, there was no evidence of any defects or woodworm infestation to the roof structure.

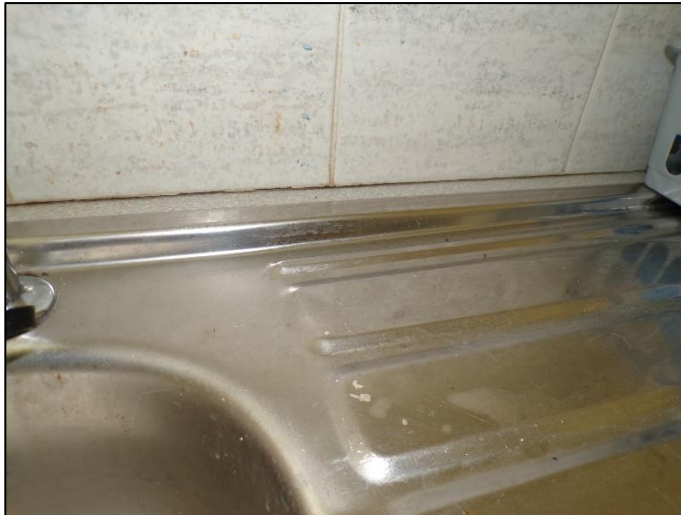
**Photograph 40**

- 3.12.4. The units are likely to be original to the time of construction and are in reasonable condition for their age.
- 3.12.5. There is splash back tiling above the worktop.
- 3.12.6. There is a gap between the tiling and worktop which should be sealed with silicone.

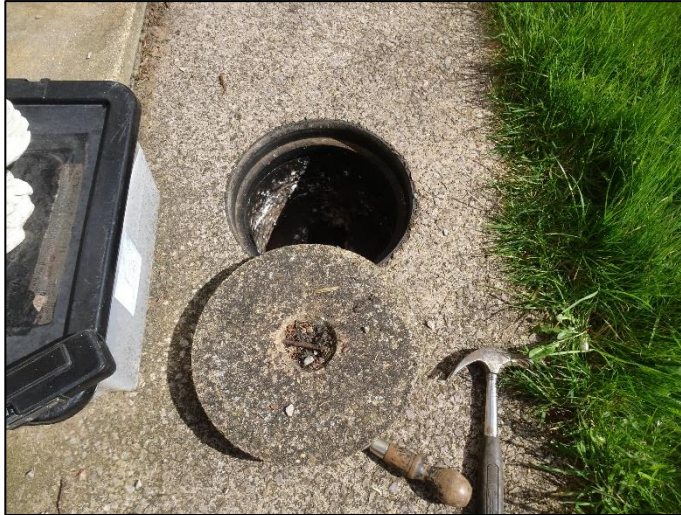
**Photograph 55**

- 3.17.4. The chamber was running freely at the time of the survey but requires general flushing and cleaning.

- 4.12. The drainage gullies require routinely cleaning out and I would recommend that the drainage inspection chamber is flushed and cleaned.
- 4.13. The electrical installation should be tested and upgraded as necessary.

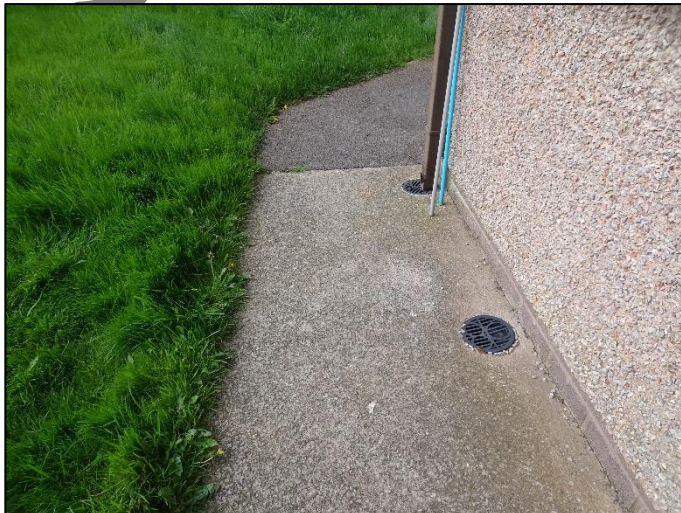
**Photograph 57**

- 3.17.6. The gulley to the front right appears to be blocked with water close to the grating.
